# State of New Mexico Energy, Minerals and Natural Resources Department Oil Conservation Division

# PLUG AND ABANDONMENT PROCEDURE

#### Hubbard #5

Blanco Pictured Cliffs DPNO 29905 SW, Sec. 22, T32N, R12W San Juan County, New Mexico

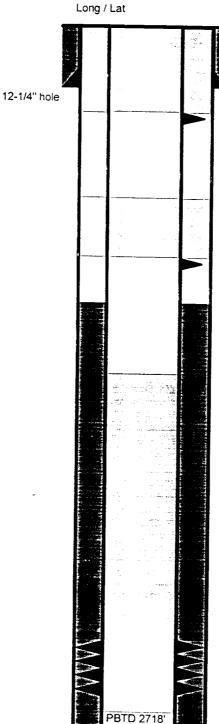
Pictured Cliffs @ 2525'

6-3/4 hole

TD 2750'

8-5/8" 24#, K55 Casing set @ 142' Cmt with 110 sxs (Circulated to Surface)

It is intended to plug and procedure and well:	d abandon the subject well bore diagram.	DEGIN SEP	EIVED - 5 1997 DI. DIV. J. S
