Atkins ENGINEERING ASSOCIATES INC.
2904 W 2nd St.
Roswell, NM 88201
voice: 575.624.2420
fax: 575.624.2421
www.atkinseng.com

Re: Summary Letter for BGT Removal and Soil Sampling Activities at PWS Sandpoint Facility, Eddy County, New Mexico.

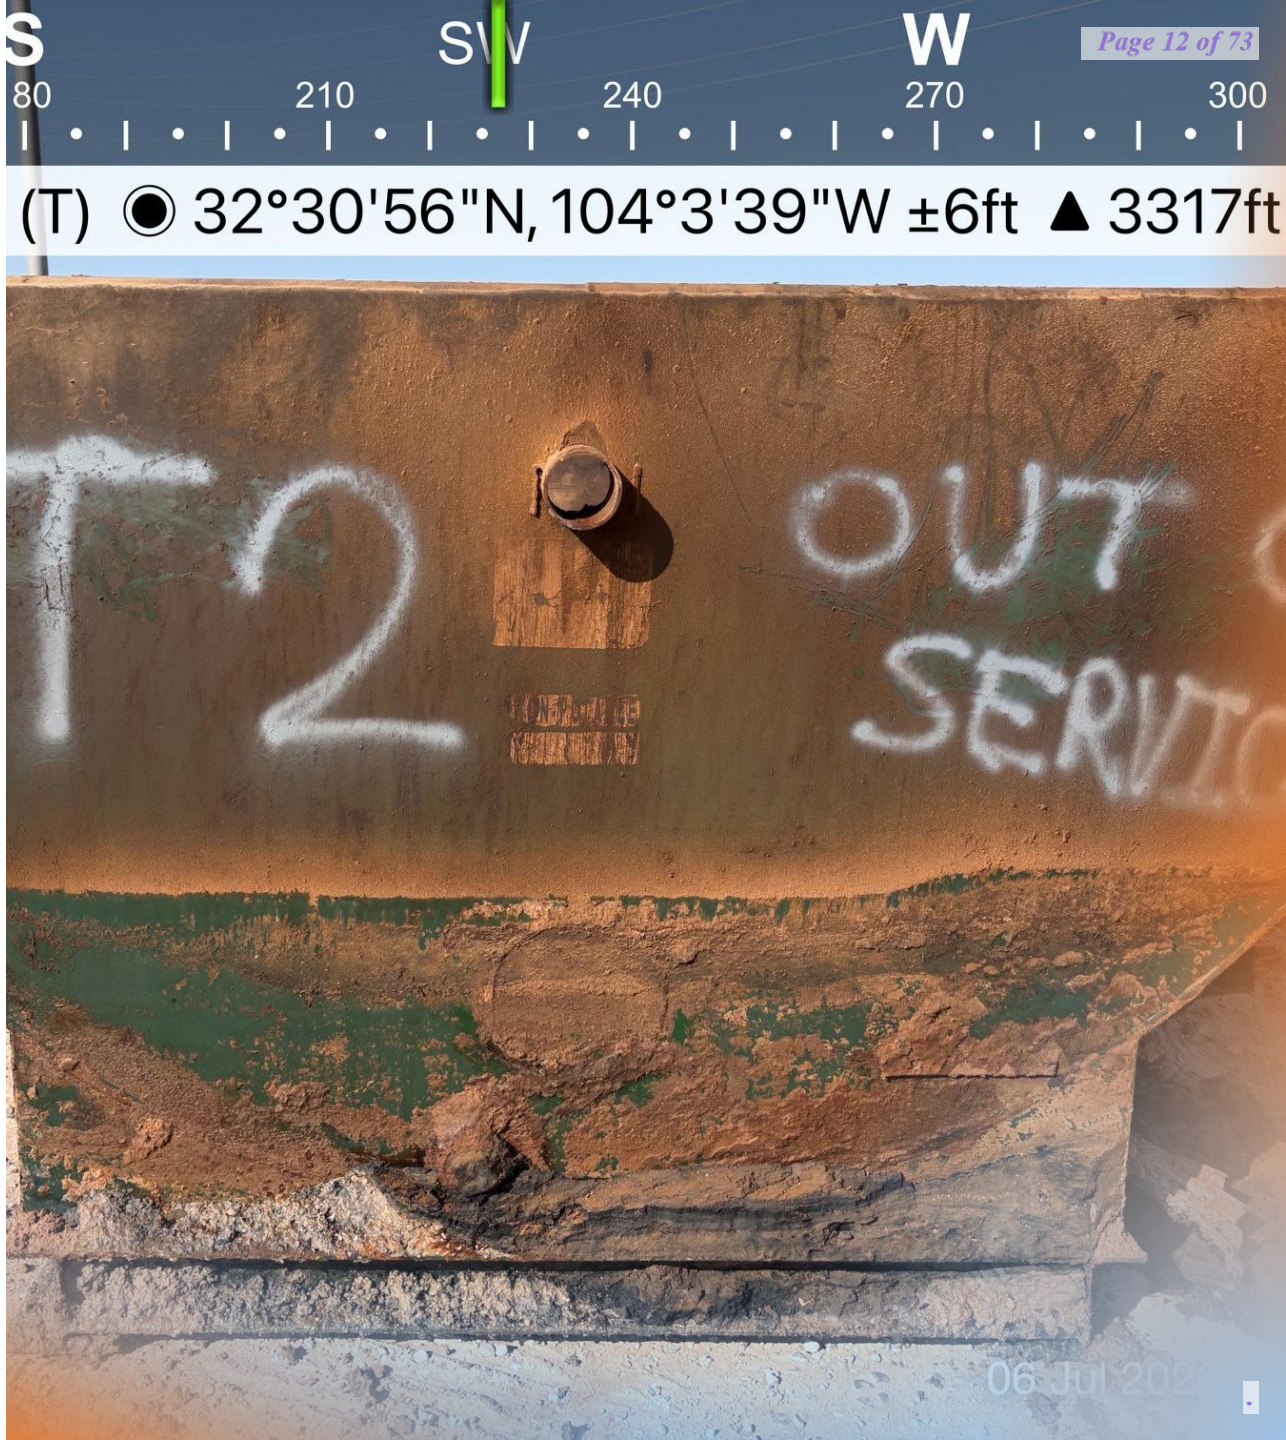
Sandpoint PWS– Tank Pull (North Side of the Tank BGT T2)(Soil Sampling Photos)

- No hits on quad gas
- No abrasions or cracks on lines

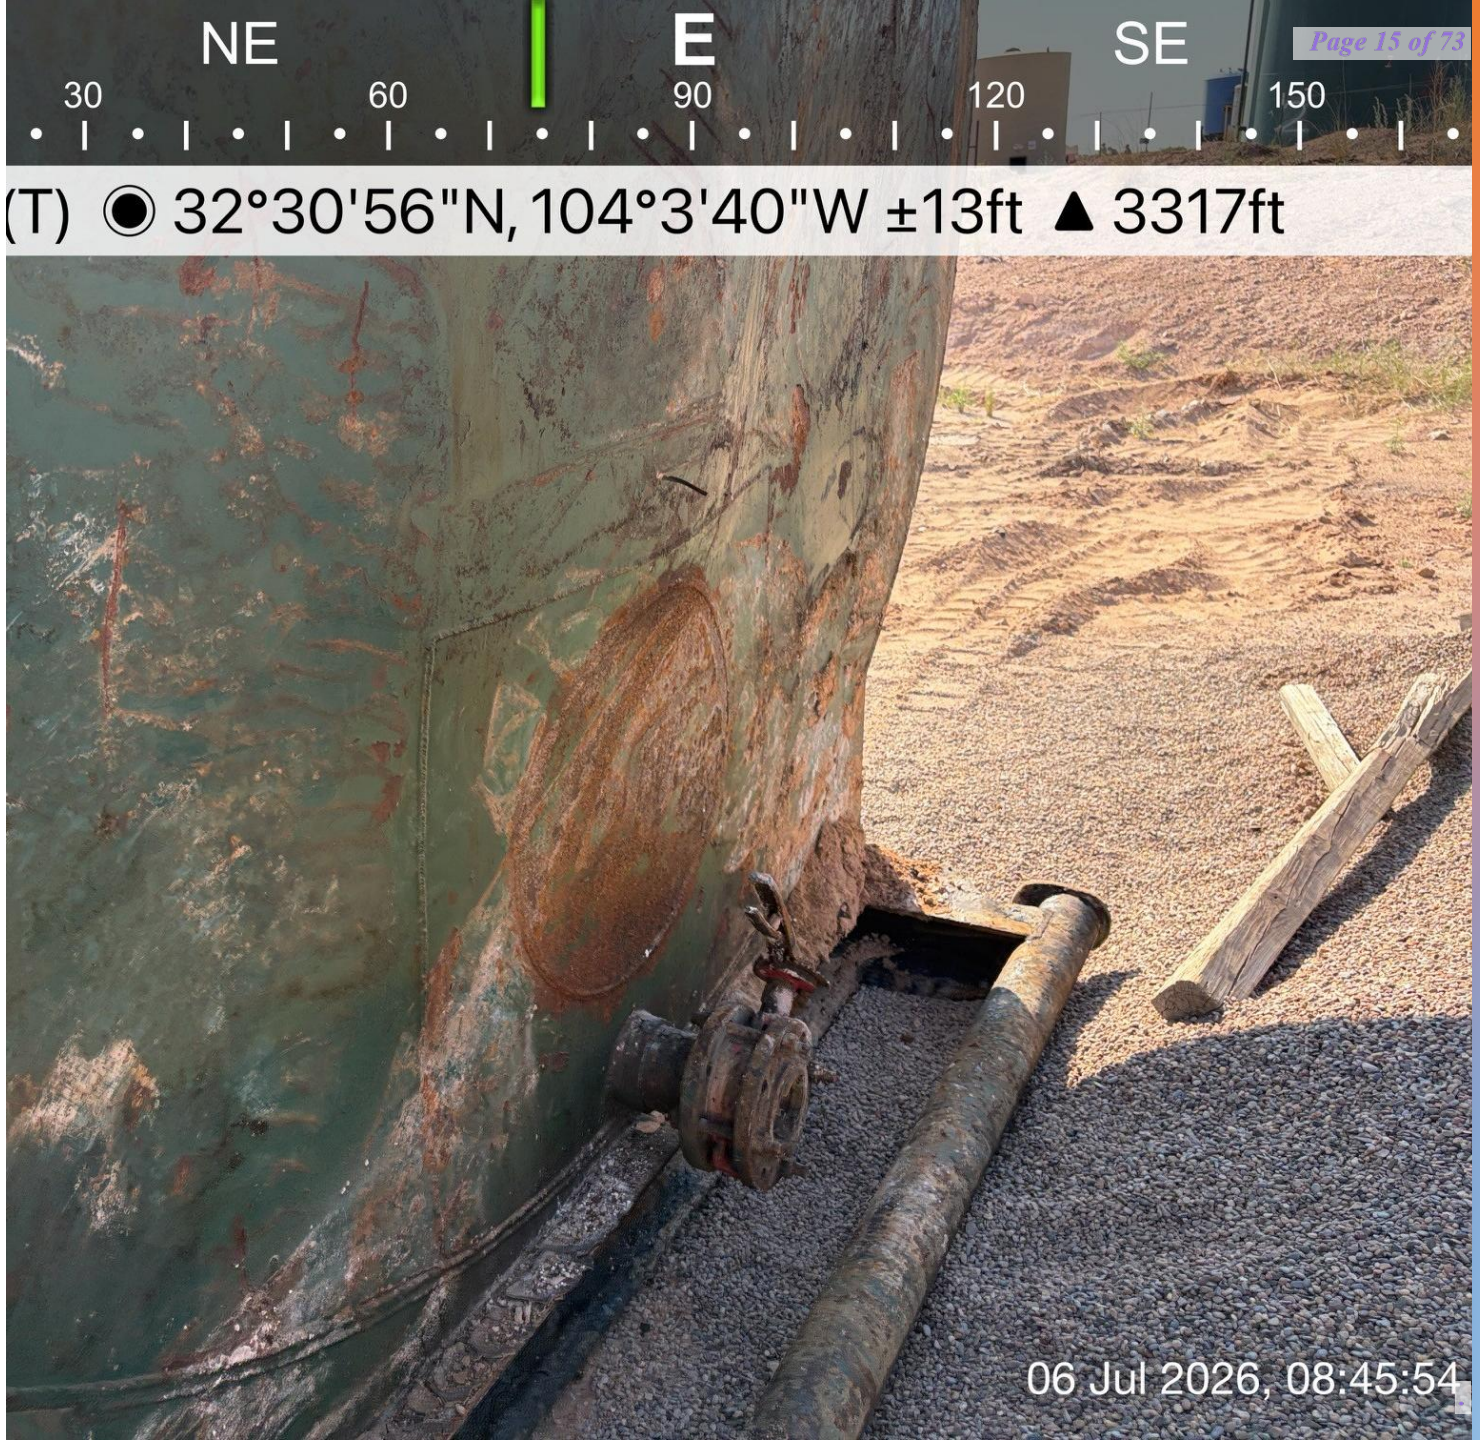
Sandpoint PWS– Tank Pull (South Side of the Tank BGT T2)(Soil Sampling Photos)

- No hits on quad gas
- No abrasions or cracks on lines

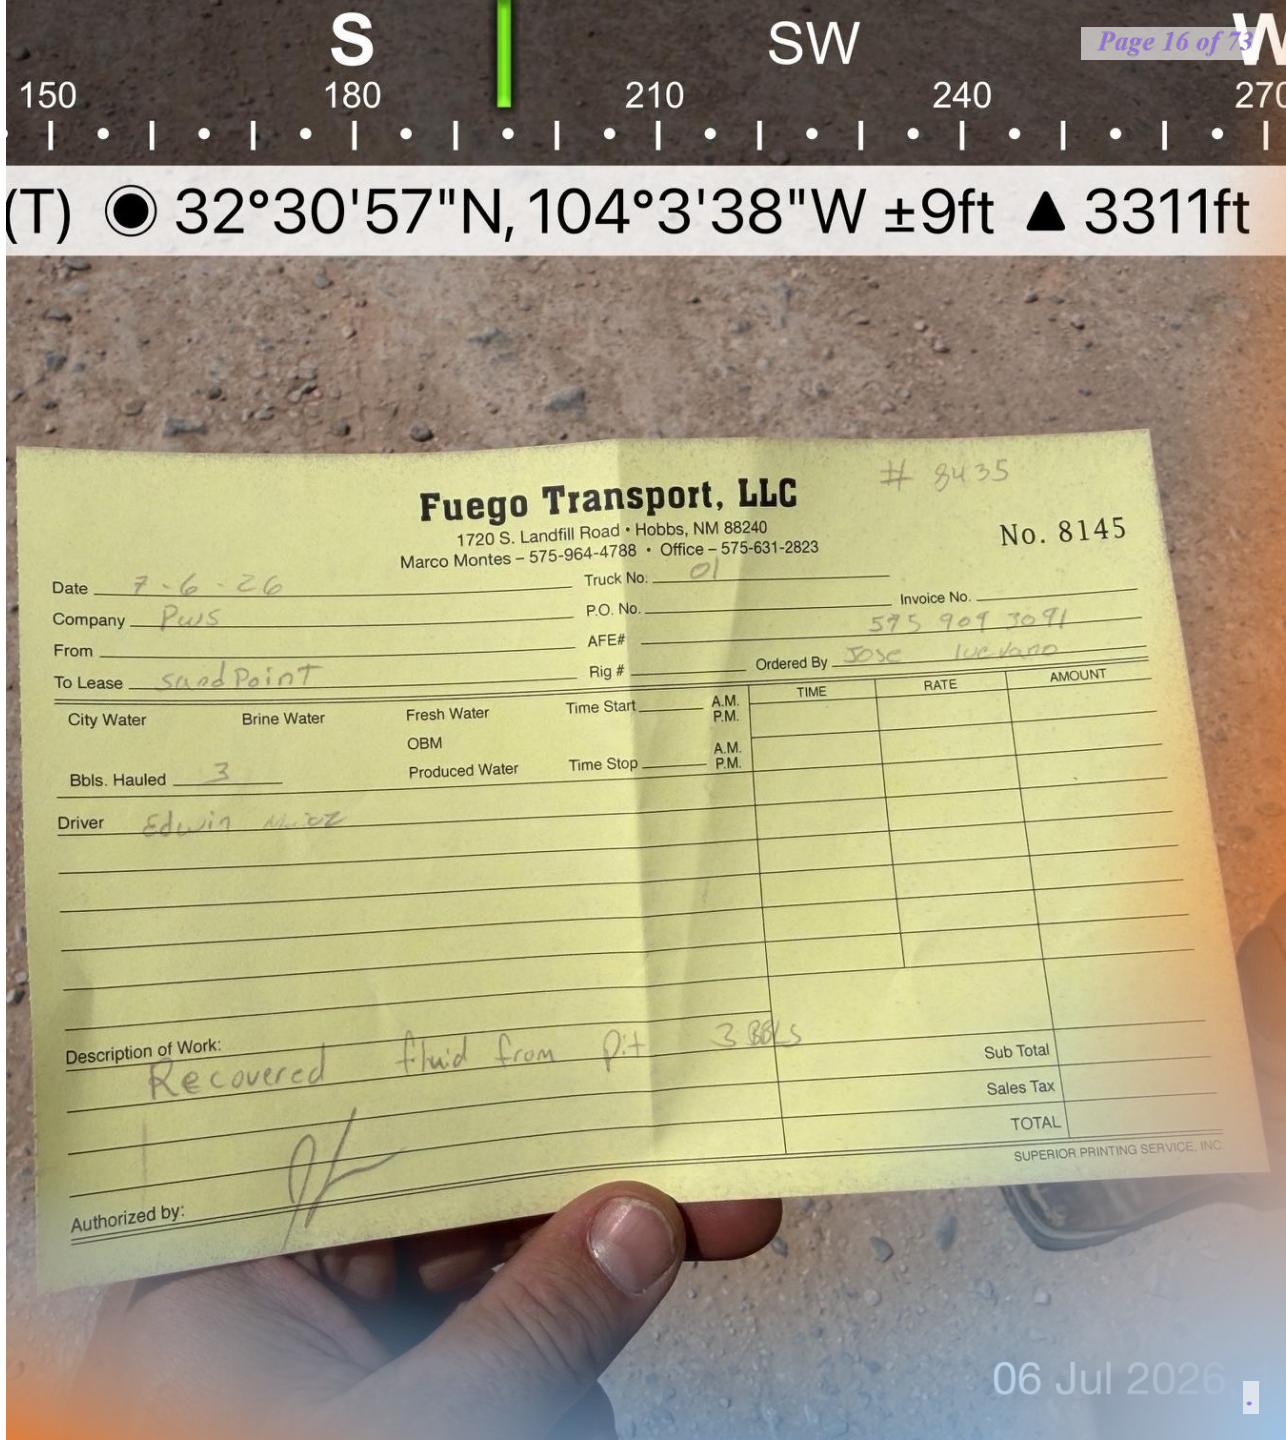
Sandpoint PWS– Tank Pull (Vacuum Truck ticket)

- 3bbl recovered
- Liner removed after

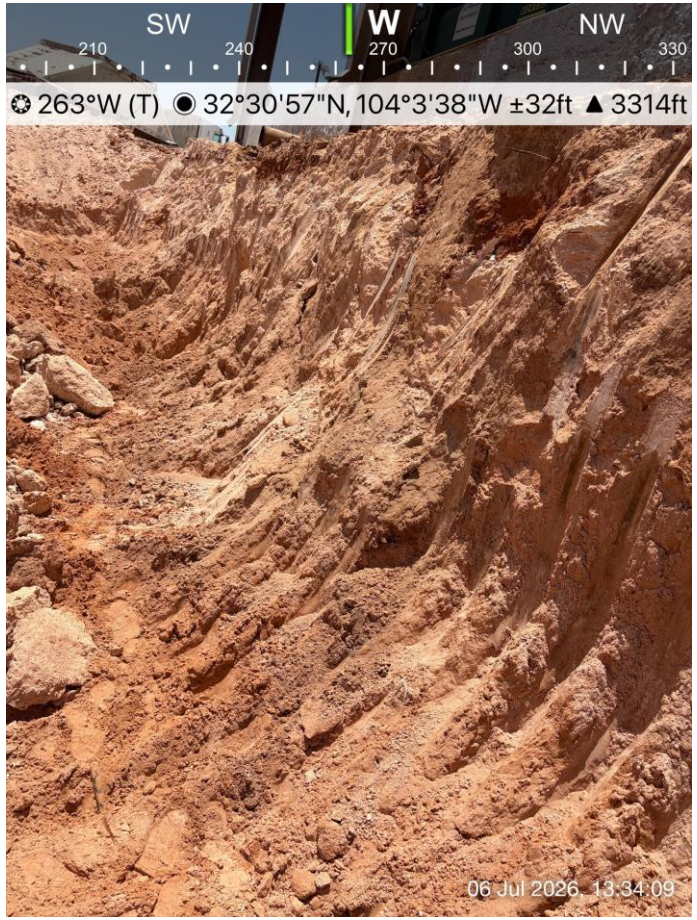
Samples T1 and TC

1. Soil Sample Location (T1) was in the northeast corner of the property beneath the former tank. The sample was collected at 7 feet BGS at 14:44. On-site PID results were 15.0. Details of the subsurface soil conditions are included in the site photos.
