ENSOLUM

January 16, 2026

Re: Closure Request
Golden 8 Federal #001
Incident Numbers nKMW1035646177, nKMW1106629393, nJMW1333053660, nAB1422637219, nAB1607837012, nAB1633656856, nAB1803638613, and nAB1929041495
Eddy County, New Mexico

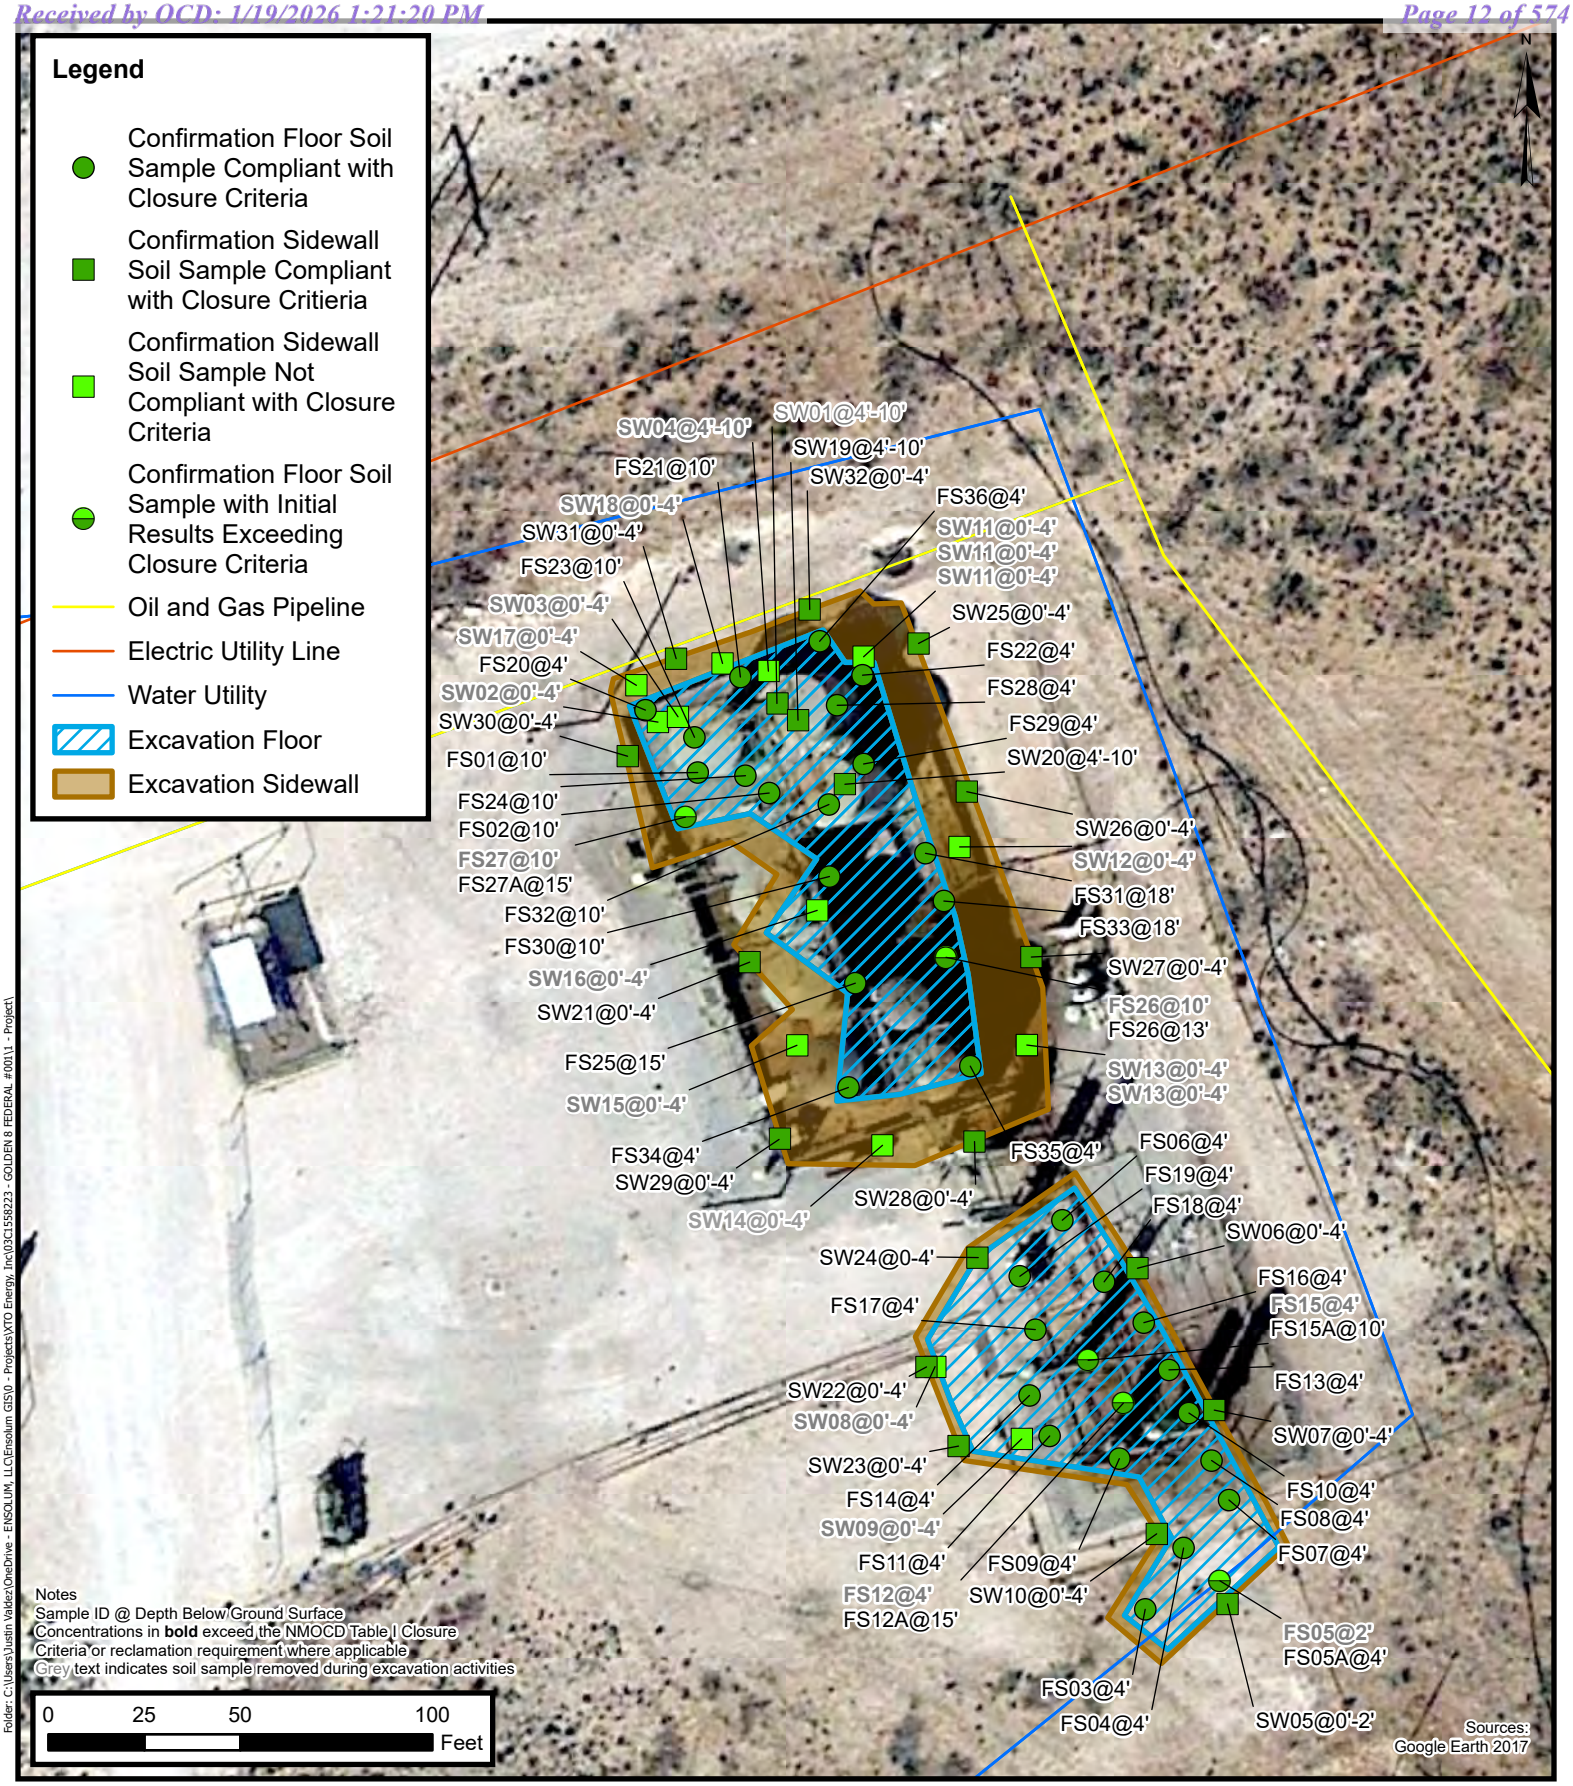
FIGURE 2

Deferral Locations

XTO Energy, Inc
GOLDEN 8 FEDERAL #001
Incident Numbers: nKMW1035646177, nKMW1106629393, nJMW1333053660, nAB1422637219, and nAB1929041495
Unit K, Section 8, T 21S, R 29E
Eddy County, New Mexico

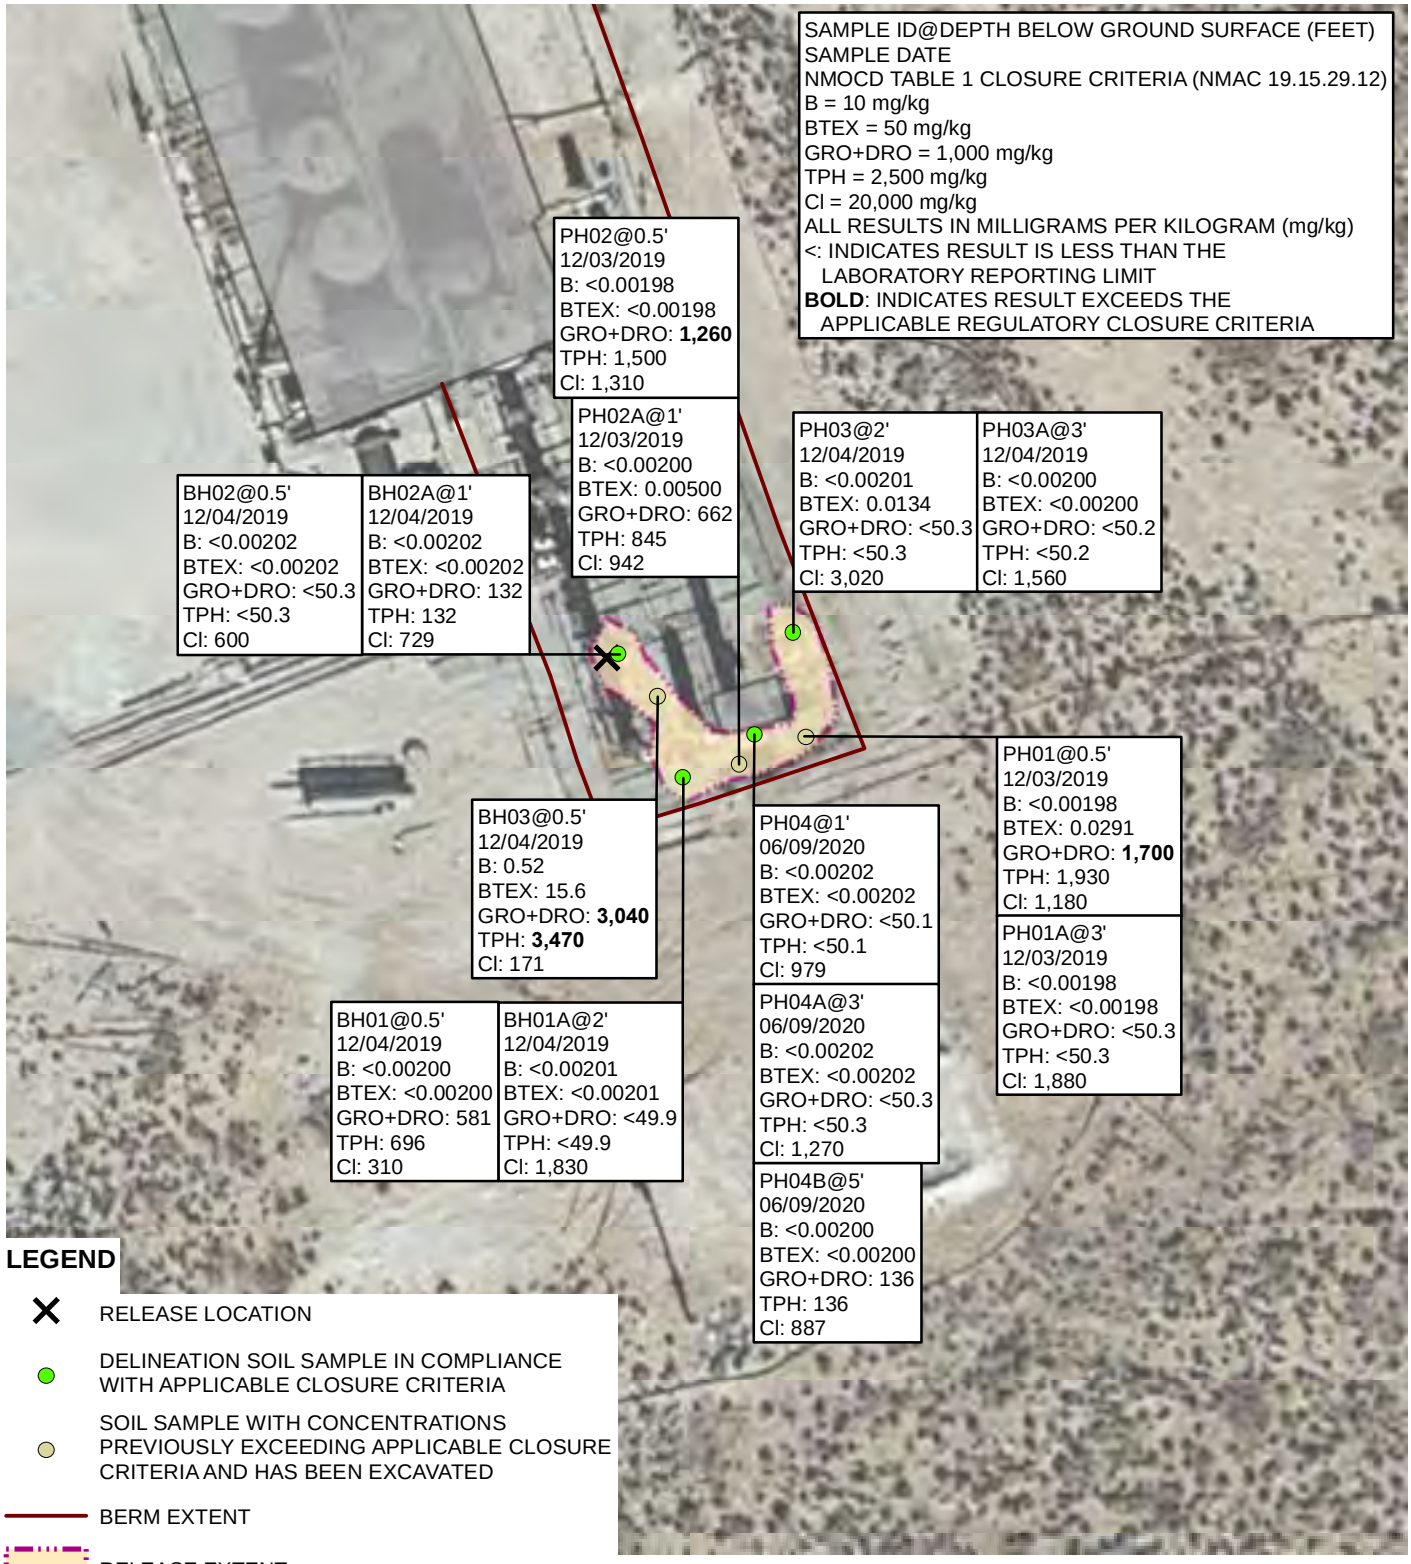
FIGURE 3
DELINEATION SOIL SAMPLE LOCATIONS
GOLDEN 8 FEDERAL BATTERY 1
UNIT K SEC 8 T21S R29E
EDDY COUNTY, NEW MEXICO
XTO ENERGY, INC.

Soil from all potholes and boreholes were field screened for volatile aromatic hydrocarbons and chloride. The delineation soil samples were collected, handled, and analyzed as described above at Xenco in Carlsbad, New Mexico. Field screening results and observations for each pothole and borehole location were logged on lithologic/soil sampling logs, which are included in Attachment 4. The delineation soil sample locations are depicted on Figure 3.
