Re: Reclamation Report
Golden 8 Federal #001
Incident Numbers nKMW1035646177, nKMW1106629393, nJMW1333053660, nAB1422637219, nAB1607837012, nAB1633656856, nAB1803638613, and nAB1929041495
Eddy County, New Mexico

Ensolum, LLC (Ensolum), on behalf of XTO Energy, Inc (XTO), has prepared the following *Reclamation Report* for the Golden 8 Federal #001 (Site). This *Reclamation Report* documents the Site history, reclamation activities completed to date, and proposes a vegetation monitoring plan.

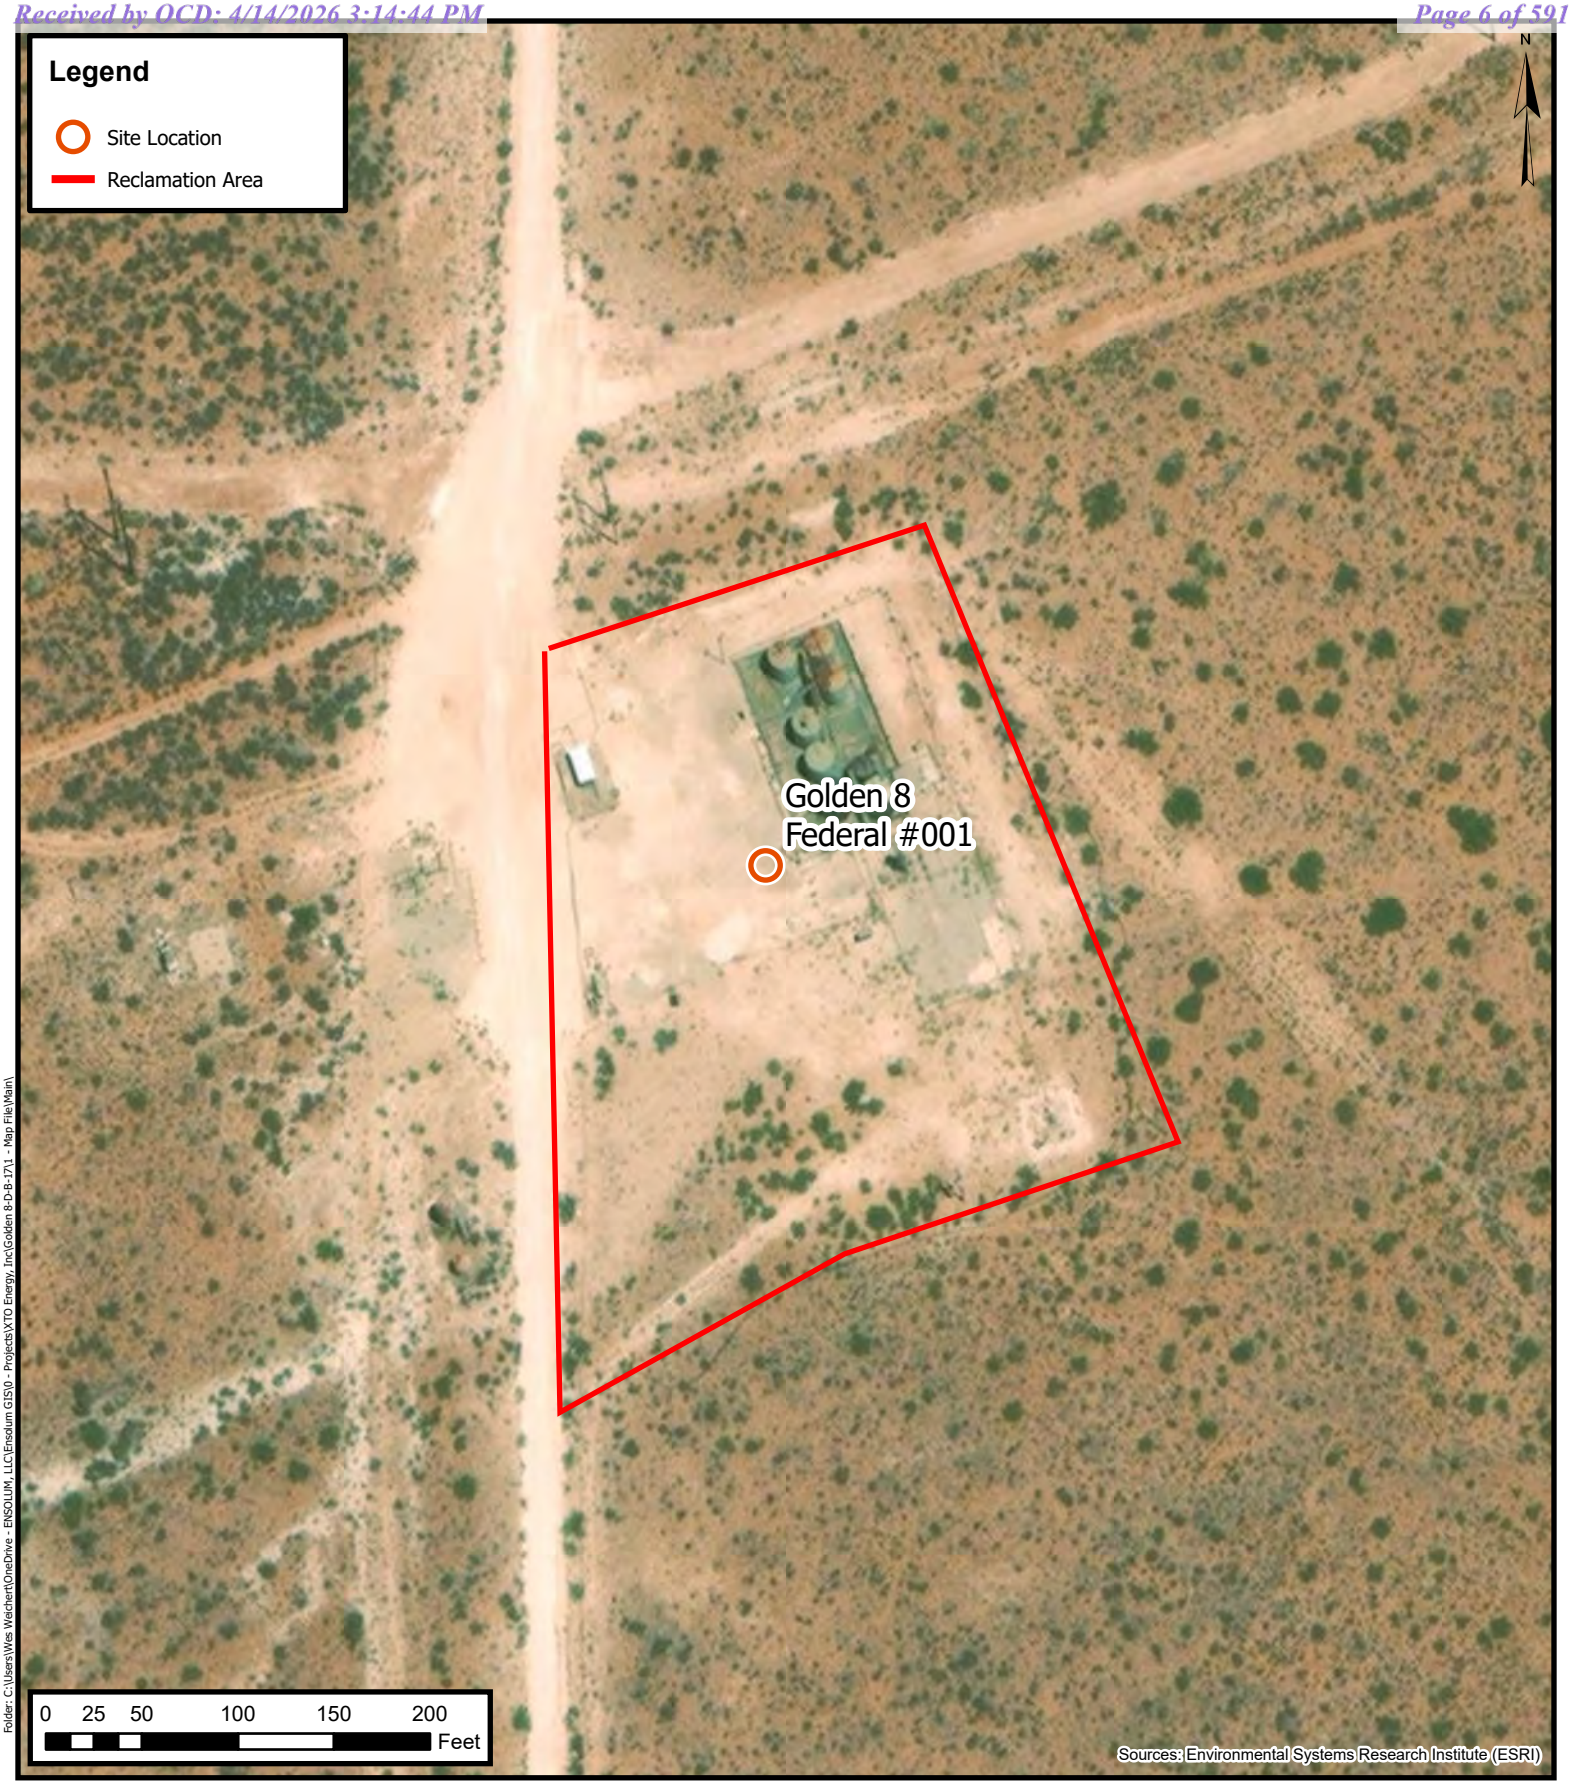
FIGURE 1

Excavation Area Map

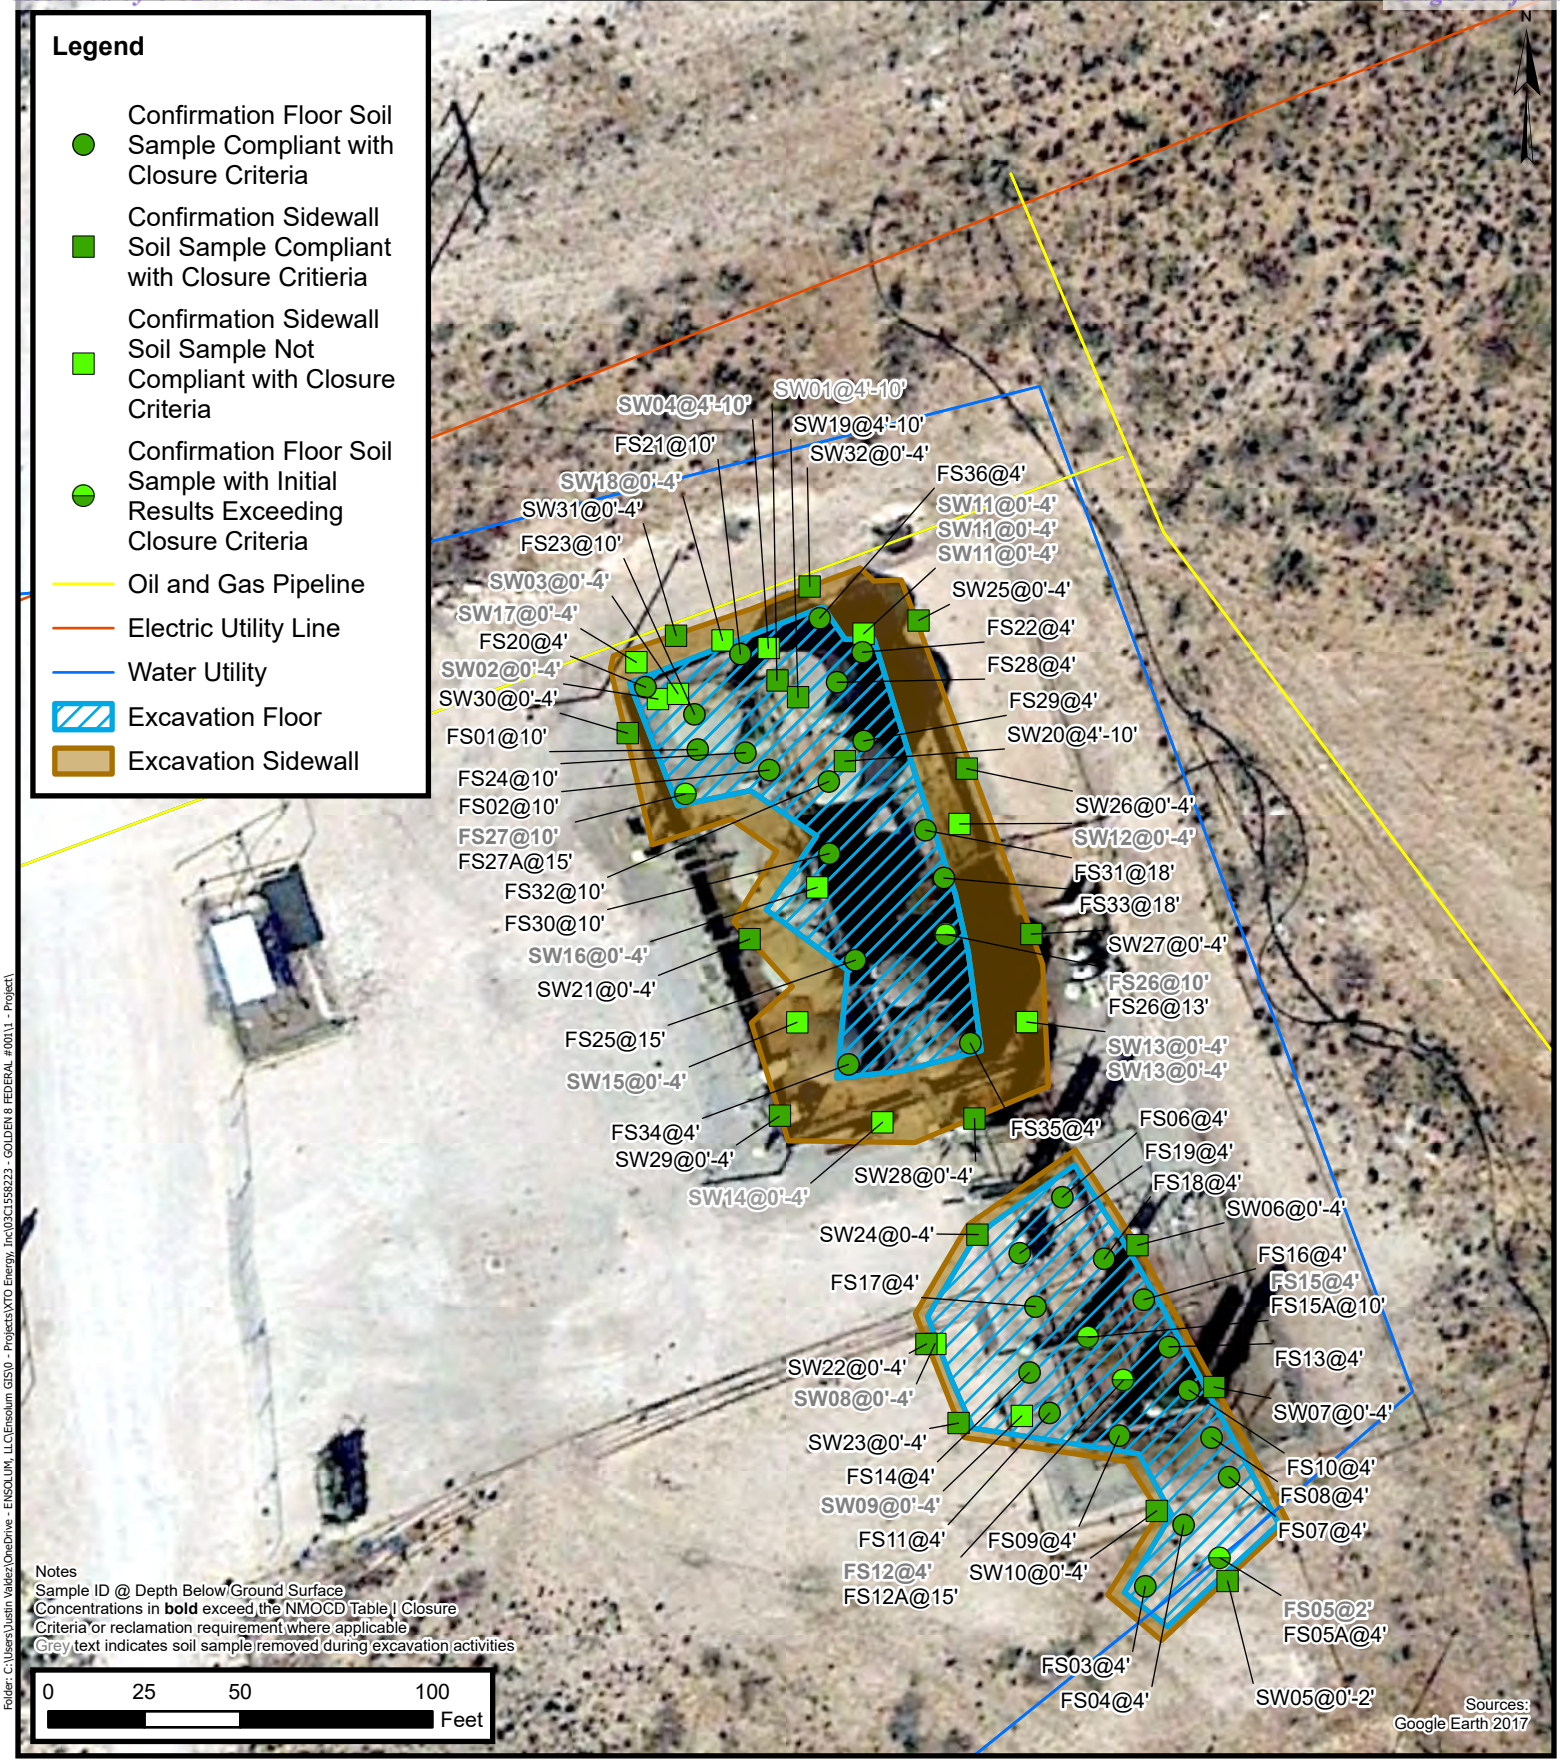
FIGURE 2

Deferral Locations
