From: Hansen, Edward J., EMNRD
Sent: Thursday, November 07, 2013 4:21 PM
To: Hack Conder (hconder@riceswd.com)
Cc: VonGonten, Glenn, EMNRD; Lowe, Leonard, EMNRD; Leking, Geoffrey R, EMNRD; Katie Jones <kjones@riceswd.com> (kjones@riceswd.com); lflores@rice-ecs.com; Scott Curtis (scurtis@riceswd.com)
Subject: Remediation Plan (1R427-192) Termination - ROC EME Jct E-25 Site

RE: Termination Request
EME Jct. E-25 (1R427-192): UL/E, Sec. 25, T19S, R36E
RICE Operating Company – Eunice Monument Eumont (EME) SWD System

RICE OPERATING COMPANY
JUNCTION BOX FINAL REPORT

EME Jct. E-25 (1R427-192)

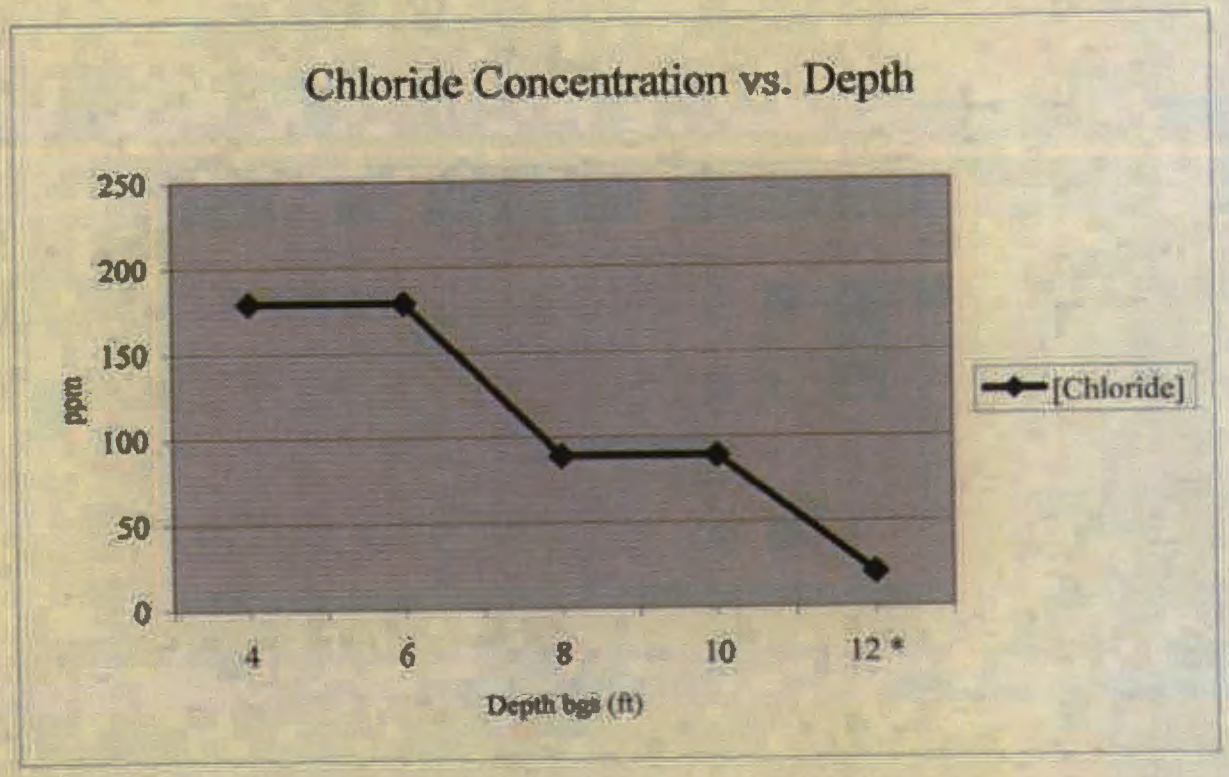
Vertical Delineation at Source

Depth bgs (ft)	[Cl⁻] ppm
4	179
6	179
8	89
10	89
12 *	20

* lab test = <20 ppm;
field test = 89 ppm

Groundwater = 57 ft

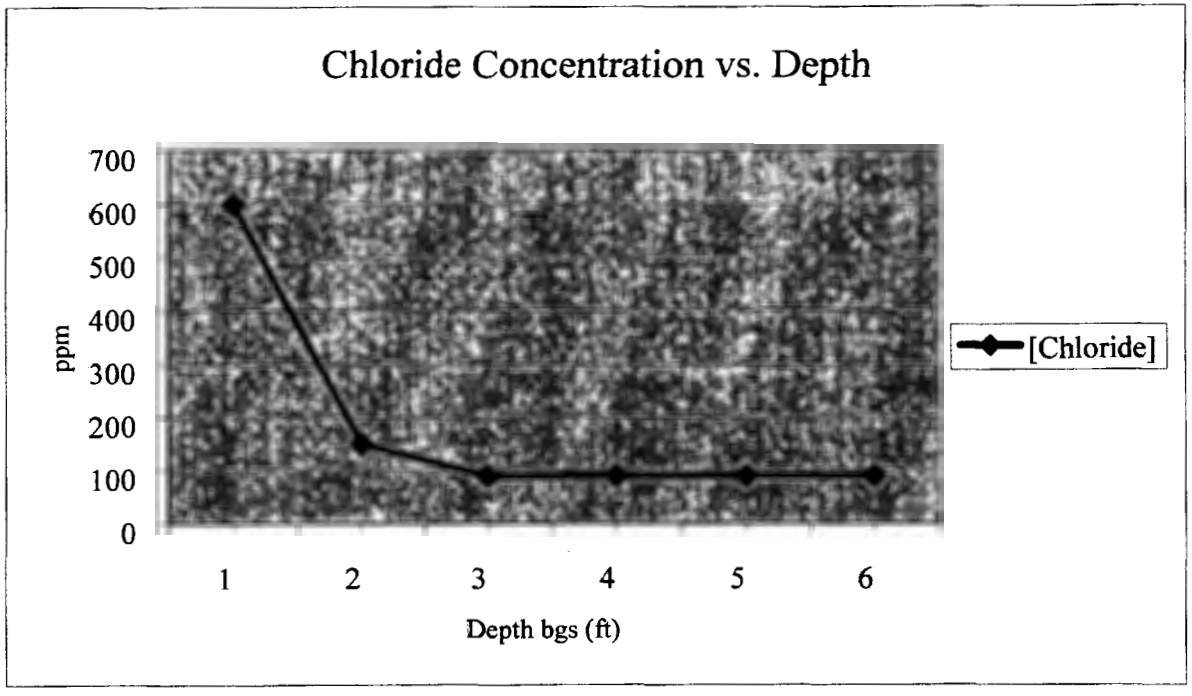
5 ft NORTH of junction

Depth bgs (ft)	[Cl] ppm
1	599
2	149
3	89
4	89
5	89
6	89

Groundwater = 57 ft
