EME Jct. H-4

RE: Termination Request
EME Jct. H-4 EOL: UL/H, Sec. 4, T20S, R36E
RICE Operating Company – Eunice Monument Eumont (EME) SWD System

RICE OPERATING COMPANY
JUNCTION BOX FINAL REPORT

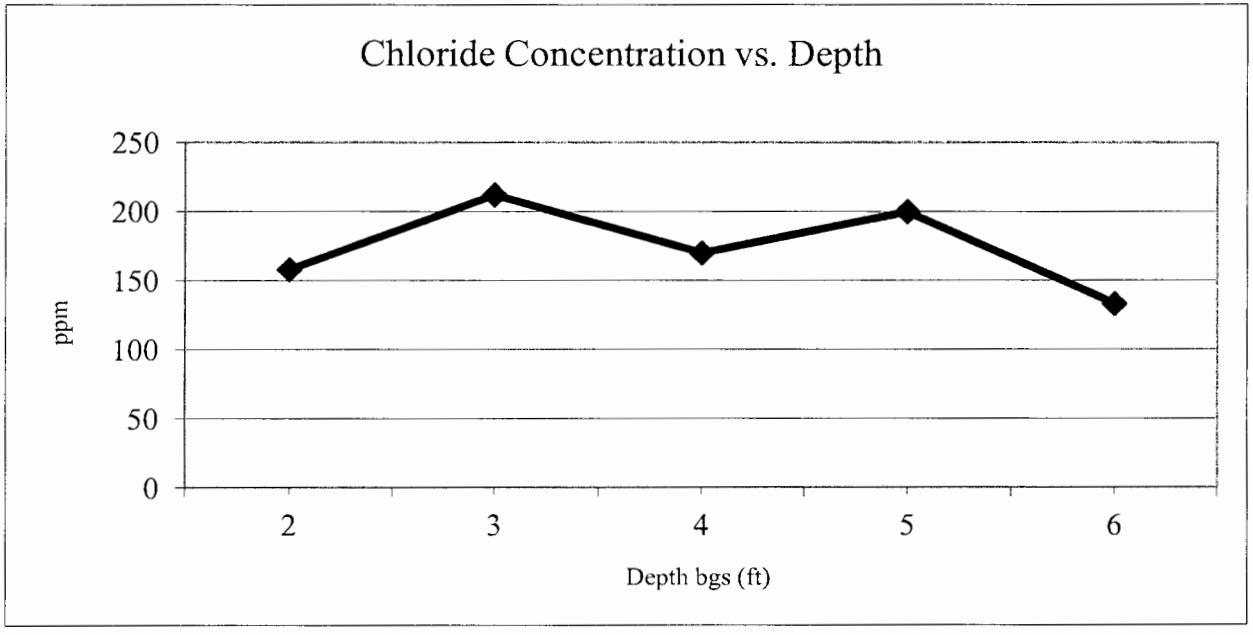
#54

Backhoe samples at junction (source)

Depth bgs (ft)	[Cl] ppm
2	158
3	212
4	170
5	200
6	133

Groundwater = 38 ft

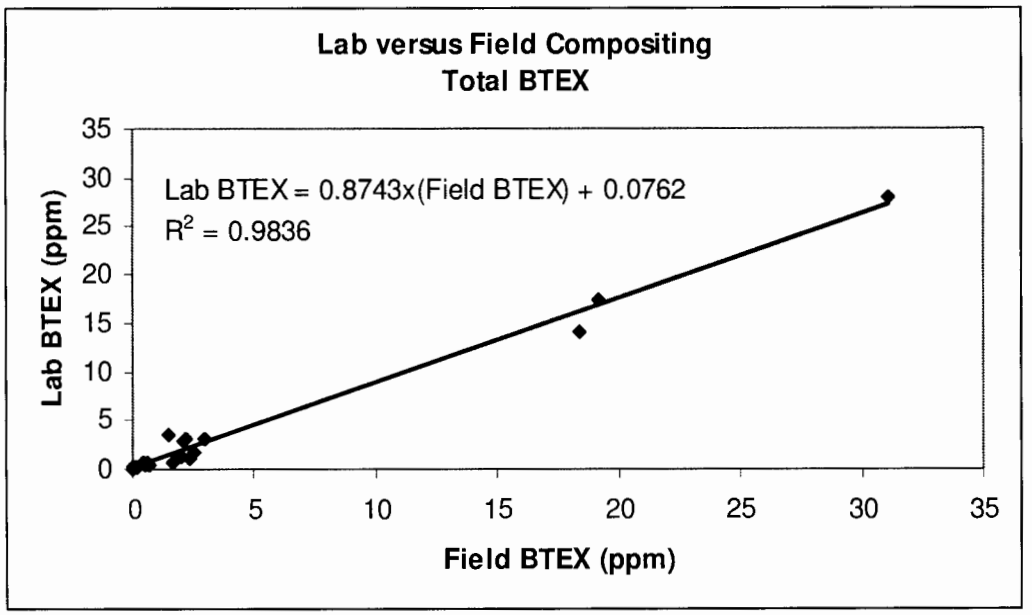
Figure 1 - Laboratory versus field-composited soil samples analyzed for BTEX.

The high R^2 value (0.9836) of the best-fit statistical regression line indicates a high degree of reliability in using the field-compositing method over the range of values observed. Below a "field-composited BTEX" value of 0.61 ppm the "lab-composited BTEX" values are slightly lower. However, above a field-composited BTEX value of 0.61 the lab-composited values run slightly lower. In other words, the field-composited values tended to produce slightly higher BTEX numbers above the point at which BTEX concentrations become significant.

There is a reason for this. BTEX is volatile and quickly biodegradable. The compositing and "packaging" of soil samples in the field minimize the handling and aeration that occur in the laboratory. Thus, field-composited soil samples lose less BTEX to evaporation and/or biodegradation prior to laboratory analysis. In other words, the field compositing and packaging of soil samples better preserves sample integrity, and for this reasons would appear to represent the better method of procuring soil samples for subsequent analysis of BTEX.

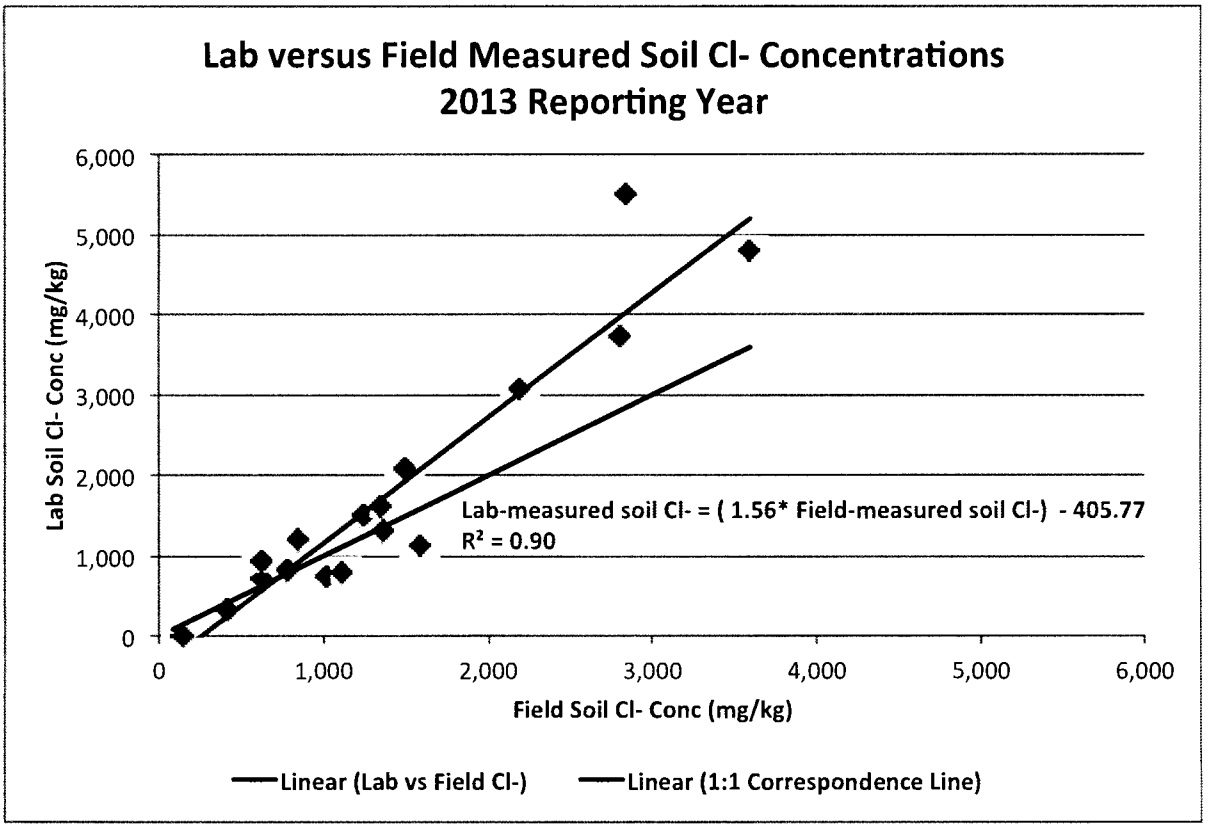
Figure 1 – Laboratory versus field measured soil chloride measurements (n = 29 paired sets).

A straight line fit to the data confirms a general linear trend over a wide range of soil chloride concentrations, and the R^2 value (0.90) indicates that field measurements provide a reliable approximation of laboratory-measured values. Based on the best-fit line of lab vs field measured values, field measured values overestimate lab measure values below a field measured value of 723 mg/kg and above this underestimate the lab-measured values. This is indicated in the graph where the (blue) best-fit line of lab vs field measured chlorides crosses the (black) line which would indicate a 1:1 correspondence.
