Re: Anemone ANE Federal #2
30-015-27982
Section 9, T22S-R24E
Eddy County, New Mexico

Anemone ANE Federal #2 Work Plan

April 28, 2011

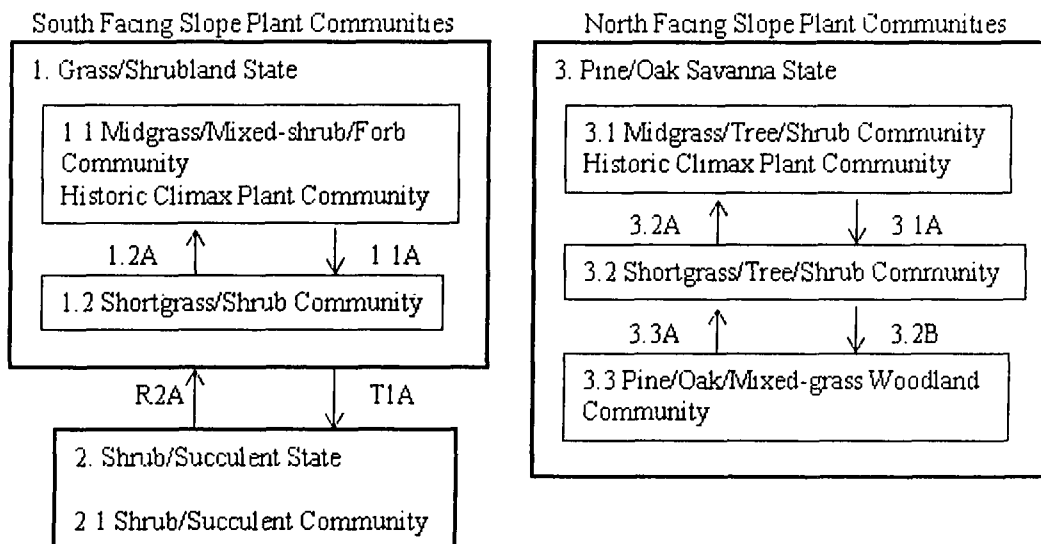
Limestone Hill
R070DY151NM

The following diagram suggests general pathways that the vegetation on this site might follow. There are other plant communities and states not shown on the diagram. This information is intended to show what might happen in a given set of circumstances; it does not mean that this would happen the same way in every instance. Local professional guidance should always be sought before pursuing a treatment scenario.

- 1.1A Heavy Continuous Grazing, Fire Suppression
- 1.2A Prescribed or No Grazing, Prescribed Burning (low relief areas)
- T1A Improper Grazing Management, Fire Suppression,
- R2A, Prescribed or No Grazing and Prescribed Burning (low relief areas and if adequate fuels is present)
- 3.1A Heavy Continuous Grazing, No Fire
- 3.2A Prescribed or No Grazing, Prescribed Burning
- 3.2B Heavy Continuous Grazing, No Fire
- 3.3A Prescribed or No Grazing and Prescribed Burning (if fine fuels have recovered)
