**Whole Earth Environmental, Inc.**

Enclosed, please find a copy of our protocol for the Milano State No. 1 project referenced in the November 4, 2009 Letter of Violation submitted by Ron Harvey, (ref: Inspection No: iREH0930858903).

## **Executive Summary Primero Operating Milano State No. 1**

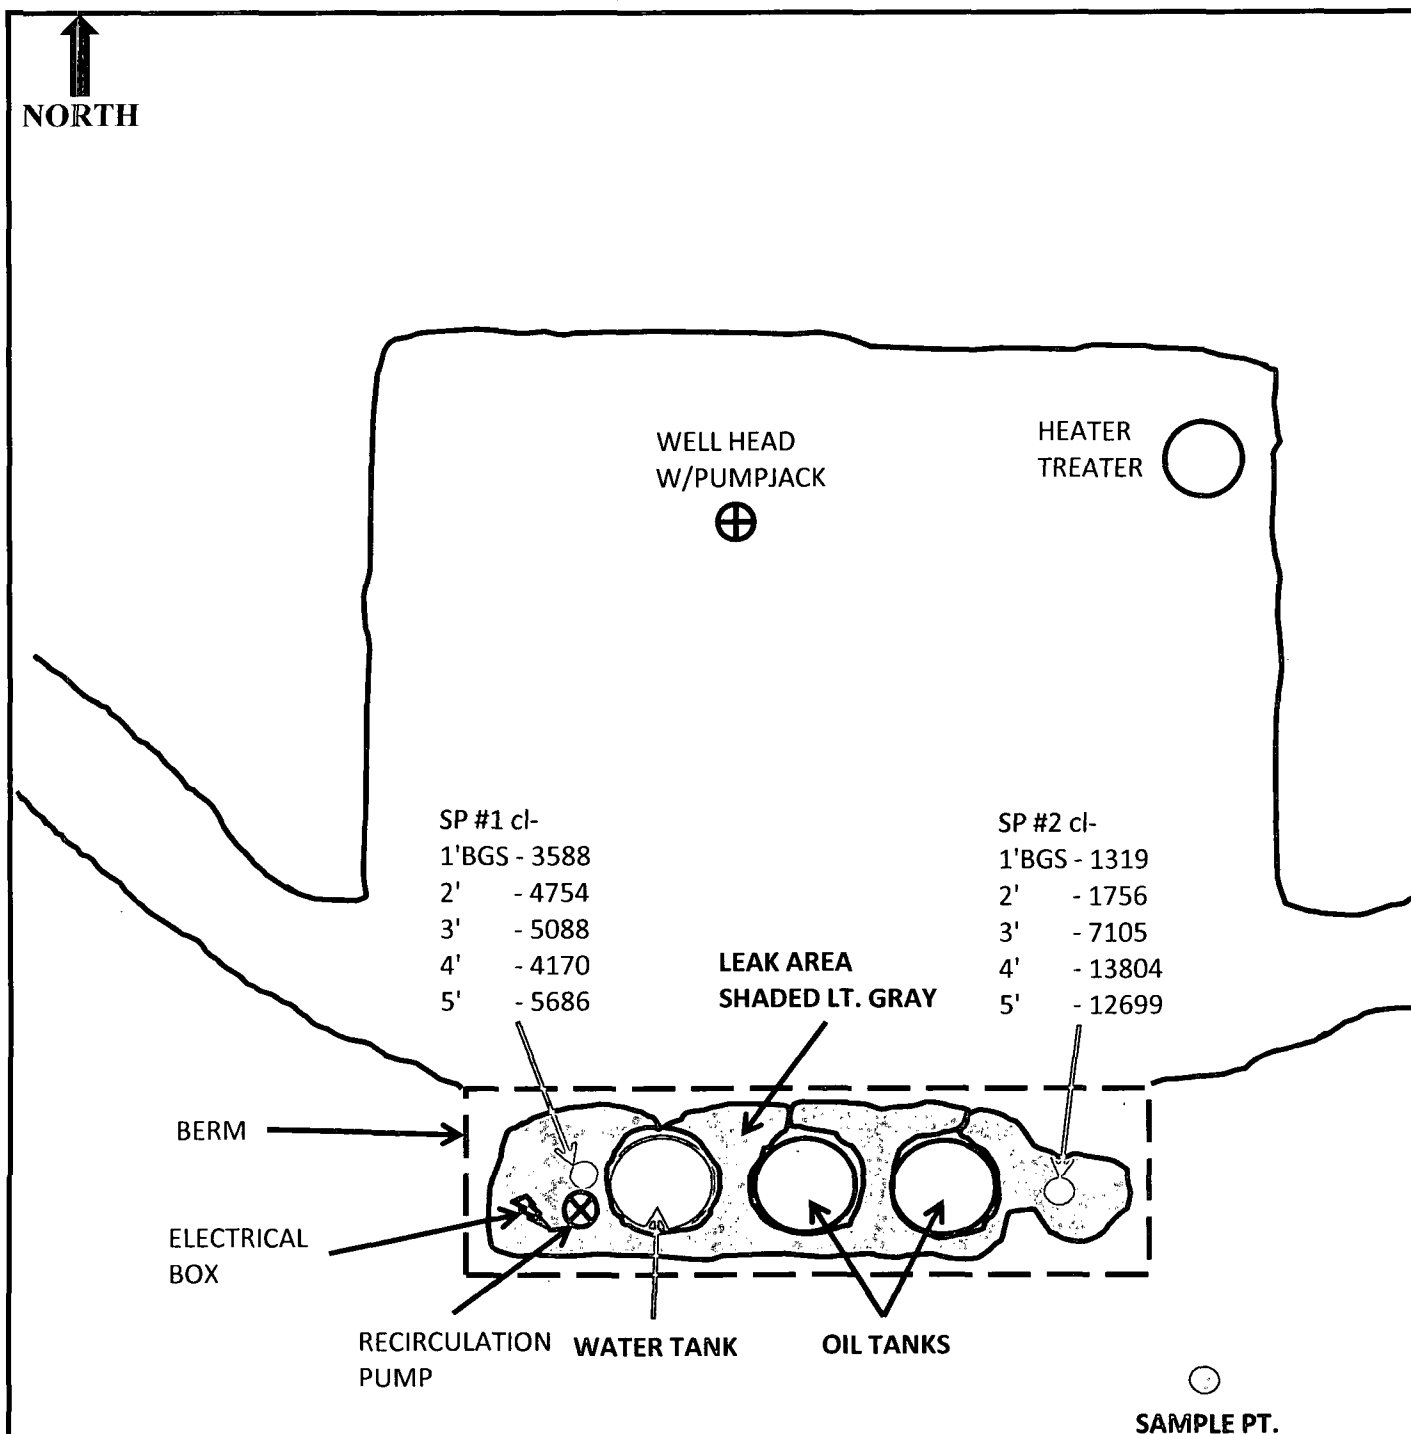
Primero Operating, LLC  
 Milano State #1 SITE MAP  
 UL/G Sec 36 - T24S - R28E  
 GPS LAT & LON NAD27 (Decimal)  
 N32.174797 / W104.035082

surface of spill area west end very black, oily, dirt mixed w/caliche, material remains the same up to the east tank then starts to change in color. Area of sp #2 possible area of past tank, and a gathering area for any run off to gather and puddle. Signs of where water did gather and was vacuumed out in area.  
 samples were hand augered from 1'bgs to 5'bgs

MEASUREMENTS OF BERMED AREA: 75'L X 25'W

Whole Earth Environmental, Inc. conducted preliminary coring within the bermed containment and found extensive chloride concentrations to a depth of five feet below ground surface. Vertical delineation of the chloride concentrations will be done at the time of final remediation.
