Hobbs Jct E-32-1

RICE OPERATING COMPANY

JUNCTION BOX CLOSURE REPORT

RE: NMOCD Case # 1R0428-65, E-32-1 Junction Box
Hobbs SWD System Abandonment
Closure Report

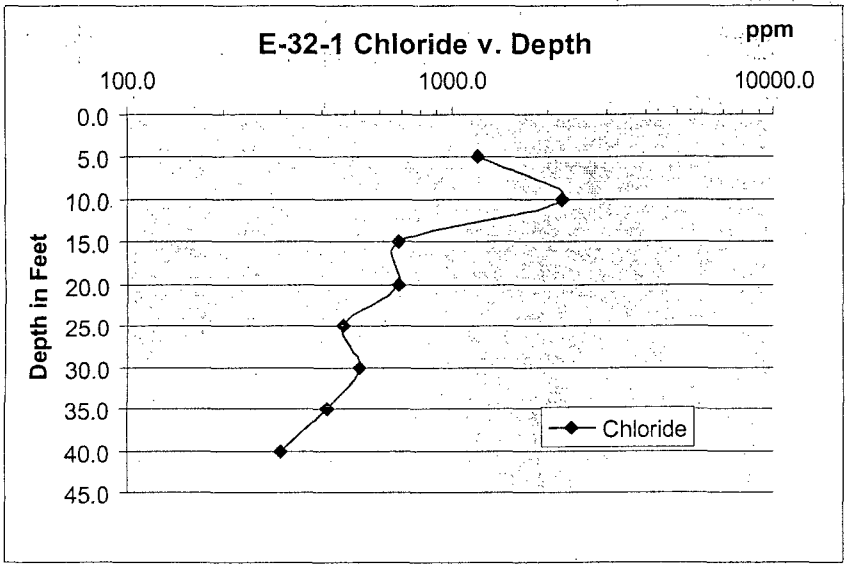
Figure 1: Chloride Concentrations with Depth

ROC staff performed field chloride measurements and PID measurements every five feet starting at 6 feet bgs. The peak chloride concentration of 2,196 mg/kg, is at 10 feet bgs (Figure 1). Laboratory analyses confirm the results of the field tests (3,180 mg/kg at 9-10 feet bgs and 284 mg/kg at 39-40 feet bgs. Below this center of mass, chloride concentrations declined to 299 mg/kg at 41 feet bgs. Background chloride concentrations in the area, as determined from the background boring located in Section 32, Unit A (Appendix B), are approximately 80 mg/kg.

Neither hydrocarbon odors nor PID measurements above 2 ppm were detected in the boring (Appendix B). Therefore, no laboratory analyses for petroleum hydrocarbons were necessary.

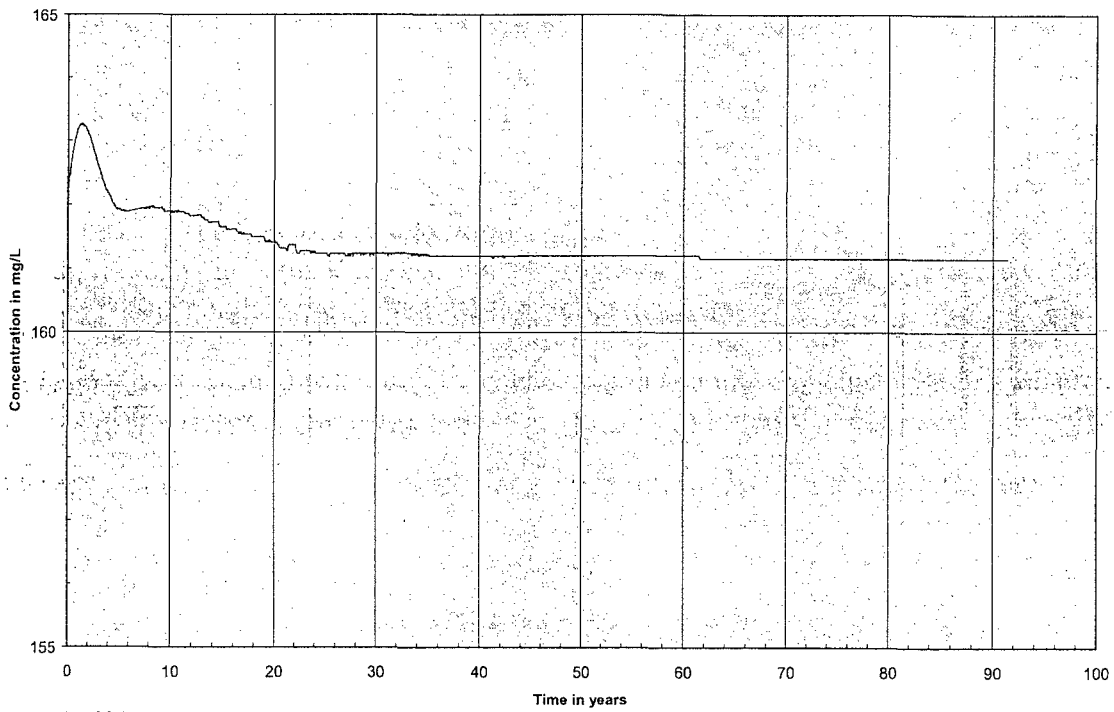
Figure 2: Chloride Concentration in the Aquifer with Vegetation, E-32-1 Site

As can be seen in Figure 2, chloride in the lower vadose zone enters ground water raising chloride concentration to 163 mg/L about two years after re-vegetation of the site. With establishment of vegetation at the site, infiltration is reduced. With "drying" out of the vadose zone soil materials, hydraulic conductivities are reduced. The resultant vadose zone chloride flux to ground water is lowered such that ground water chloride concentration does not rise above 162 mg/L after approximately 20 years (see Appendix D).

Experience at similar sites and HYDRUS-1D simulations of the conditions similar to those observed at this site support simple re-vegetation of the surface as an effective corrective action.

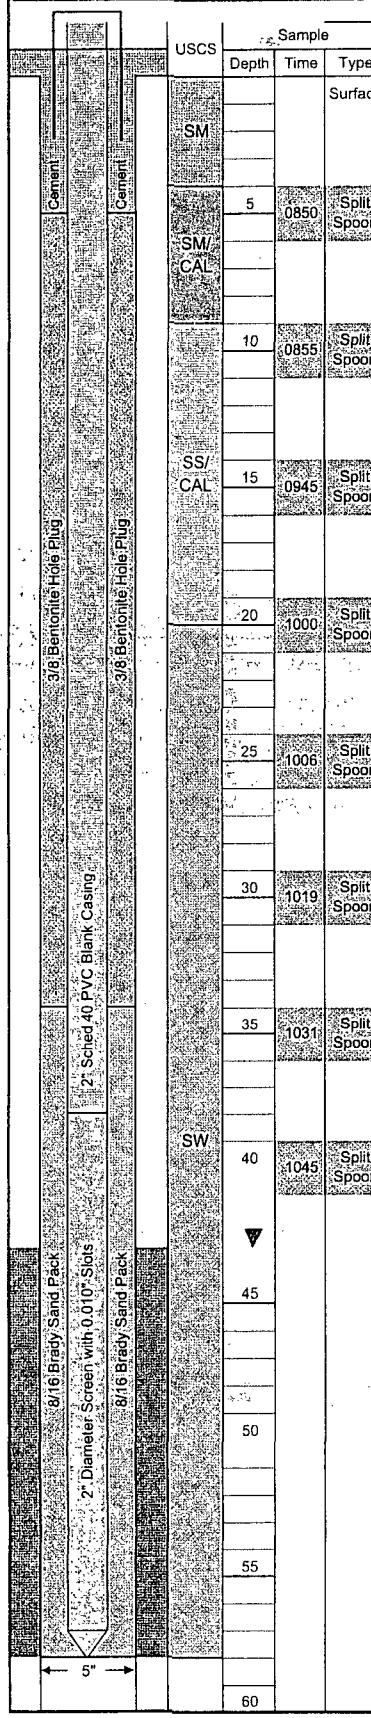
LITHOLOGIC LOG

USCS	Depth	Time	Sample Type	Blowcounts (blows - in)	Chloride (ppm)	PID (ppm)	LITHOLOGIC DESCRIPTION: LITHOLOGY, COLOR, GRAIN SIZE, SORTING, ROUNDING, CONSOLIDATION, DISTINGUISHING FEATURES
SM			Surface				Silty loam; moderate yellowish brown (10YR 5/4); dry.
SM/ CAL	5	0850	Split Spoon	22-12"	1204	2	Calcic sand - sandy caliche; very pale orange (10 YR 8/2); moderately hard; dry.
SS/ CAL	10	0855	Split Spoon	50 6"	2196	2	Calcic sandstone, very pale orange (10 YR 8/2) and grayish orange (10 YR 7/4), indurated, consolidated with hard quartz sandstone streaks. Sand component is fine-grained, subangular, moderately well sorted, dry.
	15	0945	Split Spoon	50 - 4"	689	2	
	20	1000	Split Spoon	32 - 12" 42 - 12"	686	2	Light brown (5 YR 5/6) fine sand, slightly moist, subangular, well sorted.
	25	1006	Split Spoon	50 - 5"	465	2	Light brown (5 YR 5/6) fine sand, slightly moist, unconsolidated, subangular, well sorted.

30	1019	Split Spoon	50 - 6"	518	2	Light brown (5 YR 5/6) fine sand, subangular, well sorted, with intermittent streaks of sandstone.
	35	1031	Split Spoon	50 - 10"	414	2	Light brown (5 YR 5/6) fine sand, subangular, well sorted, with intermittent streaks of sandstone.
SW	40	1045	Split Spoon	50 - 11"	299	2	Light brown (5 YR 5/6) fine sand, slightly moist, subangular, well sorted; with intermittent streaks of sandstone.
	▼						Groundwater encountered at approximately 43 ft below ground surface.
	45						Light brown (5 YR 5/6) fine sand, wet-moist, subangular, well sorted, with intermittent streaks of sandstone.
	50						Light brown (5 YR 5/6) fine sand, wet-moist, subangular, well sorted.
	55						Light brown (5 YR 5/6) fine sand, wet-moist, subangular, well sorted.
	60						Bottom of boring at 58 feet below ground surface.

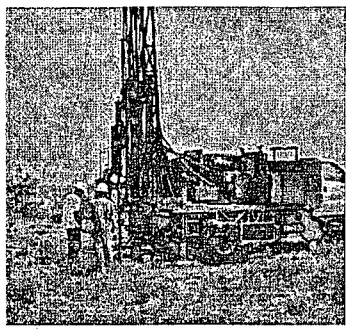
BORING NO.: A-32
SITE ID: Hobbs SWD System
CONTRACTOR: Atkins Engineering
DRILLING METHOD: Hollow Stem Auger
START DATE: 05/03/06
COMPLETION DATE: 05/03/06
COMMENTS: Located in area with no expected impact from oil and gas activities (background conditions).

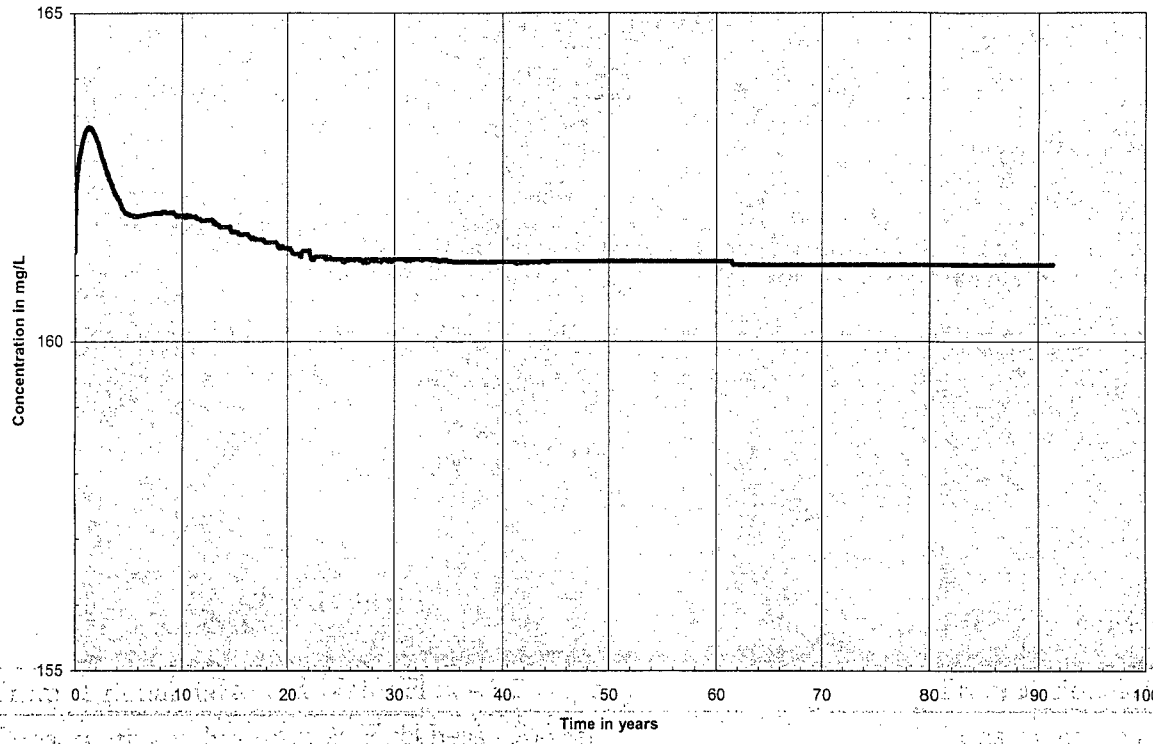
Figure 1: Chloride Concentration in the Aquifer with Vegetation, E-32-1 Site

The remedy modeled featured vegetation acting as an evapotranspiration (ET) barrier in 3.0 feet of silt loam above eight inches of sand to reduce upwards wicking of chloride. With vegetation established, vadose zone flux to ground water declines. The resultant chloride concentration in ground water peaks about two years after installation of the ET barrier at less than 165 mg/L and declines there after (see Figure 1).

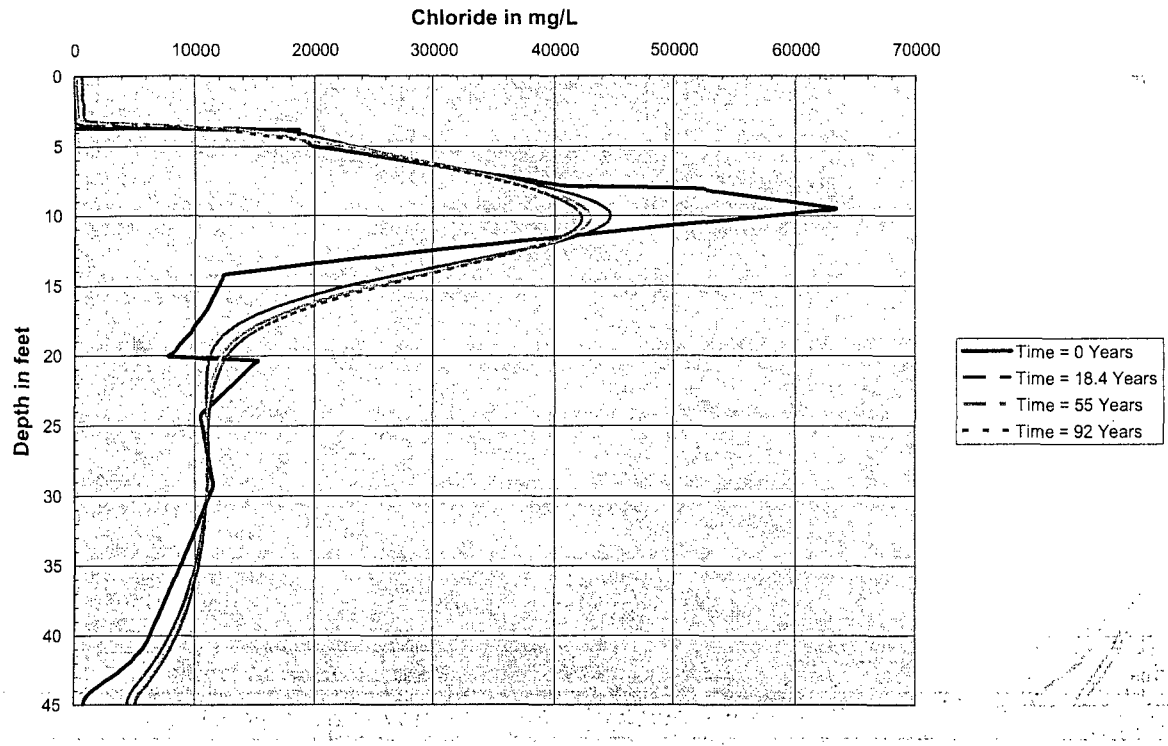
Figure 2: Chloride Profiles at Time, E-32-1 Site

Figure 2 is a graph of predicted soil water chloride concentration profiles at times in the future with the remedy installed. Between year 0 and year 92, peak chloride concentration moves about 1.0 foot downwards, a migration rate of 0.011 feet per year. This rate implies that peak chloride concentration will enter ground water about 2700 years from now.

The maximum chloride concentration value is42,300 mg/L in the vadose zone at 10.5 feet bgs (Time = 92 Years, Figure 2). Examination of the HYDRUS 1-d output

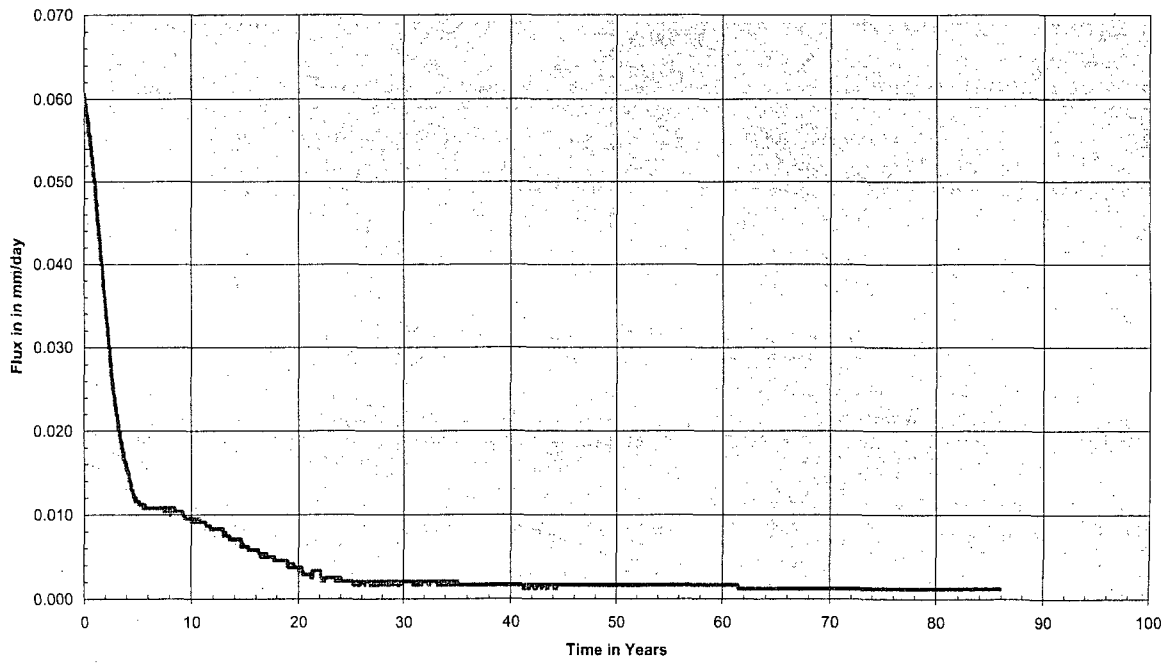
Figure 3: Vadose Zone Water Flux into the Aquifer, Vegetation, E-32-1 Site

files reveals no vadose zone water flux to ground water exceeding 0.00166 mm/day after year 42. Neither of these values will be equaled or exceeded in the future. Due to dispersion, peak vadose zone chloride concentration will decrease. As can be seen in Figure 3, with vegetation at the site, predicted vadose zone water flux will be less than or equal to this maximum value after year 50.

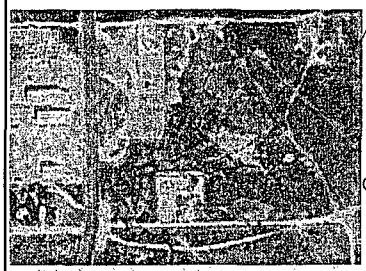
LITHOLOGIC LOG AND MONITORING WELL CONSTRUCTION DIAGRAM

MONITOR WELL NO.: MW-1
SITE ID: Hobbs E-32-1 Junction Box
CONTRACTOR: Atkins Engineering
DRILLING METHOD: Hollow Stem Auger
START DATE: 5/4/2006
COMPLETION DATE: 5/4/2006
COMMENTS: Located immediately adjacent to former junction box location.
