# JAMES RANCH UNIT 121H AREA

## EVIDENCE OF WATER ENCROACHMENT

### Structure Map - Top Delaware Lower Brushy Canyon

James Ranch Unit, Eddy Co., New Mexico

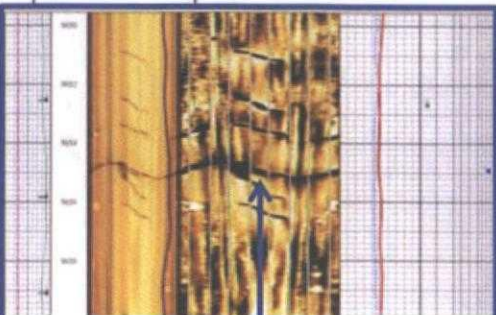
N49°E  
Delaware Fracture Orientation  
from FMI Analysis
