SECOND MILESTONE REPORT ON MONITORING ACTIVITIES AT THE BLOOMFIELD REFINERY OPERATED BY PLATEAU, INC., SAN JUAN COUNTY, NEW MEXICO

AMERICAN GROUND WATER CONSULTANTS, INC.
CONSULTING GROUND WATER GEOLOGISTS & HYDROLOGISTS
ALBUQUERQUE, NEW MEXICO

JANUARY 1981

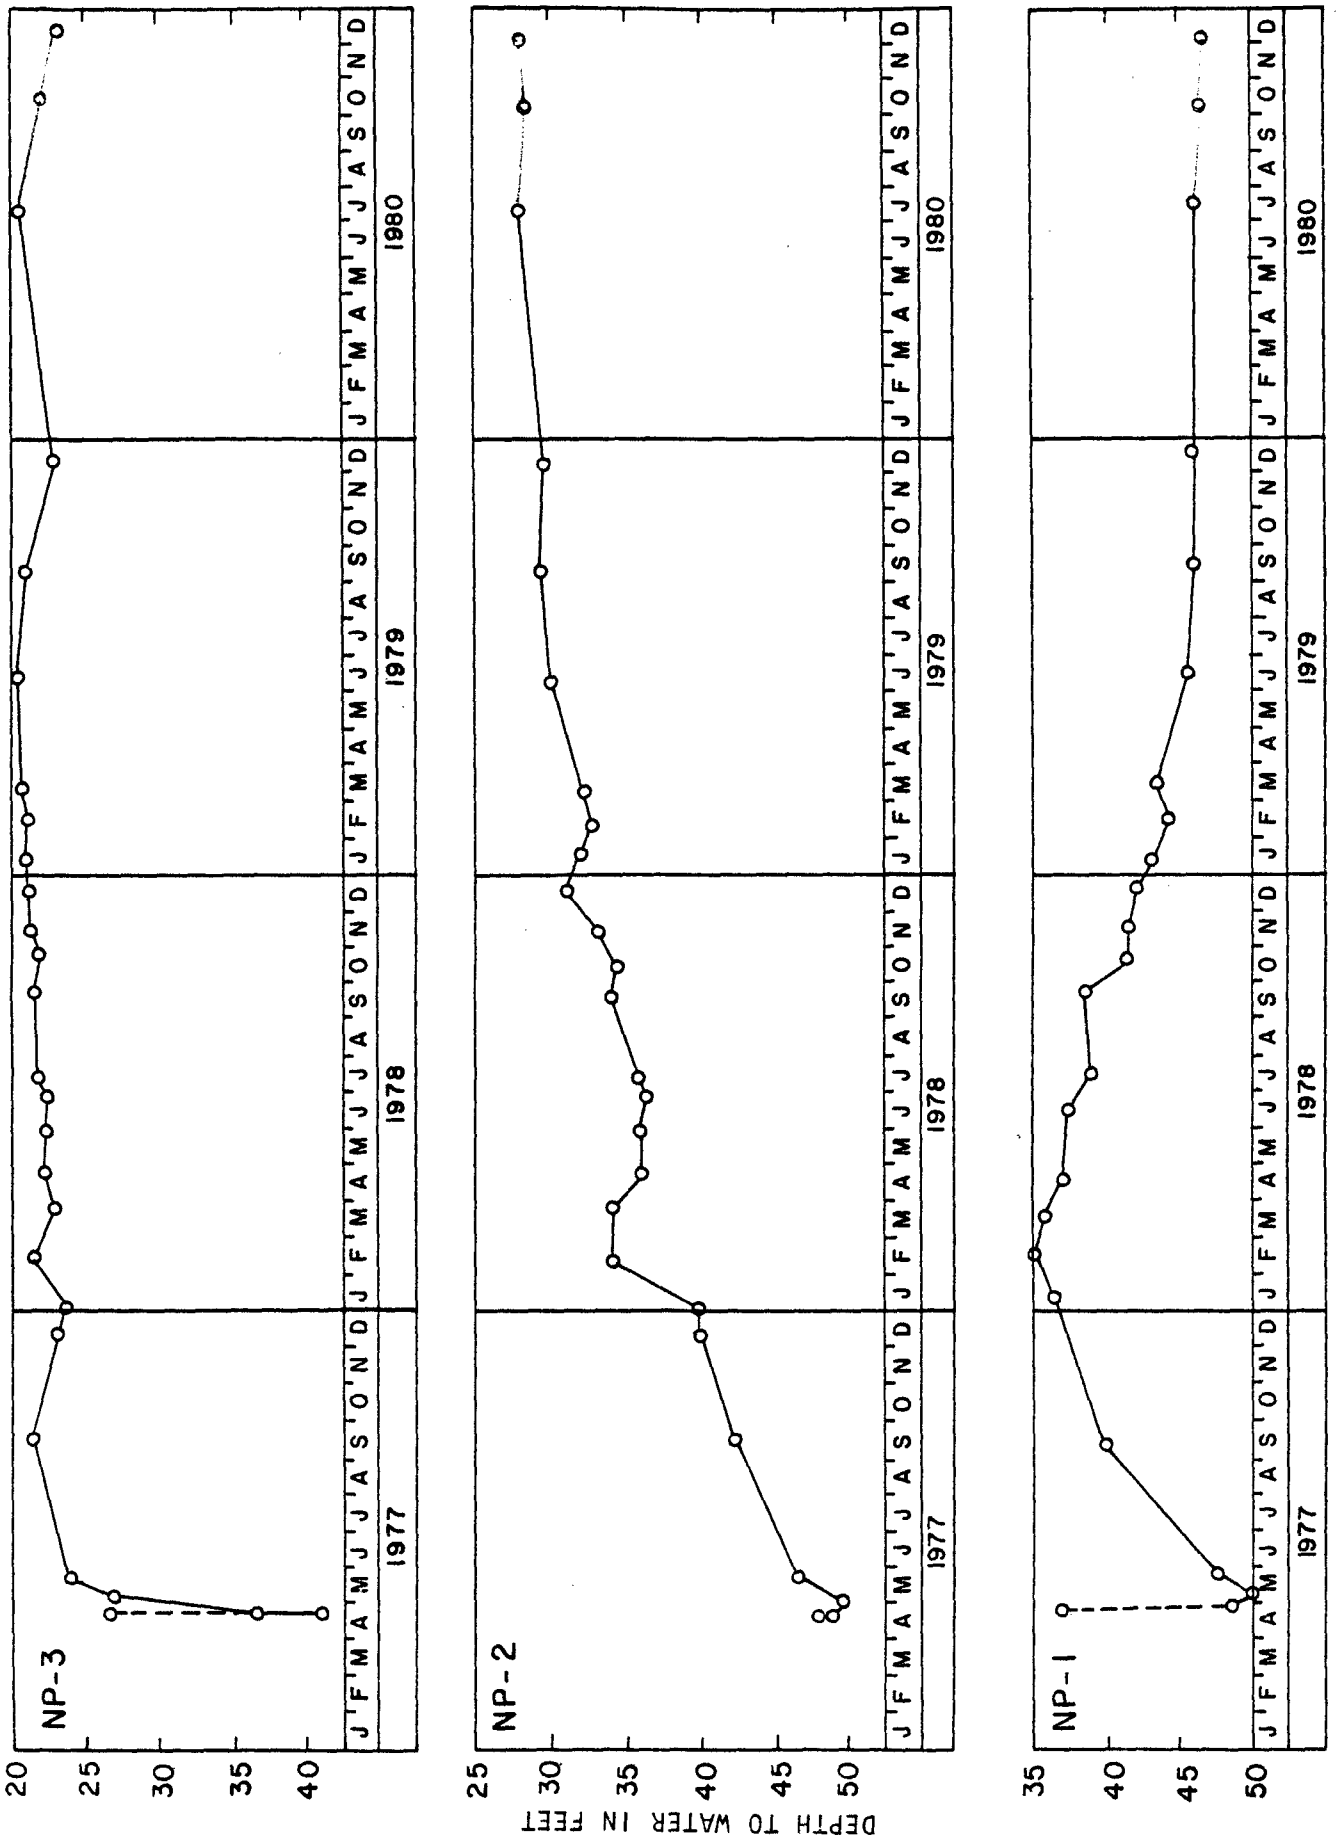
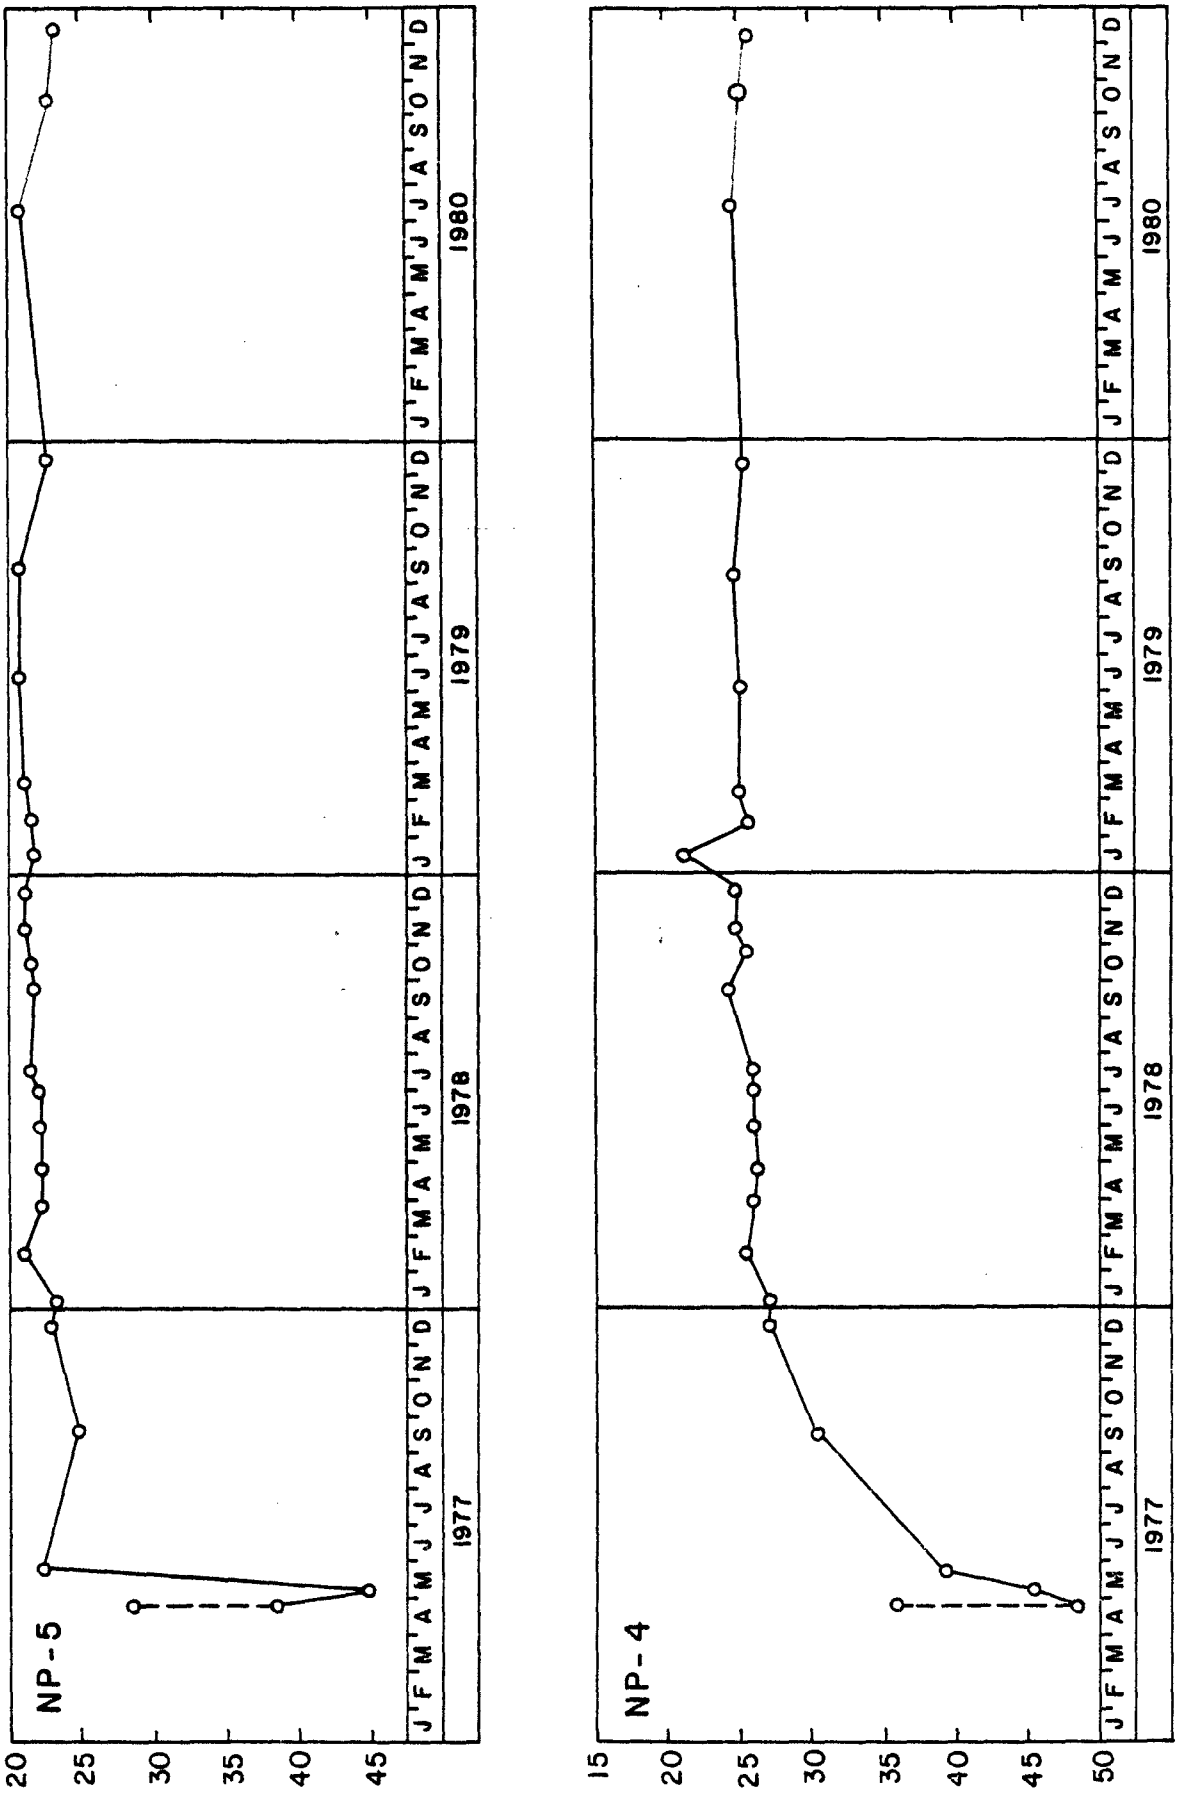
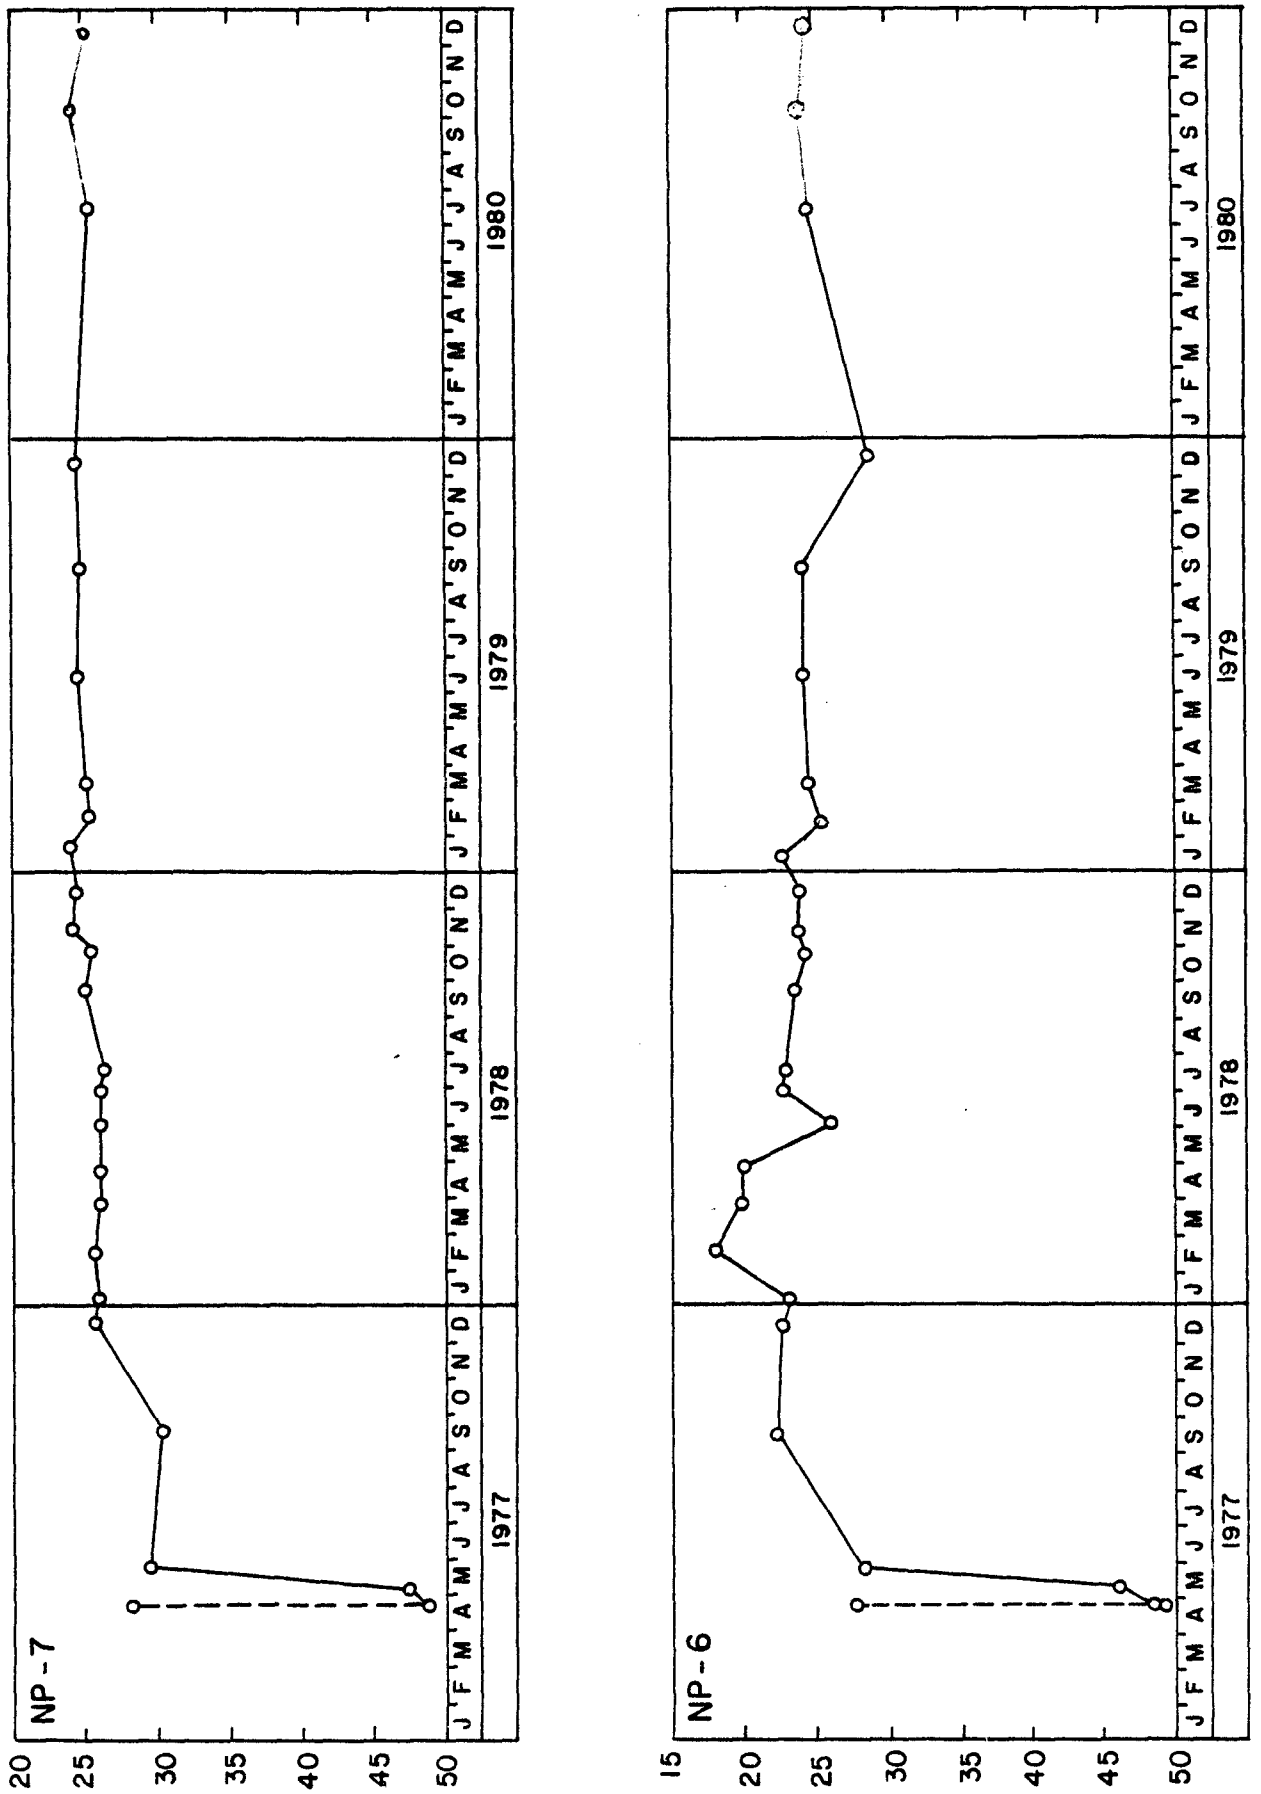
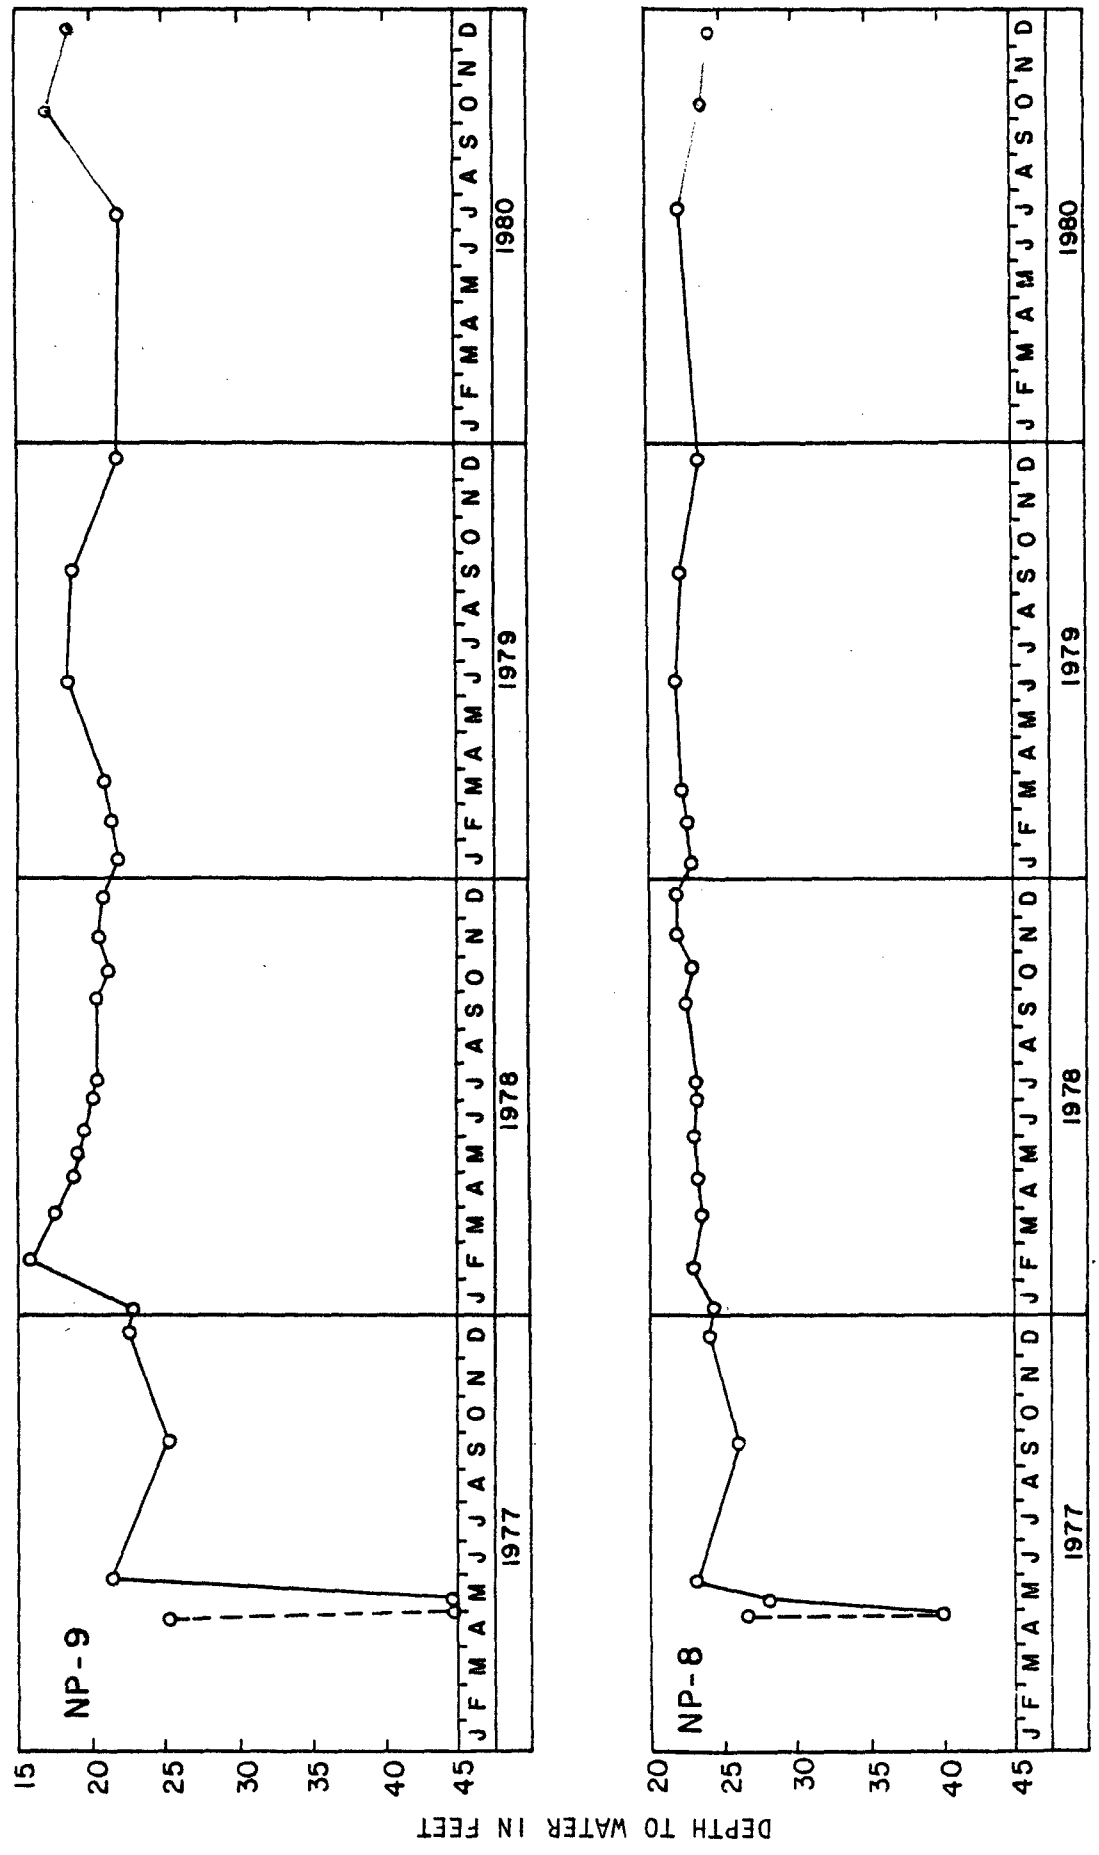
Examination of the hydrographs shows that the rise of the water in the observation holes was generally quite slow. This is because that to enter the casing, the water first had to saturate the bentonite material in the annular space between the hole wall and the casing before flowing through the low permeability bentonite to the bottom of the casing (which was set in the shale of the low permeability Nacimiento Formation). Observation wells such as NP-2, NP-4, and NP-7 required up to one year to equilibrate with the water level in the ground beneath the ponds.

Because water levels were still equilibrating in the observation holes when the first milestone report was prepared it is believed that the ground-water-level contour map, given as figure 8 in the first milestone report, and conclusions drawn from that diagram are not valid. The hydrographs contained herein indicate that the most recent measurements are nearly consistent and, therefore, are probably in equilibrium with the local ground-water levels. It is evident that because of the method of well construction the response to changes of ground-water level outside of the wells will be so slow that it will not be possible to monitor short term changes in local ground-water levels.

3. Water-level measurements are of value. However, because of the significant lag of water levels in the observation holes to changing ground-water levels in the soils adjacent to the observation holes, water-level measurements have only limited value. Because present data suggests that the water levels in the observation holes are in equilibrium with the average water levels in the soils and that these water levels have not changed over a long period, it is recommended that water-level measurements be discontinued. The fact that steady state soil moisture and thermal regimes have developed in the soils adacent to the observation holes supports this recommendation.

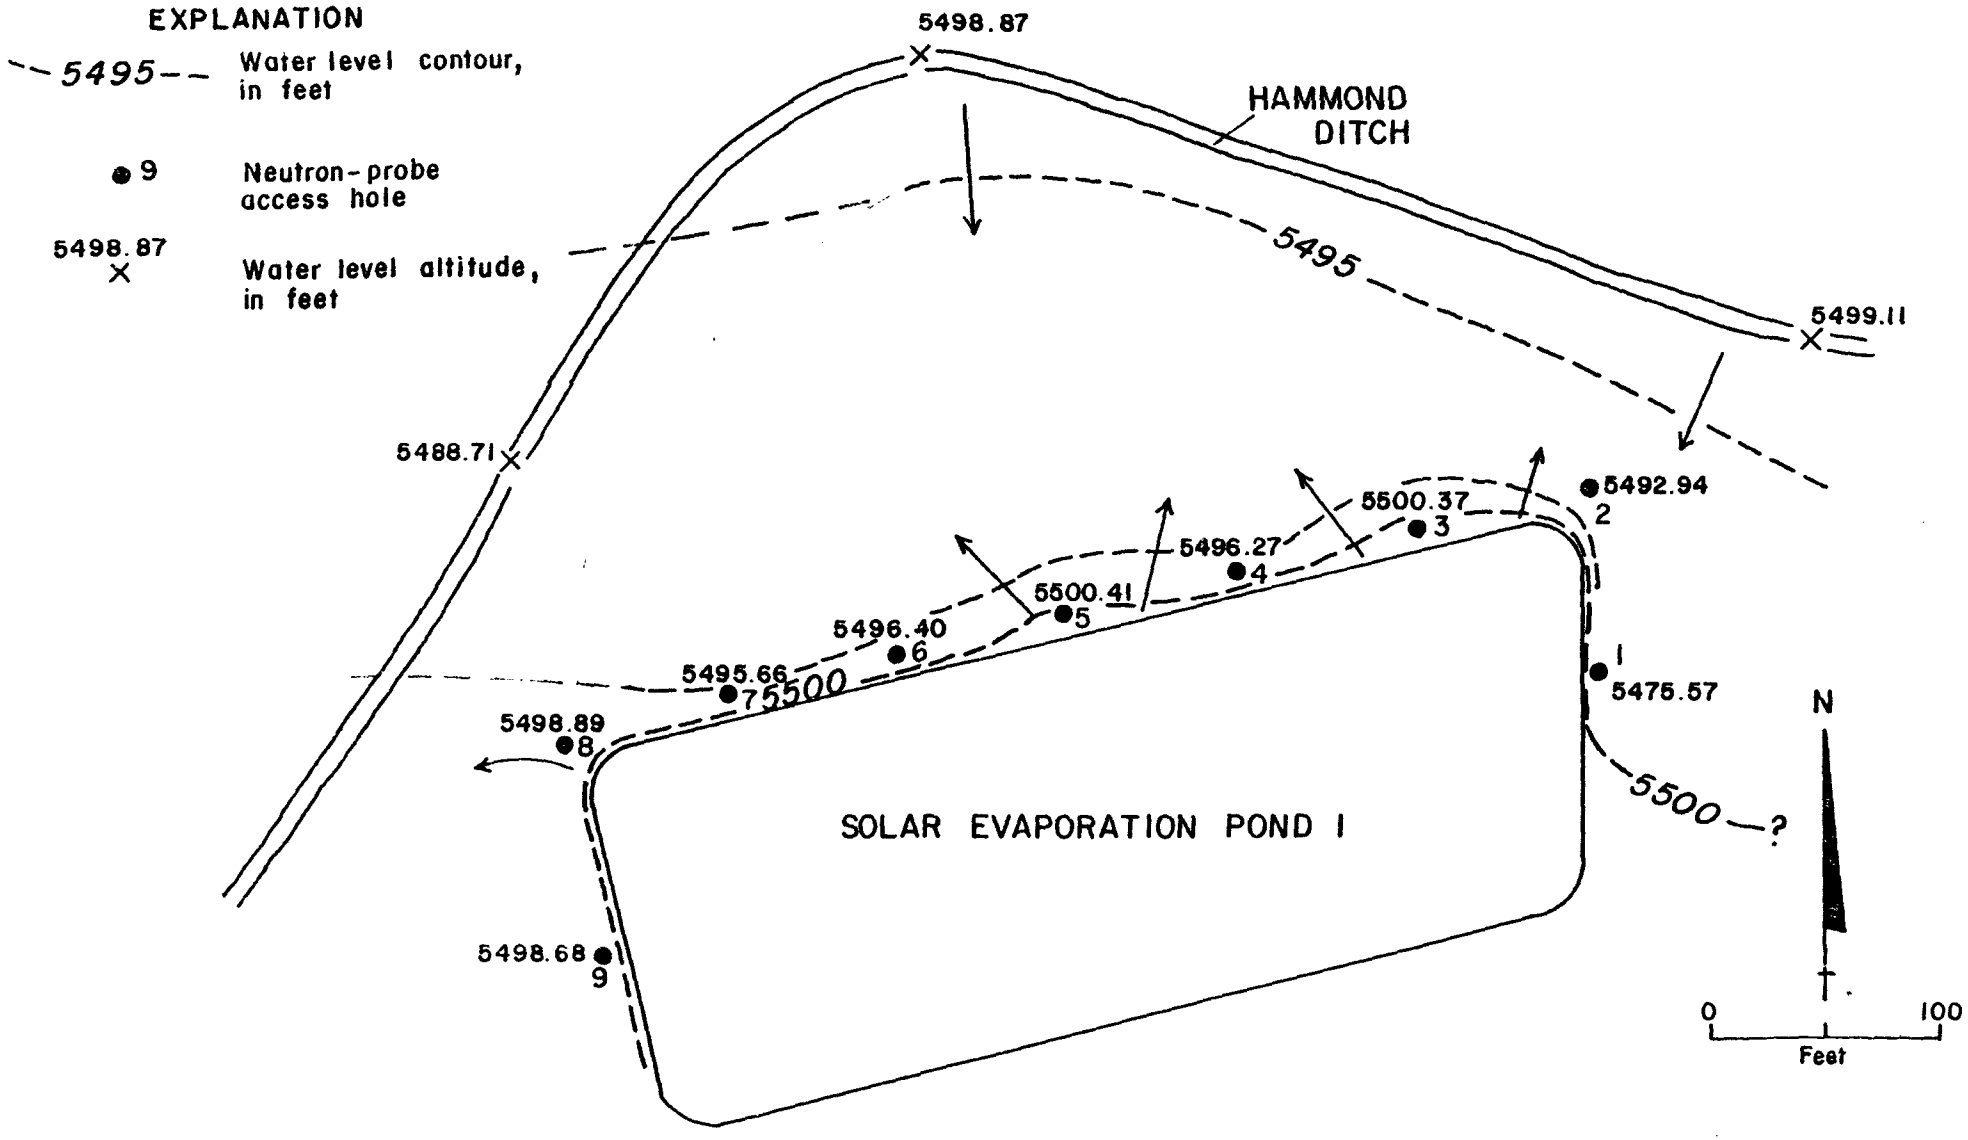
Figure 6 is the ground-water-level contour map prepared using data collected on July 9, 1980. This figure shows that both the ditch and solar evaporation Pond 1 are sources of recharge to the local ground-water systems. Certainly, the Hammond Ditch was always a source of recharge to the normally unsaturated Quaternary cobble bed in the area. After the construction and filling of solar evaporation Pond 1, it too became a source of recharge to this cobble bed. Surface water from the Hammond Ditch flows south towards Pond 1 and the water in Pond 1 flows to the north, east and west. As the water moves away from these recharge sources, it enters the cobble bed and flows away to the north in the cobble bed beneath the Hammond Ditch. It is water from these sources which is found in the arroyos between the refinery property and the San Juan River to the north.

Figure 6. Ground-water-level contour map for 9 July 1980 in vicinity of solar-evaporation pond 1.

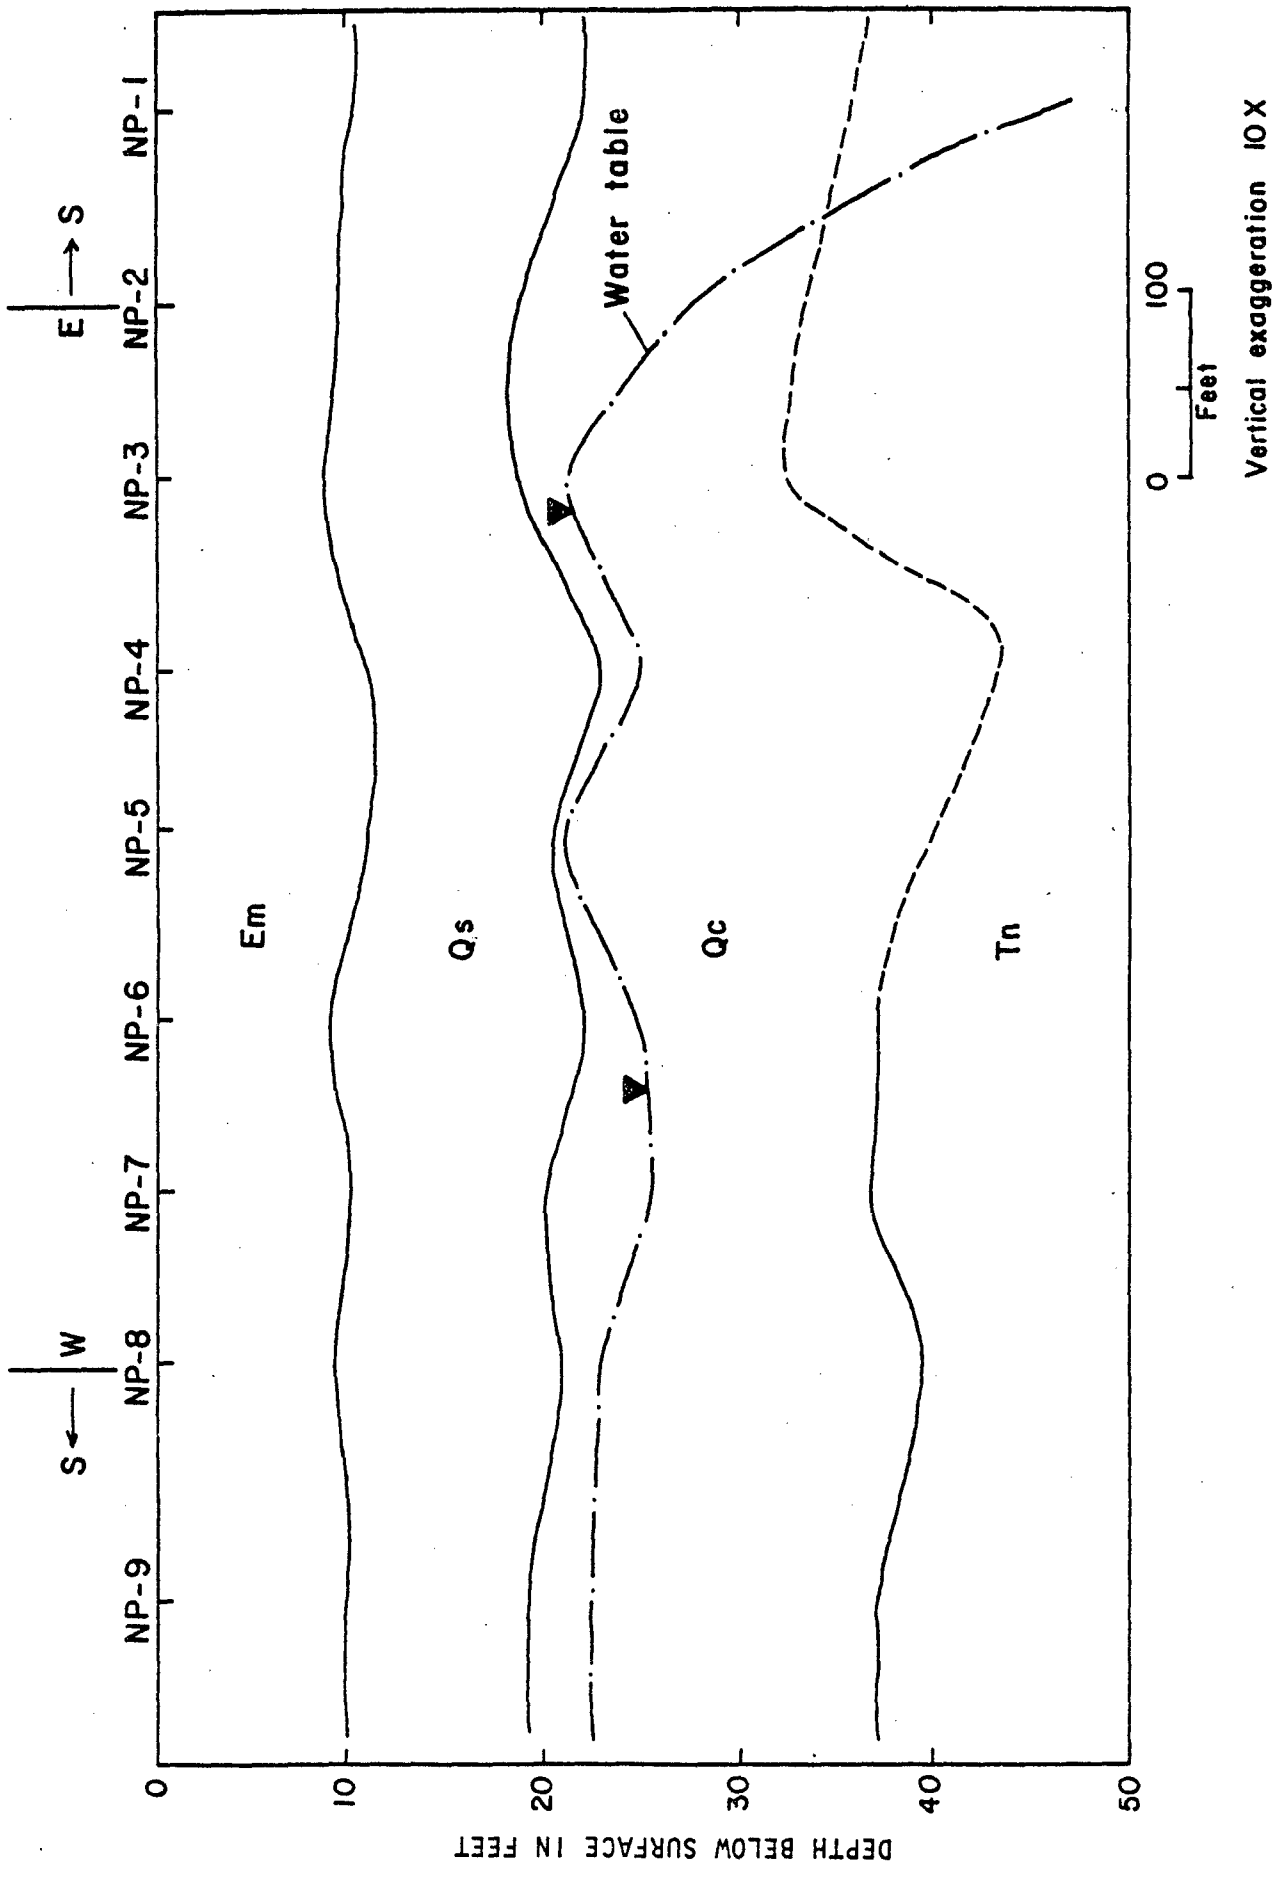
Figure 7 is a cross section through the observation wells which shows both the subsurface stratigraphy and the ground-water level. This figure indicates that the rate of seepage from Pond 1 is probably greater at the east end in the vicinity of observation hole NP-1.

Figure 7. Cross-section through neutron-probe holes at solar evaporation pond 1.
