SECOND MILESTONE REPORT ON MONITORING ACTIVITIES AT THE BLOOMFIELD REFINERY OPERATED BY PLATEAU, INC., SAN JUAN COUNTY, NEW MEXICO

AMERICAN GROUND WATER CONSULTANTS, INC.
CONSULTING GROUND WATER GEOLOGISTS & HYDROLOGISTS
ALBUQUERQUE, NEW MEXICO

JANUARY 1981

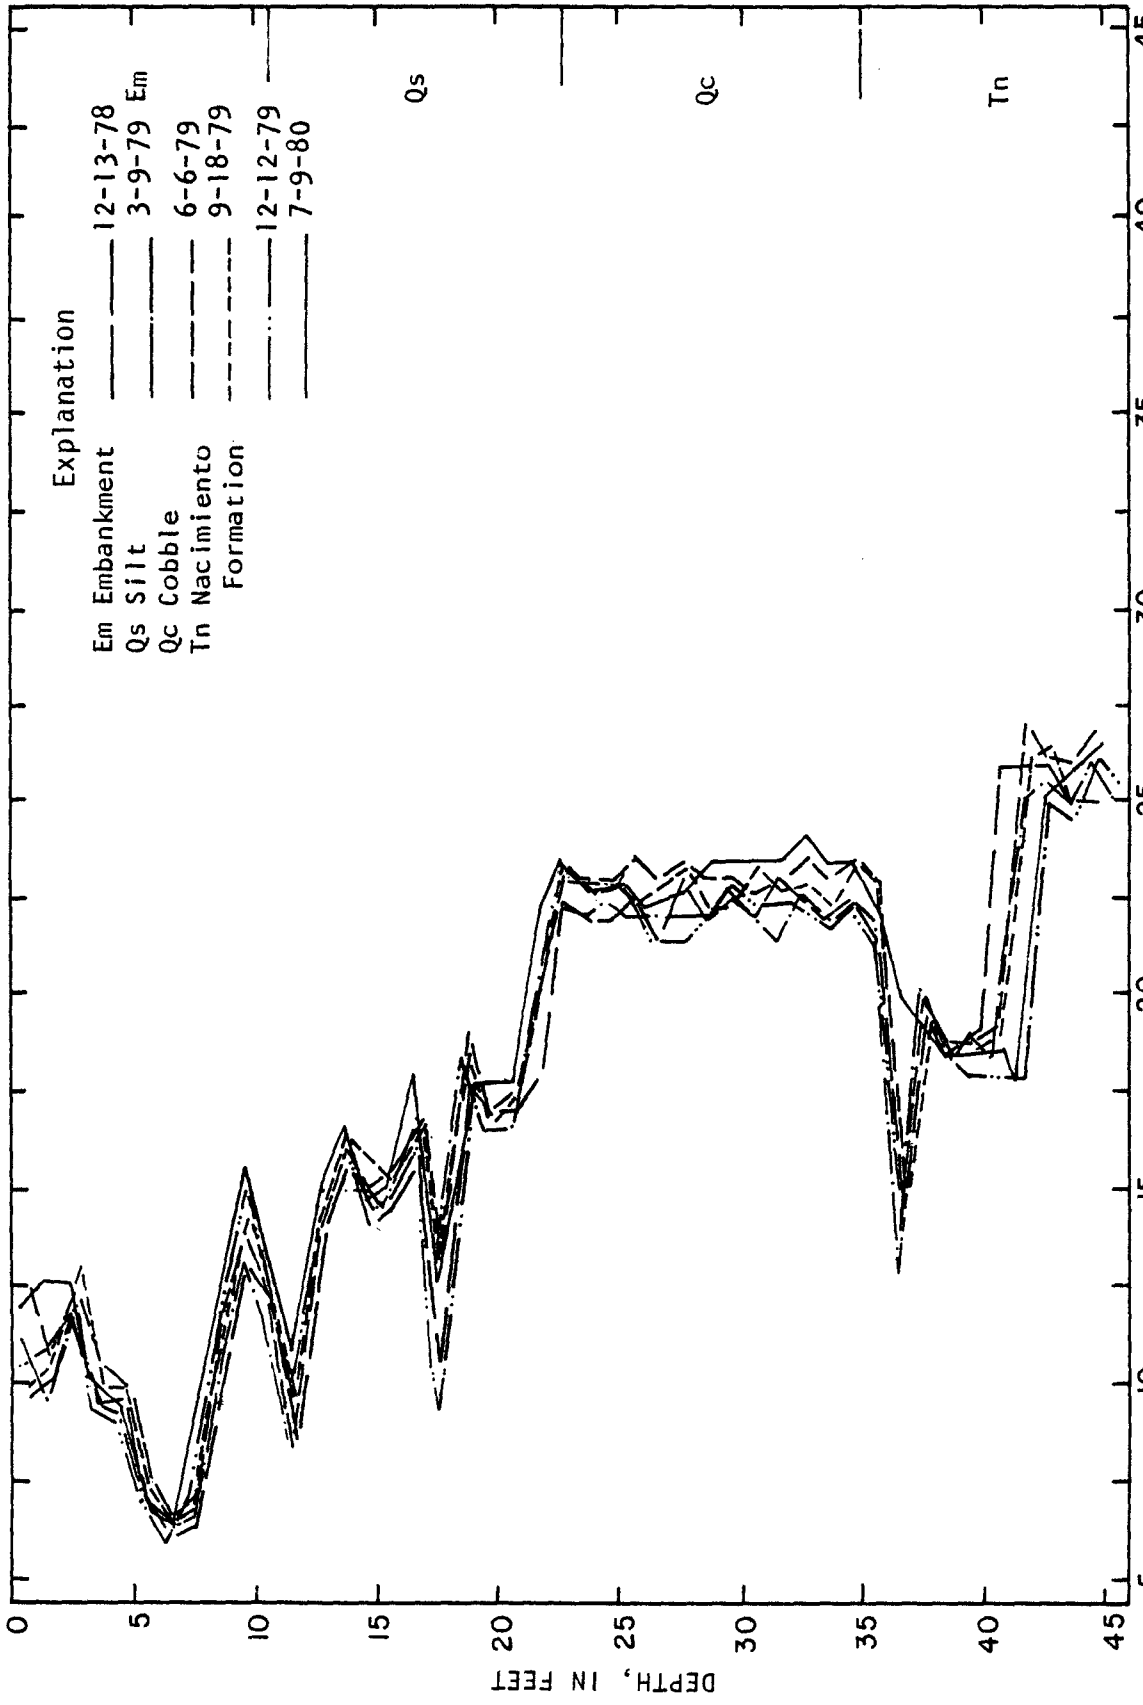
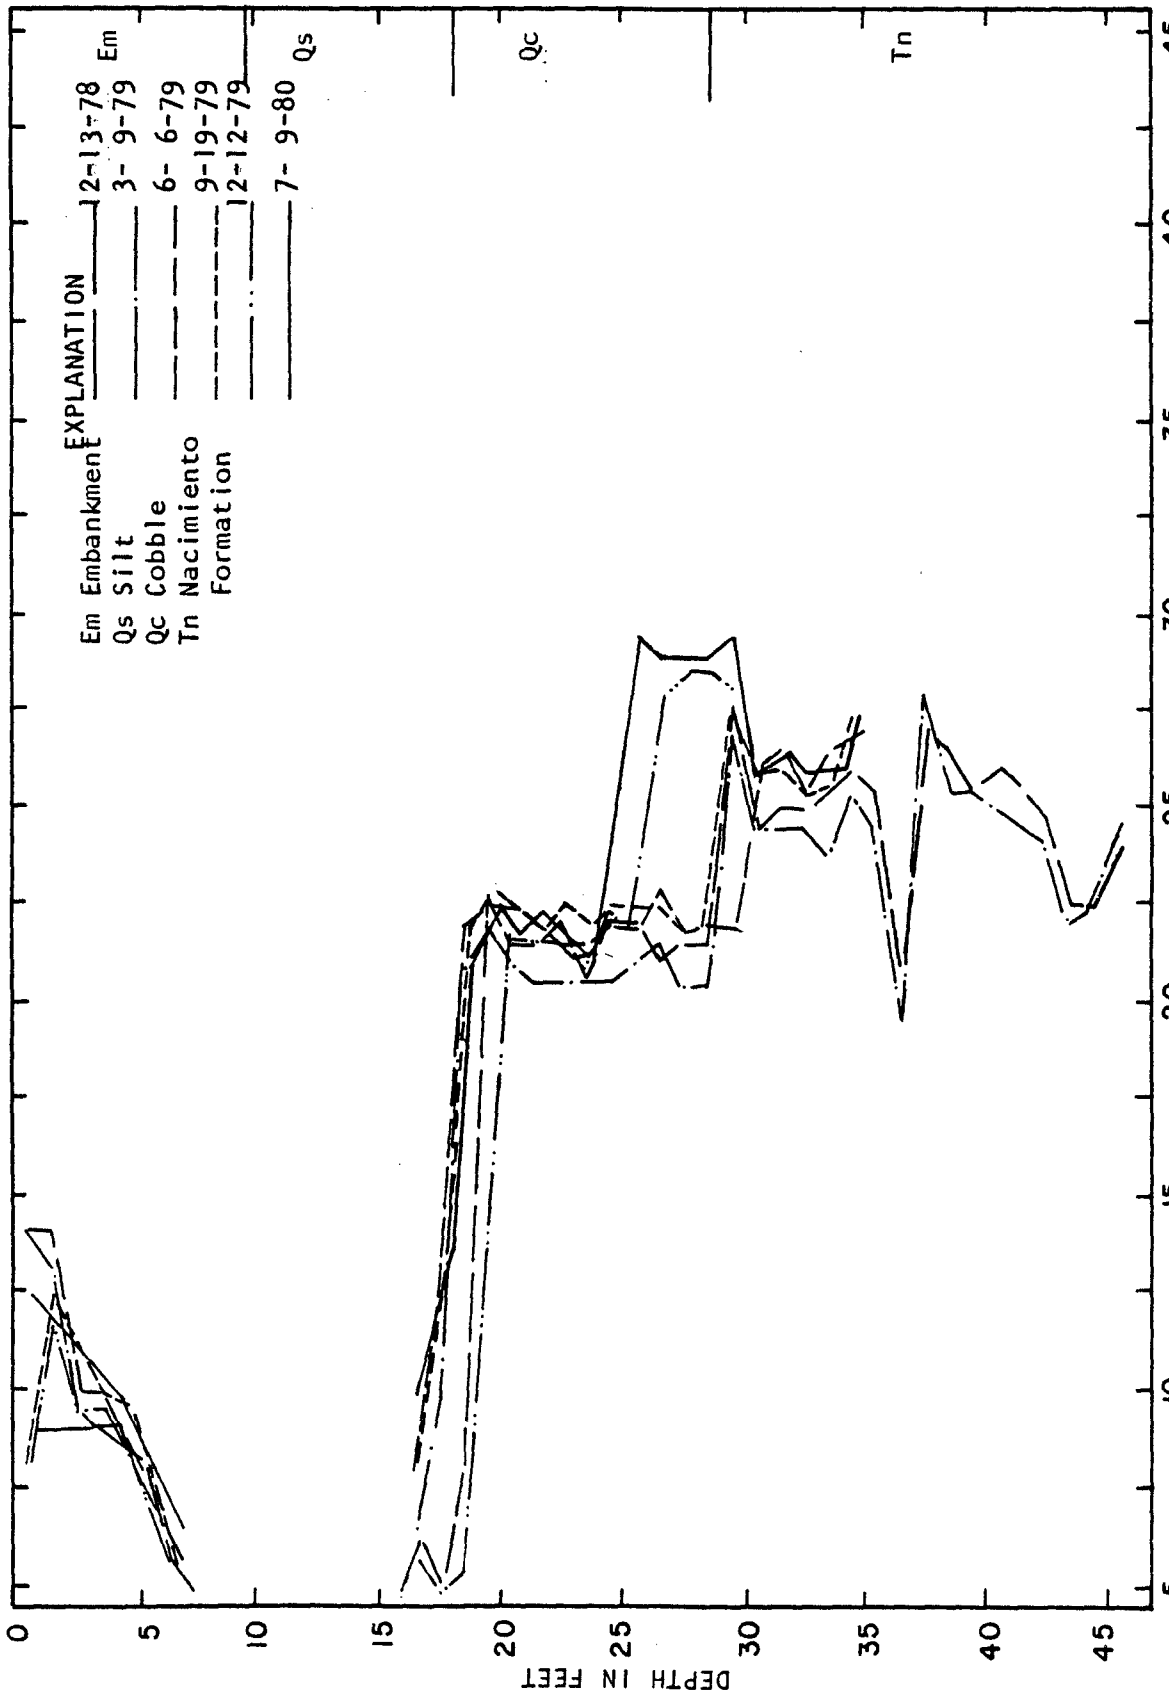
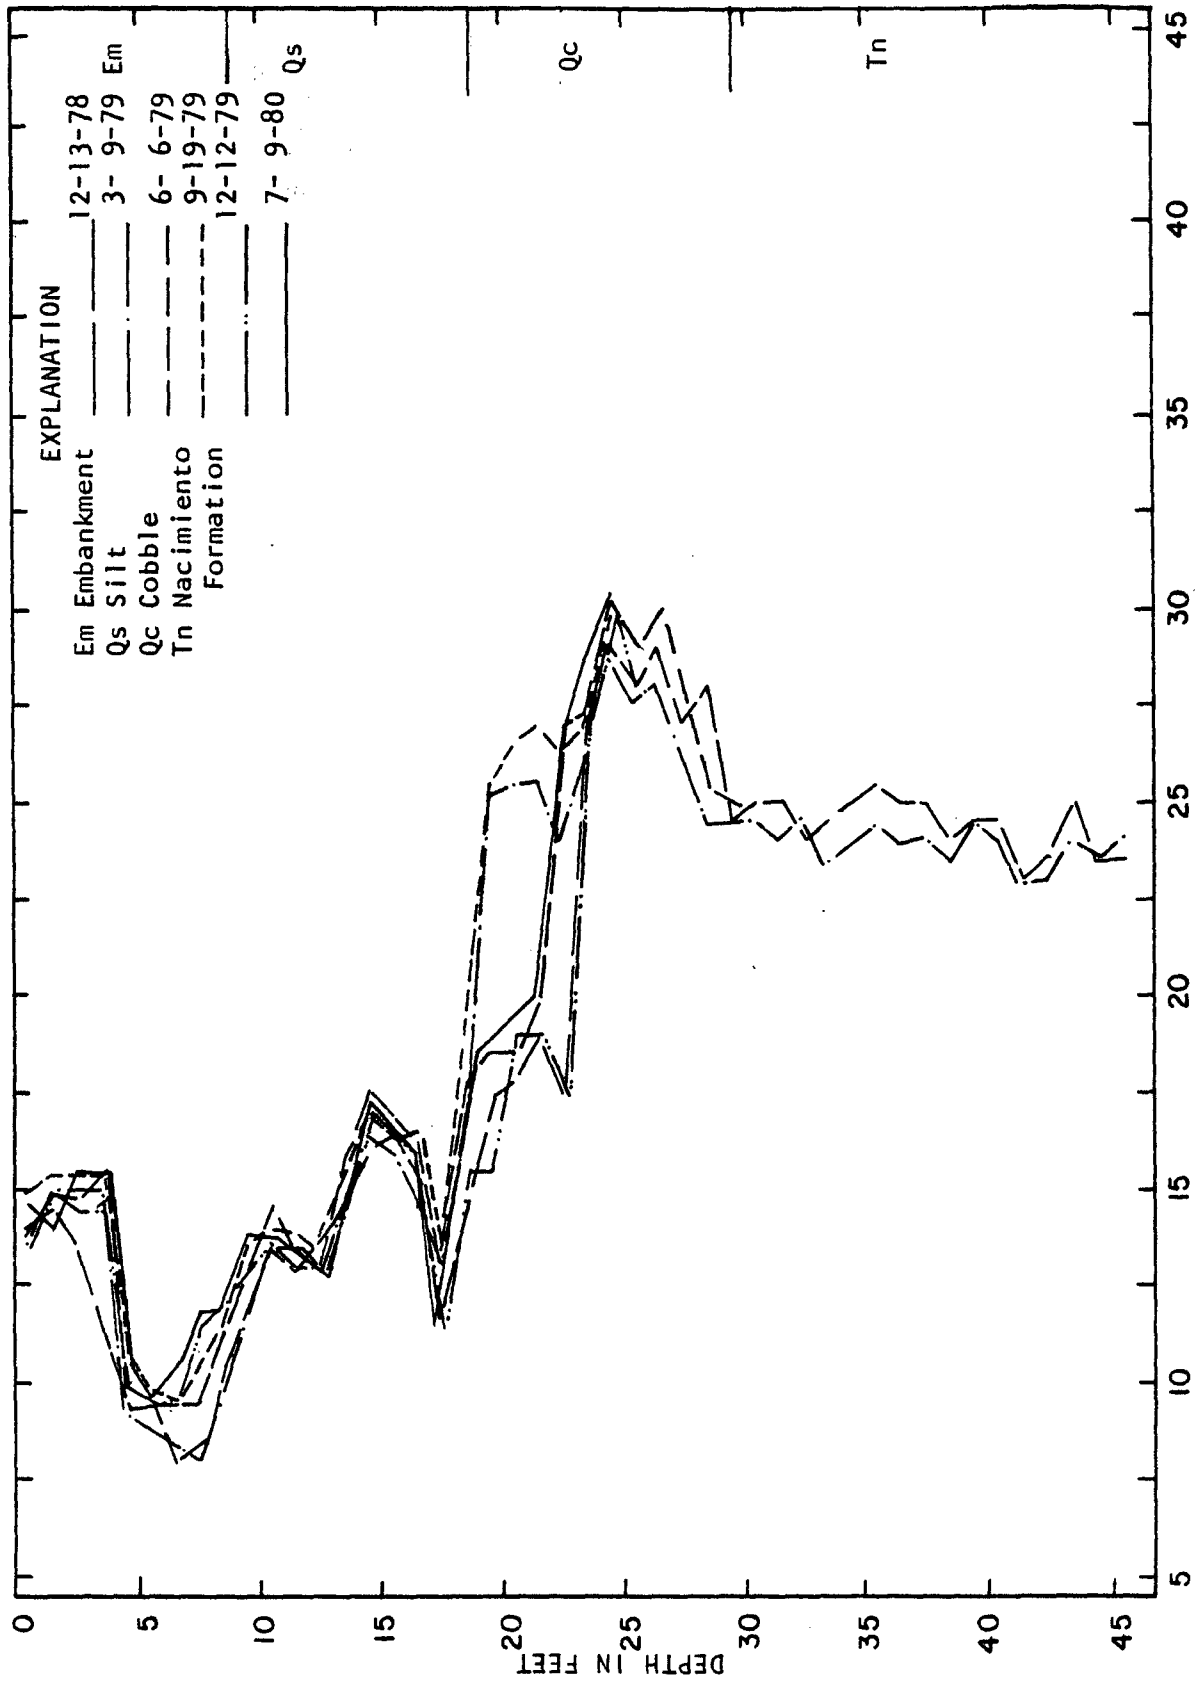
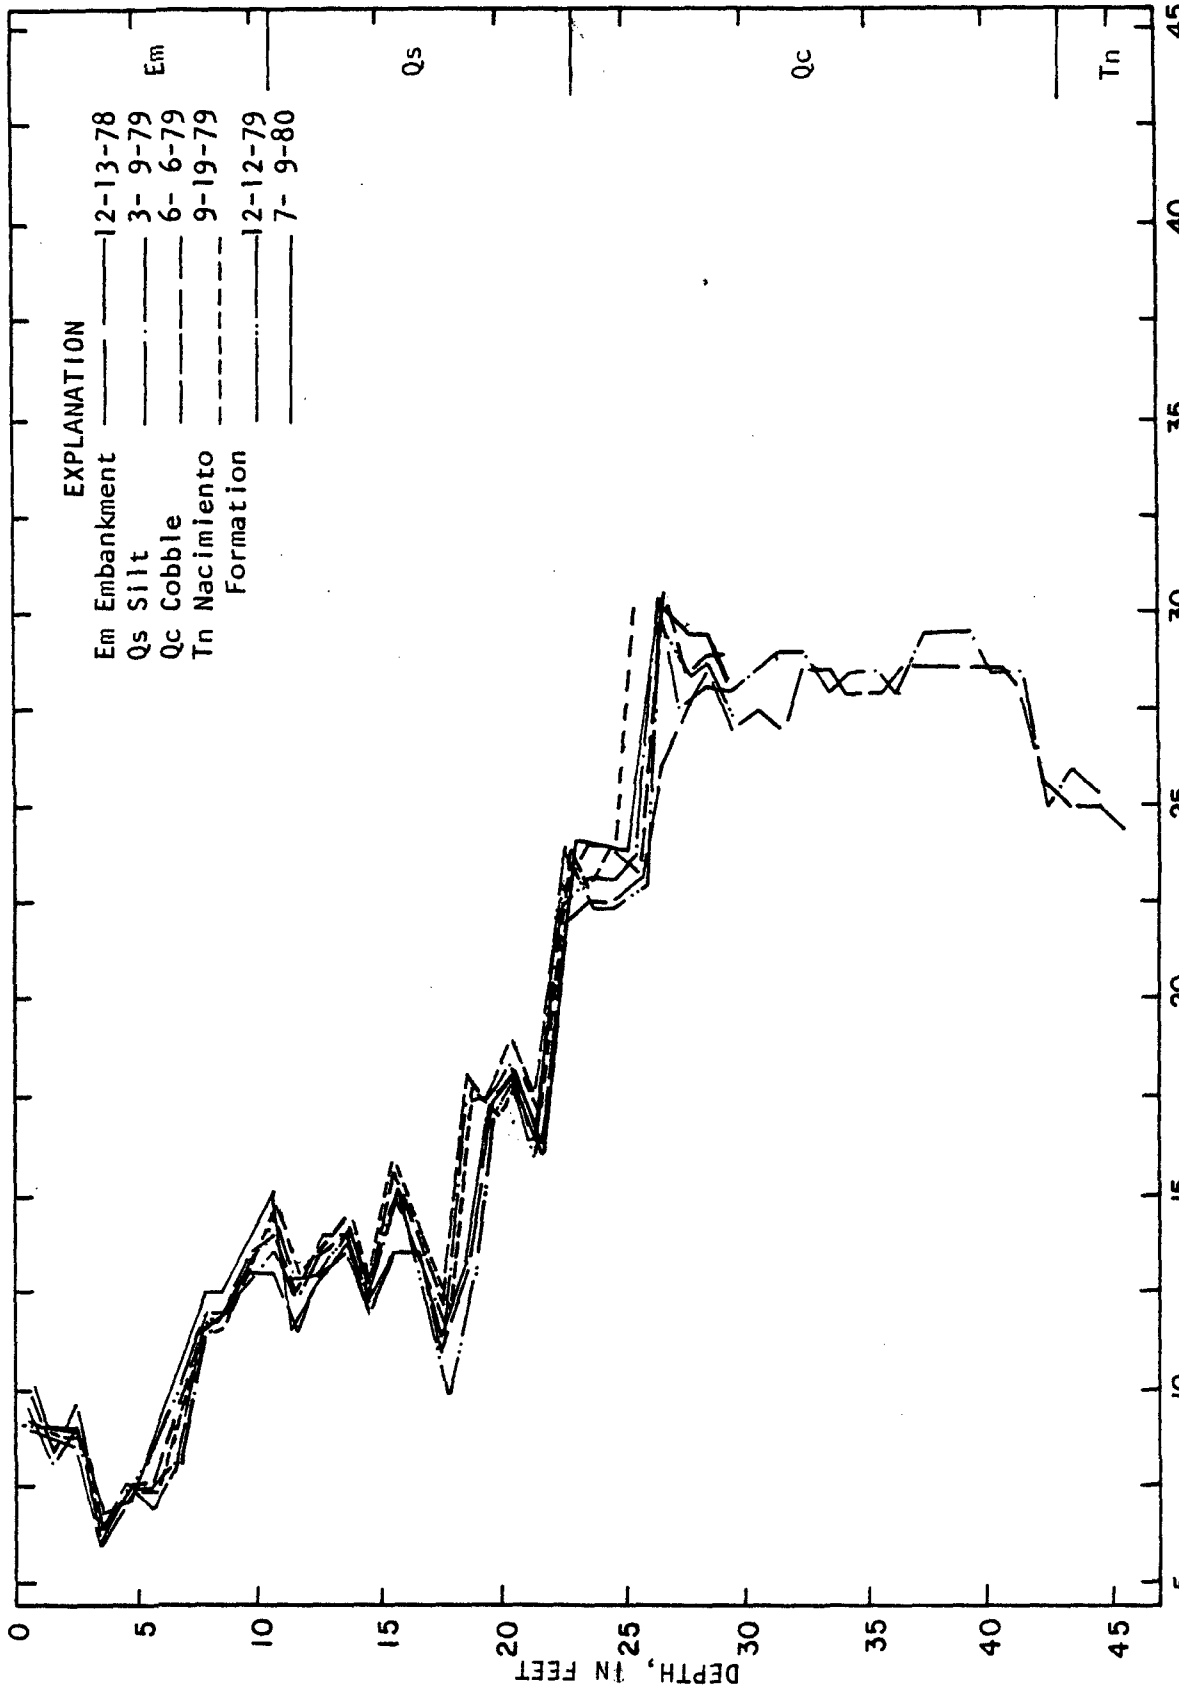
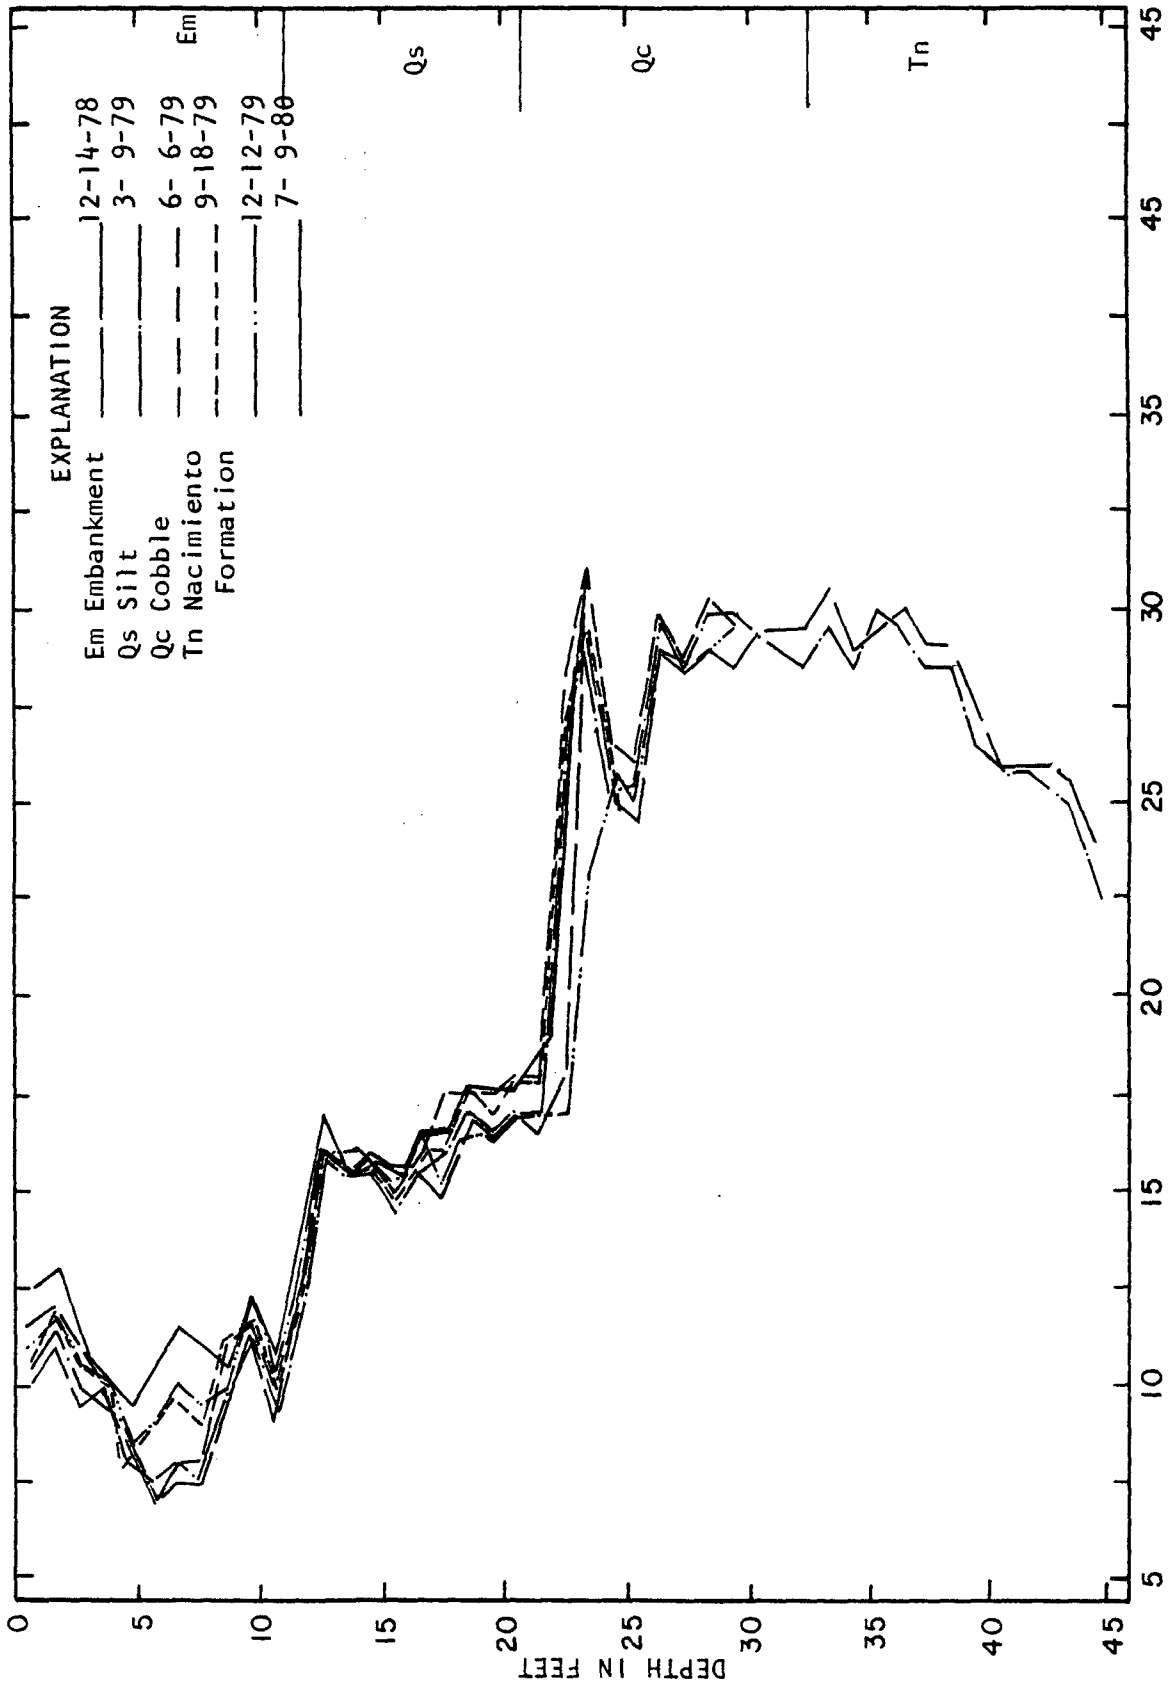
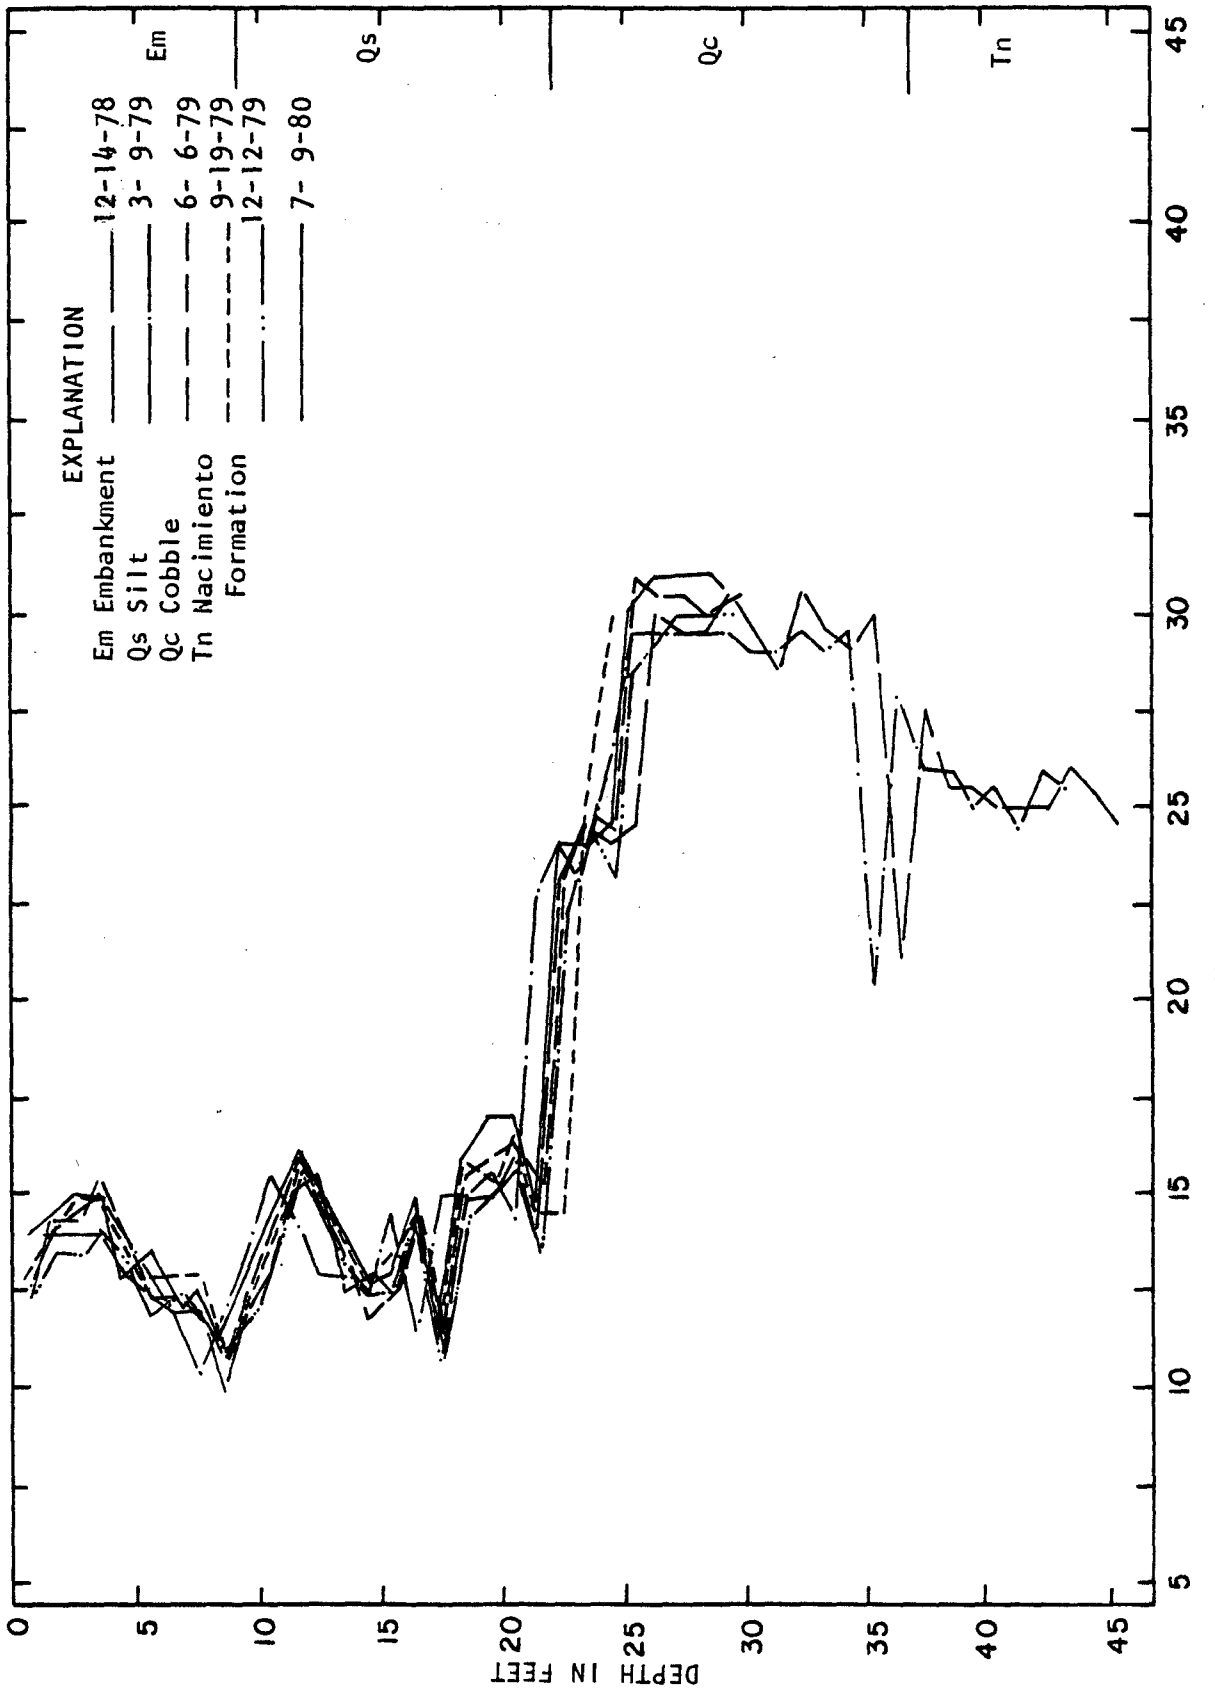
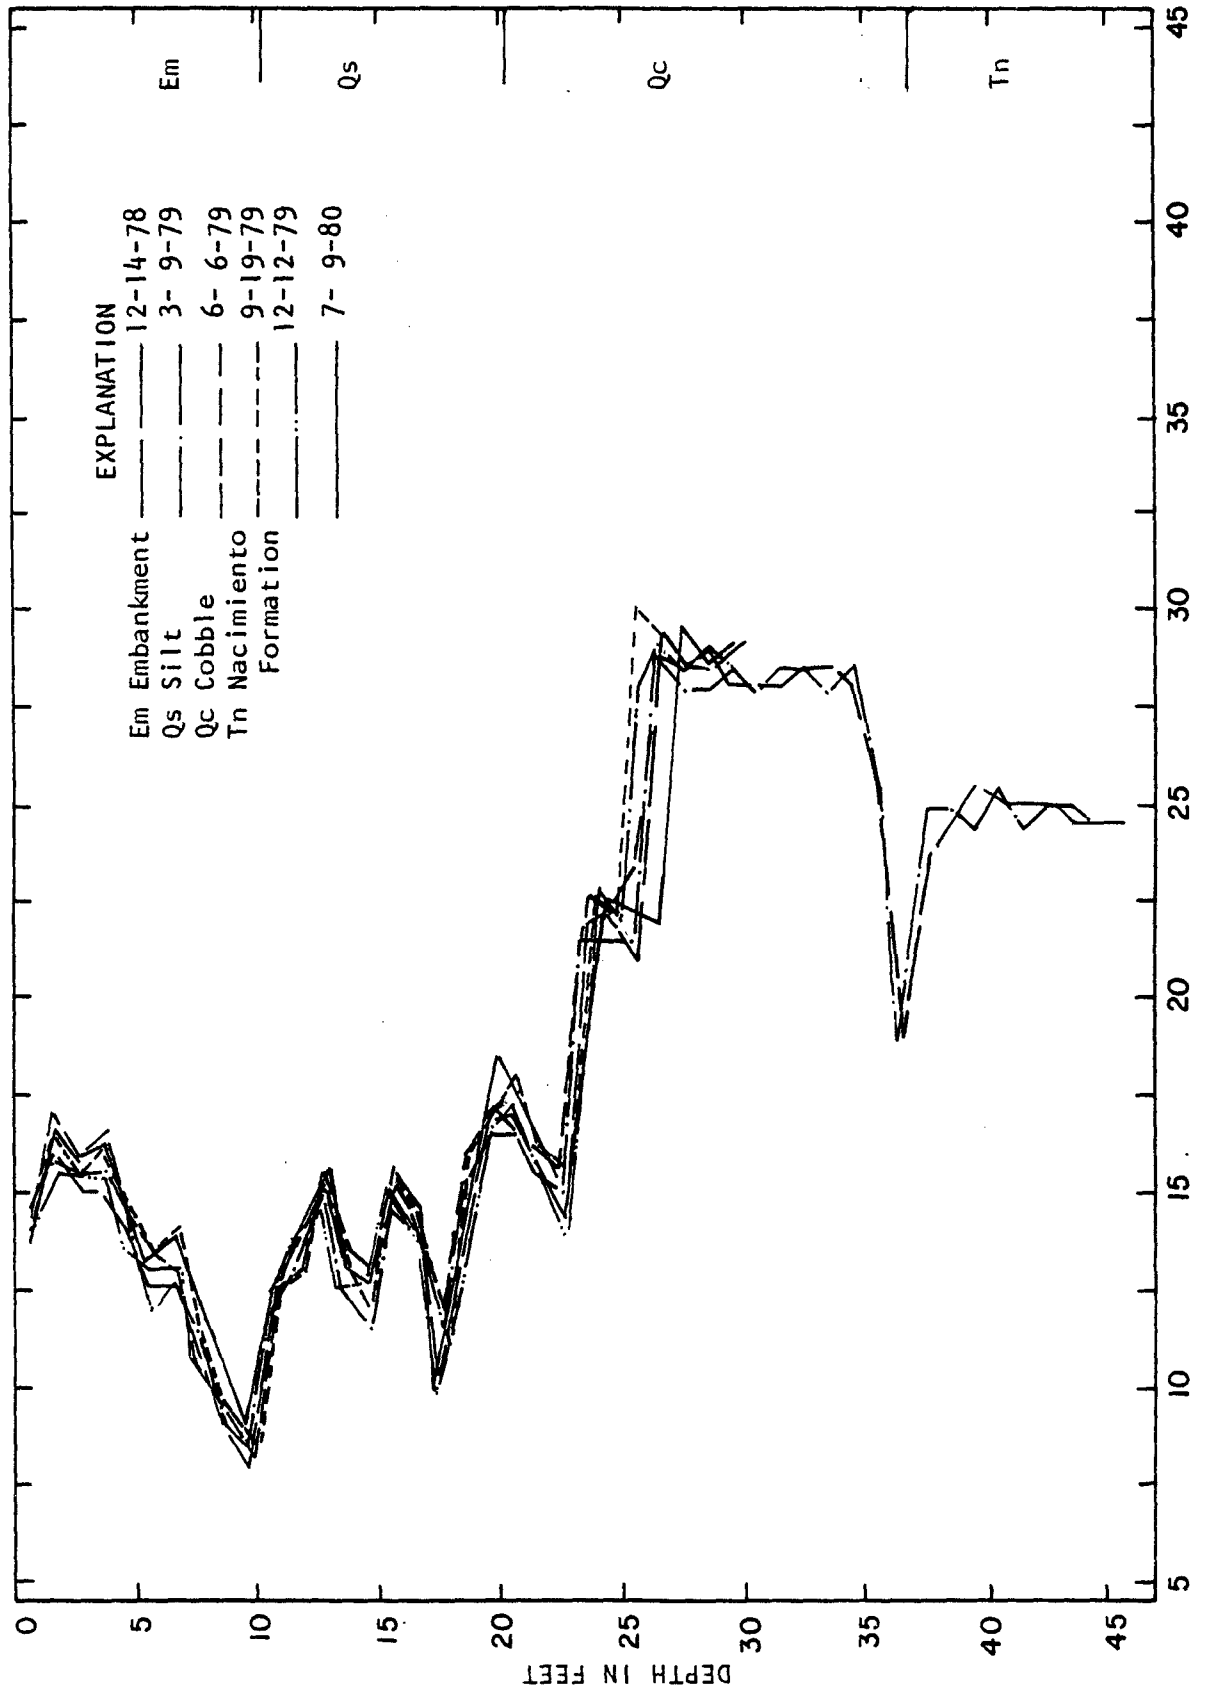
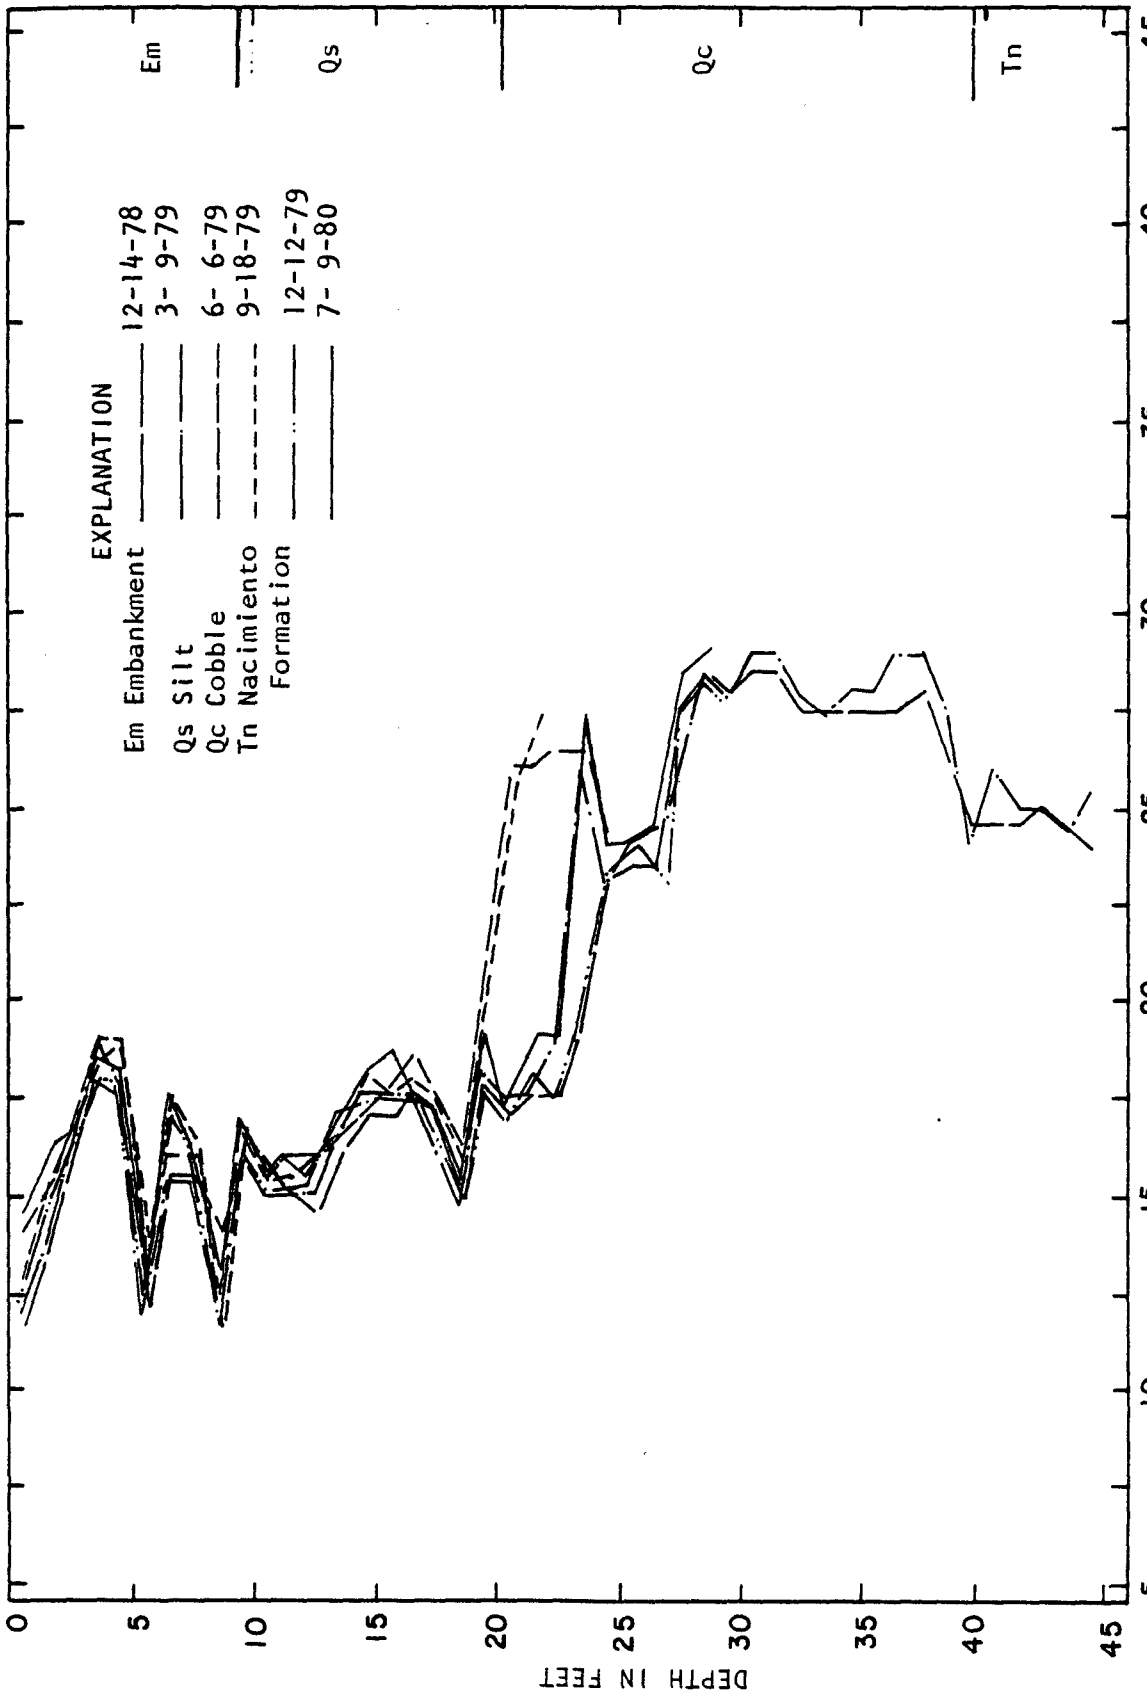
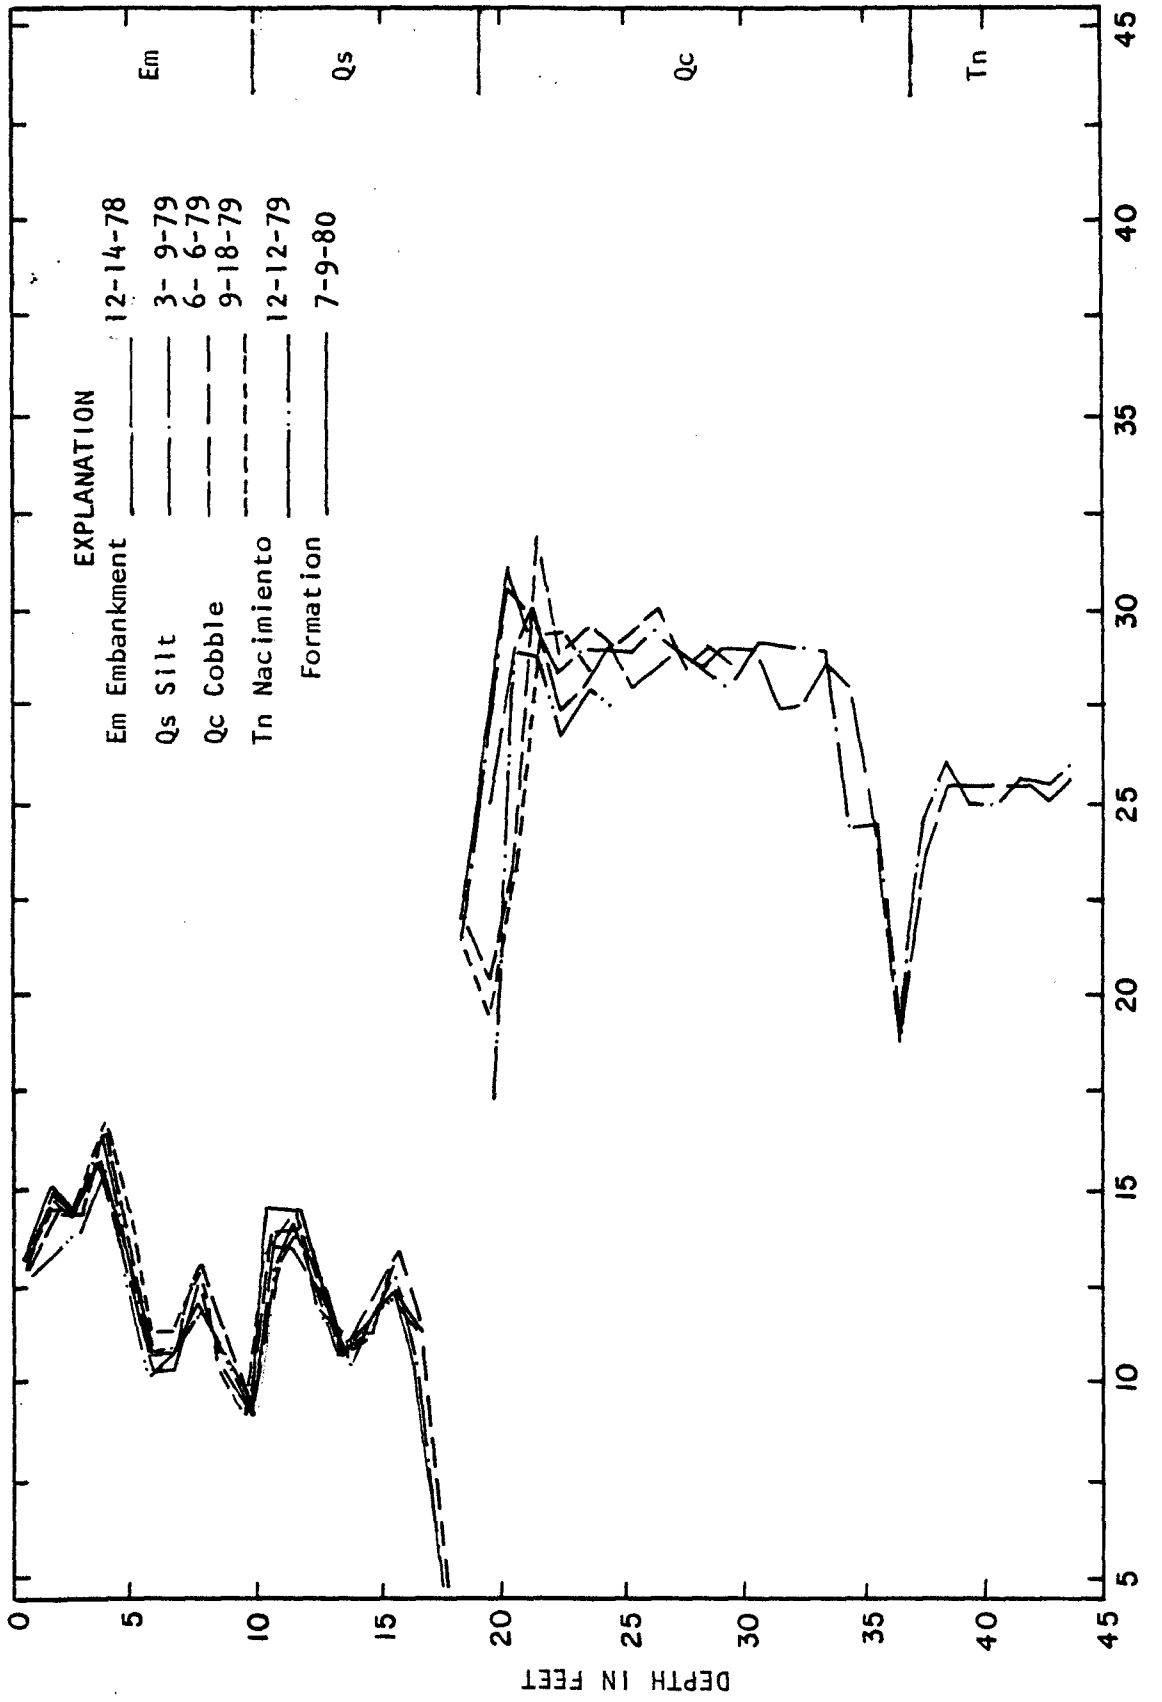
The neutron probe soil-moisture profiles are used to evaluate changes in the moisture content in the embankment and subsurface soils on the north, east and west sides of solar evaporation Pond 1. Figure 8 through 16 show the results of neutron logging in each of the nine observation holes. Original profiles and data collected since the first milestone report are in attachment 3. The neutron-logging data for December 1978 was selected as the earliest neutron-logging data so that data collected since the first milestone report could be referenced to typical soil moisture profiles which were included in the first milestone report.

Examination of the moisture profiles measured in each observation hole since the first milestone report indicates that there has been no fundamental change in the moisture content of the soils surrounding the observation holes since the preparation of the first milestone report in January 1979. Therefore, the conclusions reached in the first milestone report are as valid at this writing as they were in January 1979.

1. Neutron logging of observation holes indicates that a steady state soil moisture condition exists. No new information is being obtained by neutron logging methods and it is recommended that neutron logging of the observation holes be discontinued.

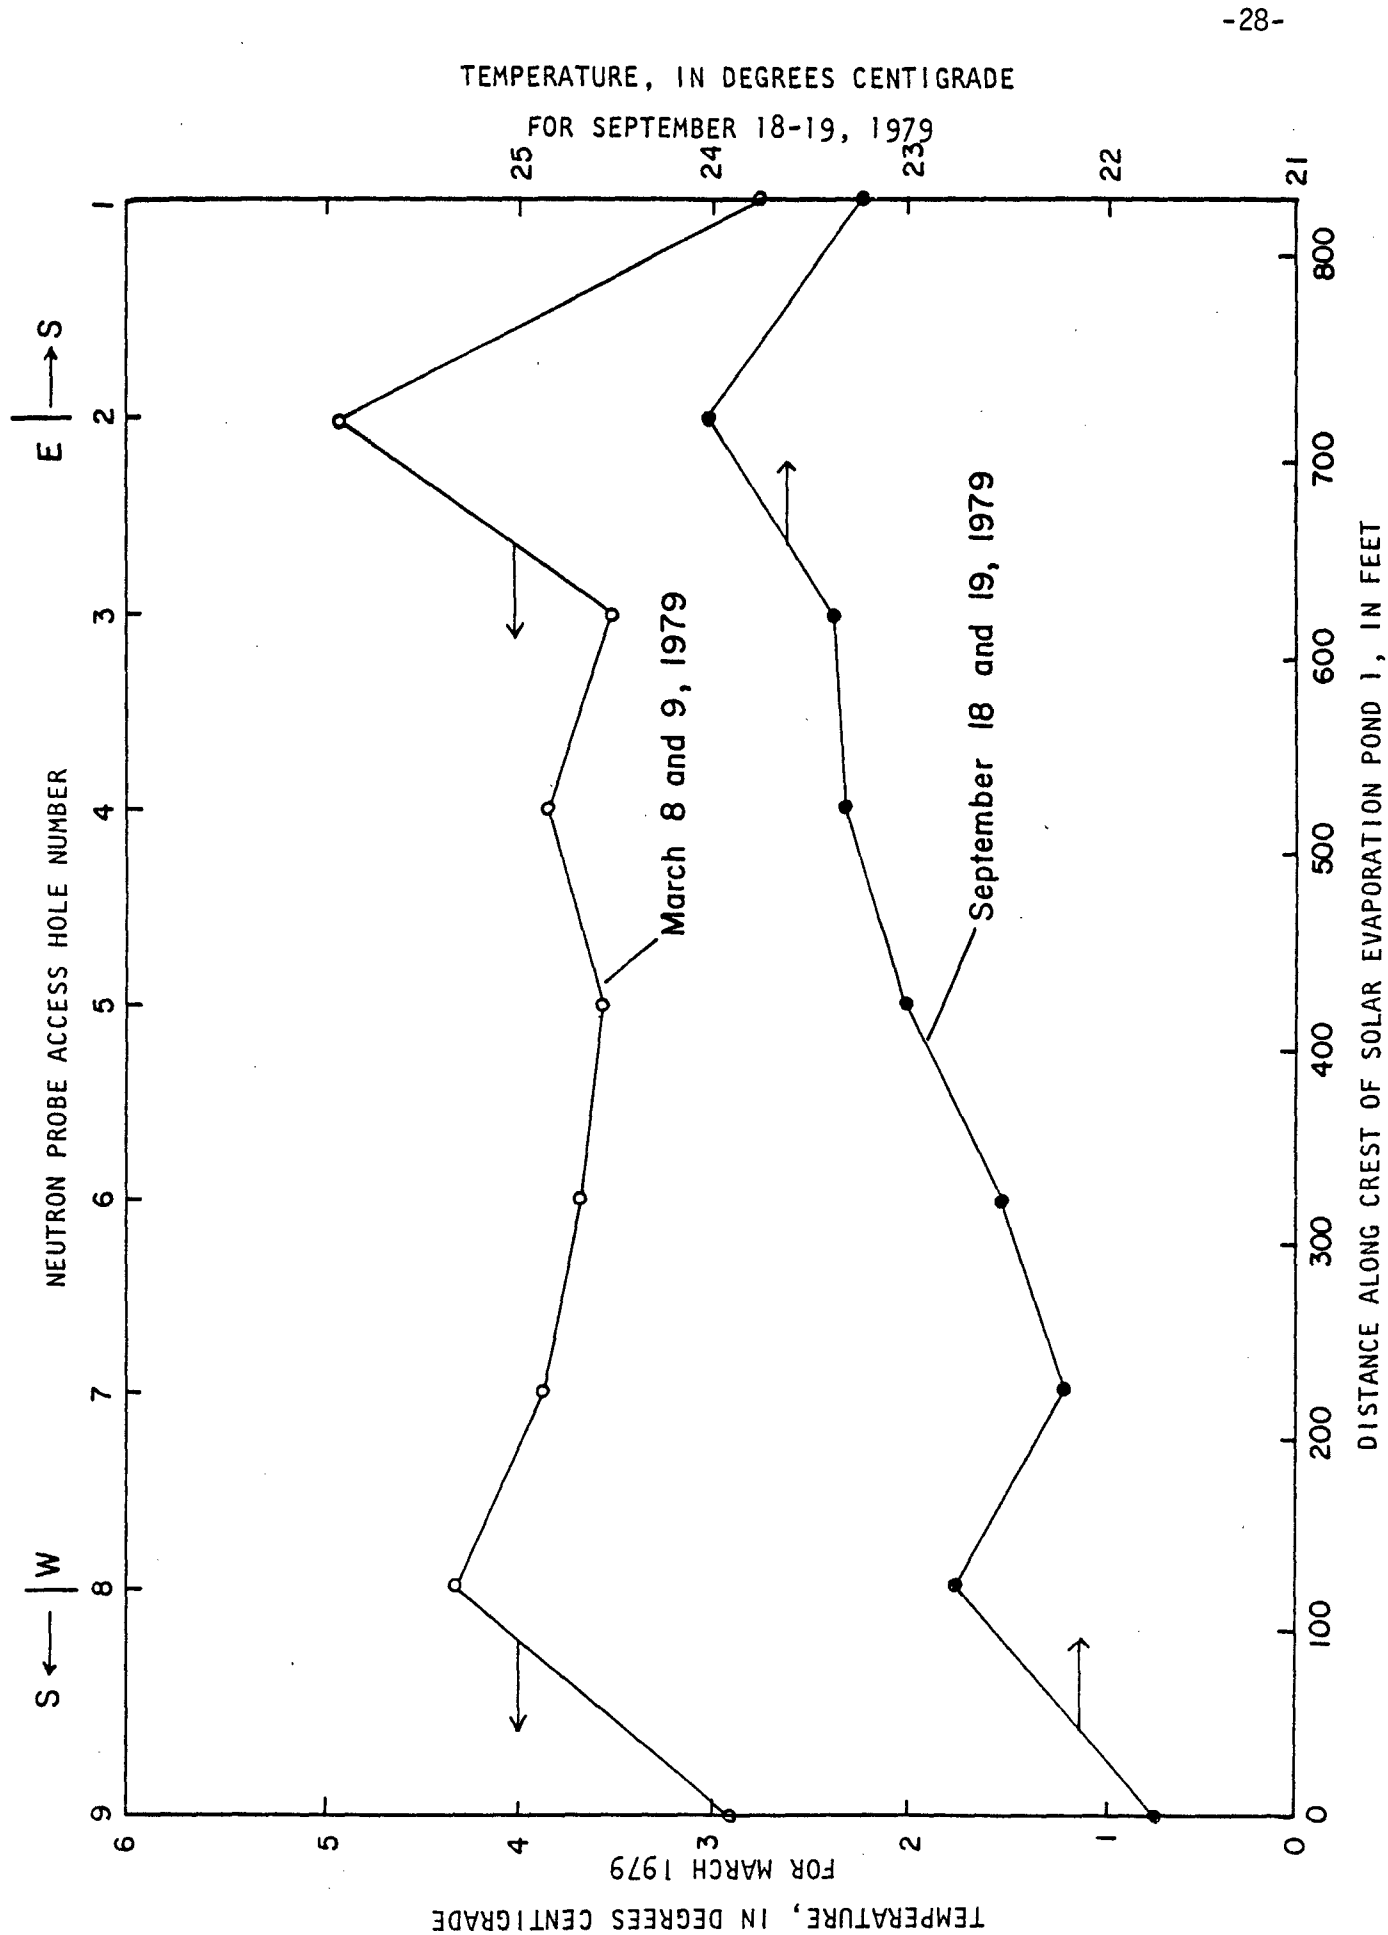
Figure 22. Subsurface temperatures at a depth of about 12 feet along the crest of solar-evaporation Pond 1.

Examination of figure 27 from the first milestone report and figure 22 of the present report indicate that the form of the temperature profiles made at three different times over a period of one year are quite similar.
