EXHIBIT 5

PUBLISHED MAP OF PICTURED CLIFFS PRODUCTION, SATURATION AND PERMEABILITY TRENDS

EXHIBIT #6

Pretreatment Flow Test

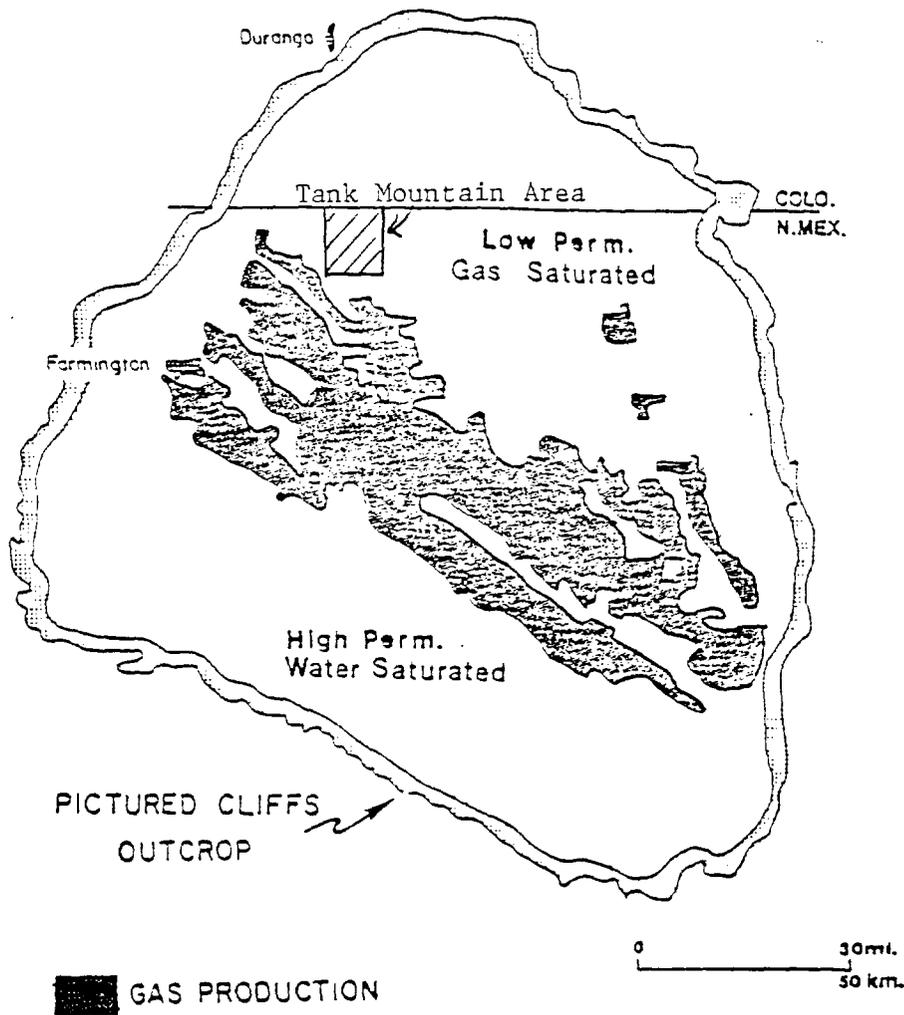
Figure 37. Distribution of producing and non-producing zones of the Pictured Cliffs. To the northeast of the gas-producing zone the sandstones are gas-saturated, but have very low permeability; to the southwest, the sandstones are relatively permeable, but are water saturated. (modified from Brown, 1973)

From: Cumella, S.P., 1981, Sedimentary History and Diagenesis of the Pictured Cliffs Sandstone, San Juan Basin, New Mexico and Colorado. University of Texas at Austin Masters Thesis. Report No. UT 81-1.

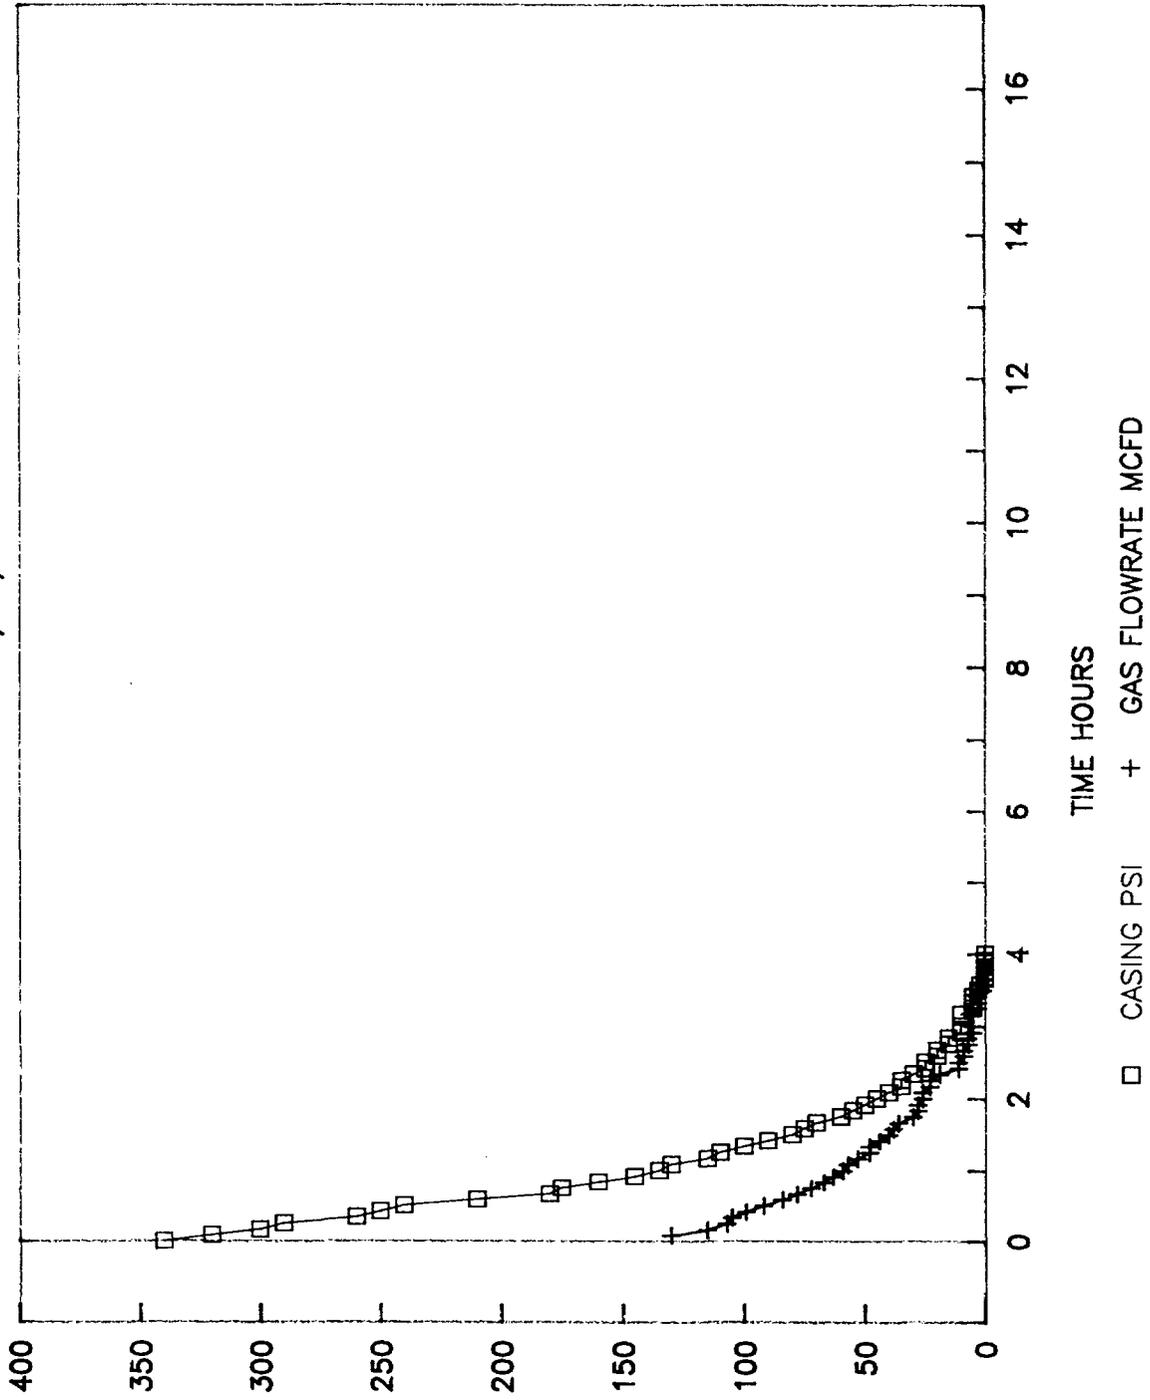
DRAW DOWN TEST 07/16/91

SAN JUAN 32--9 UNIT #106

The San Juan Unit 32-9 #106 is located in the SE/4 of Section 17-31N-9W San Juan County, New Mexico. On June 19, 1991 the well was perforated from 3398' to 3420' and 3434'-3450' with 8 shots per foot in an under balanced condition to minimize possible skin damage. The well was then shut in for 27 days. The well was flow tested on July 16, 1991. Initial shut in casing pressure was 340 psi. The well was then flow tested starting with an 8/64 choke to the atmosphere. The gas rate started at 130 mcf/d and dropped to 0 in 4 hrs. Gas rates were recorded every 5 minutes. The well had a stabilized production rate of less than 1 Mcf/day. This is below the maximum allowable production rate of 91 Mcf/day.

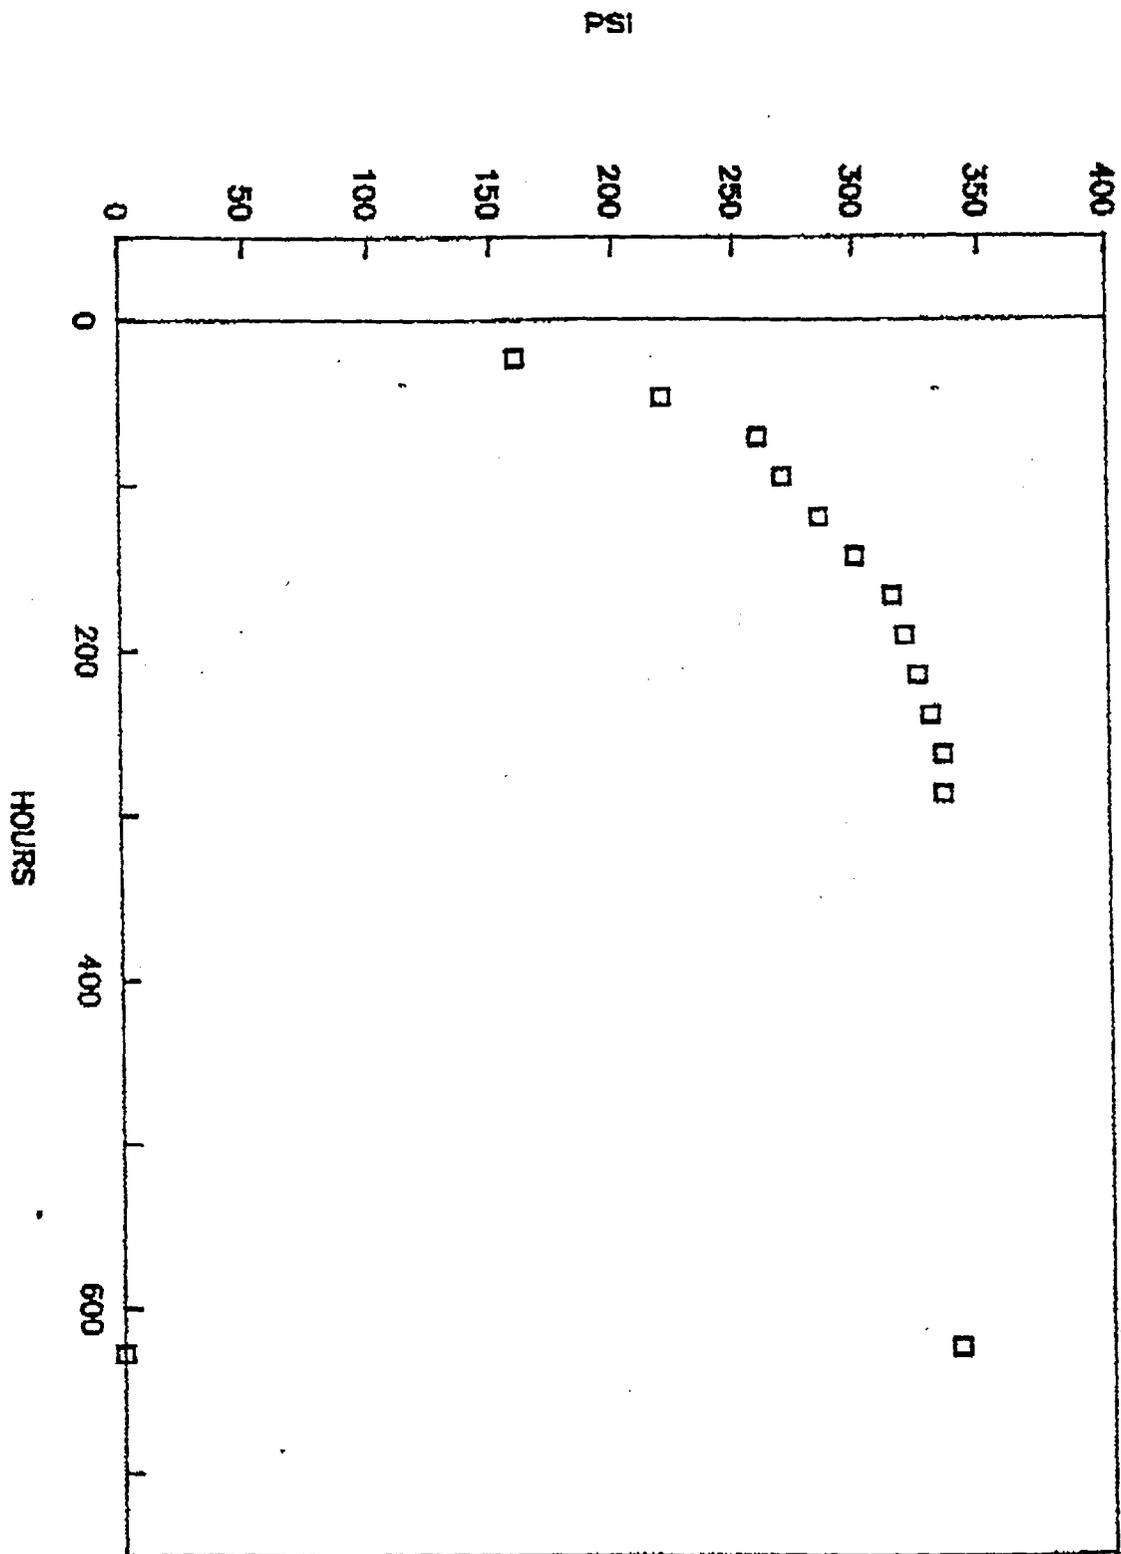
PRESSURE FALLOFF TEST

SAN JUAN 32-9 UNIT #106
