NM1 - 9

GENERAL CORRESPONDENCE

Sunco Water Disposal
Solid Shaker
Proposed To Add
November 3, 1992

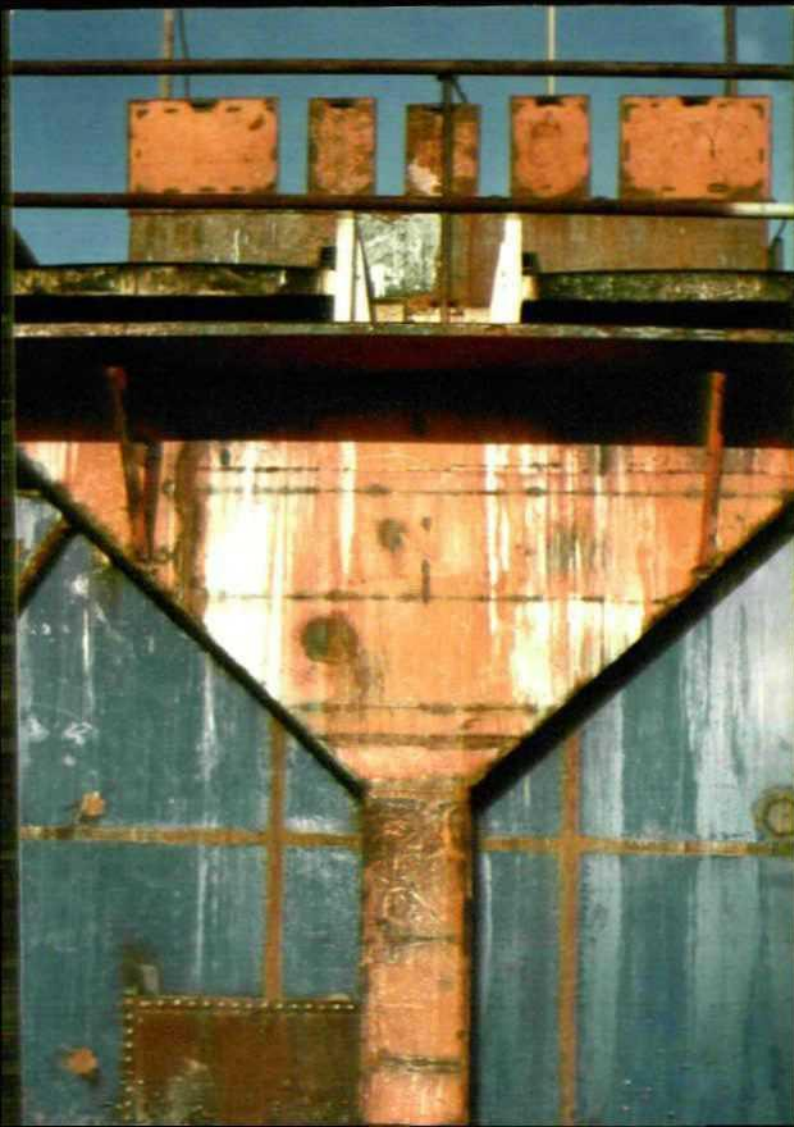
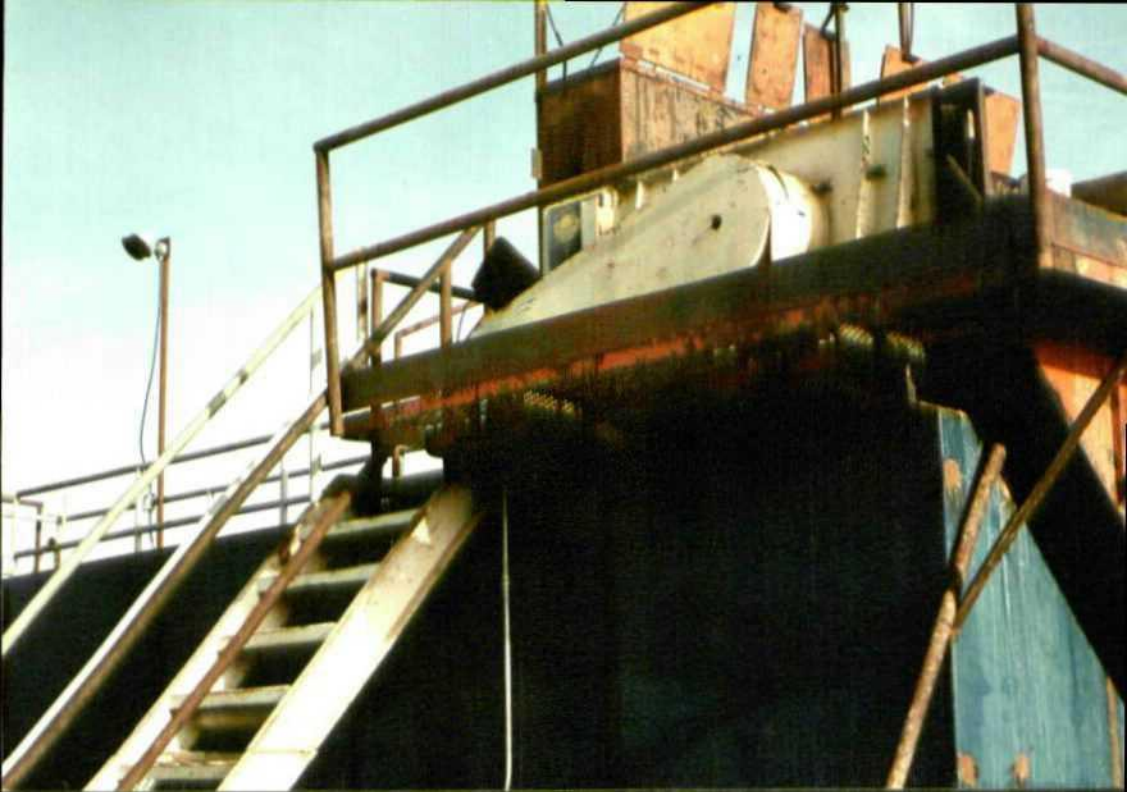
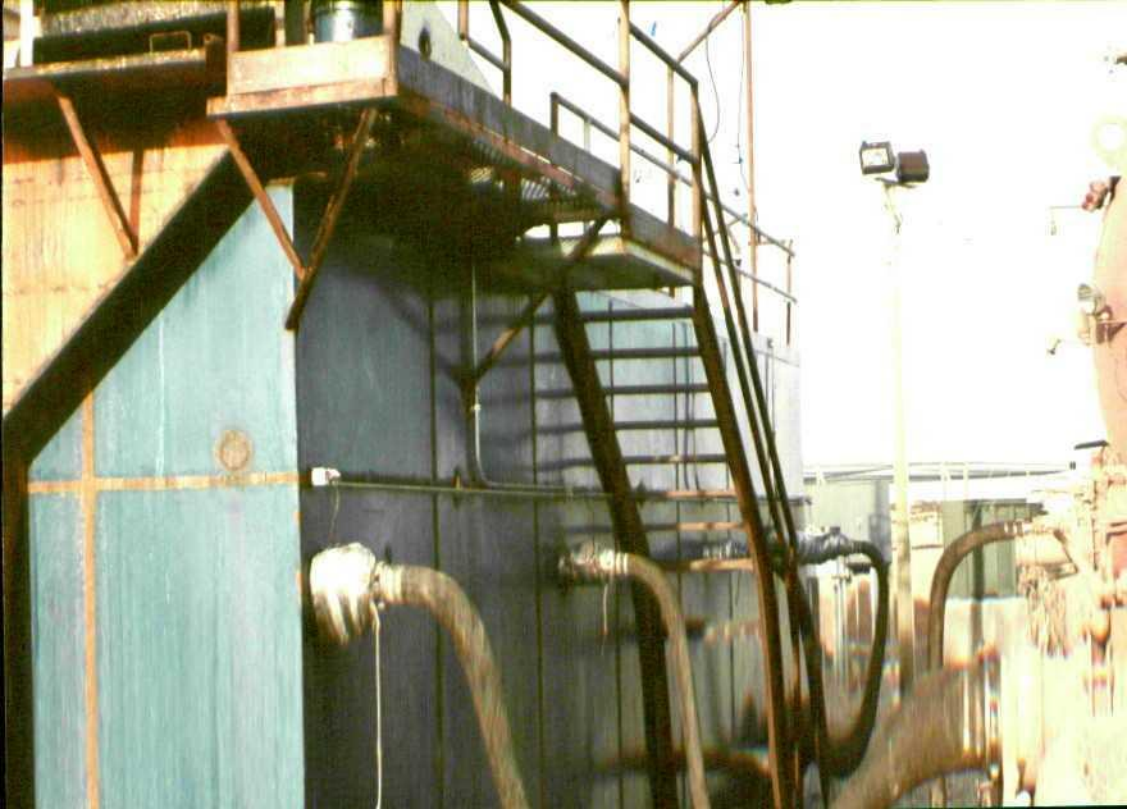
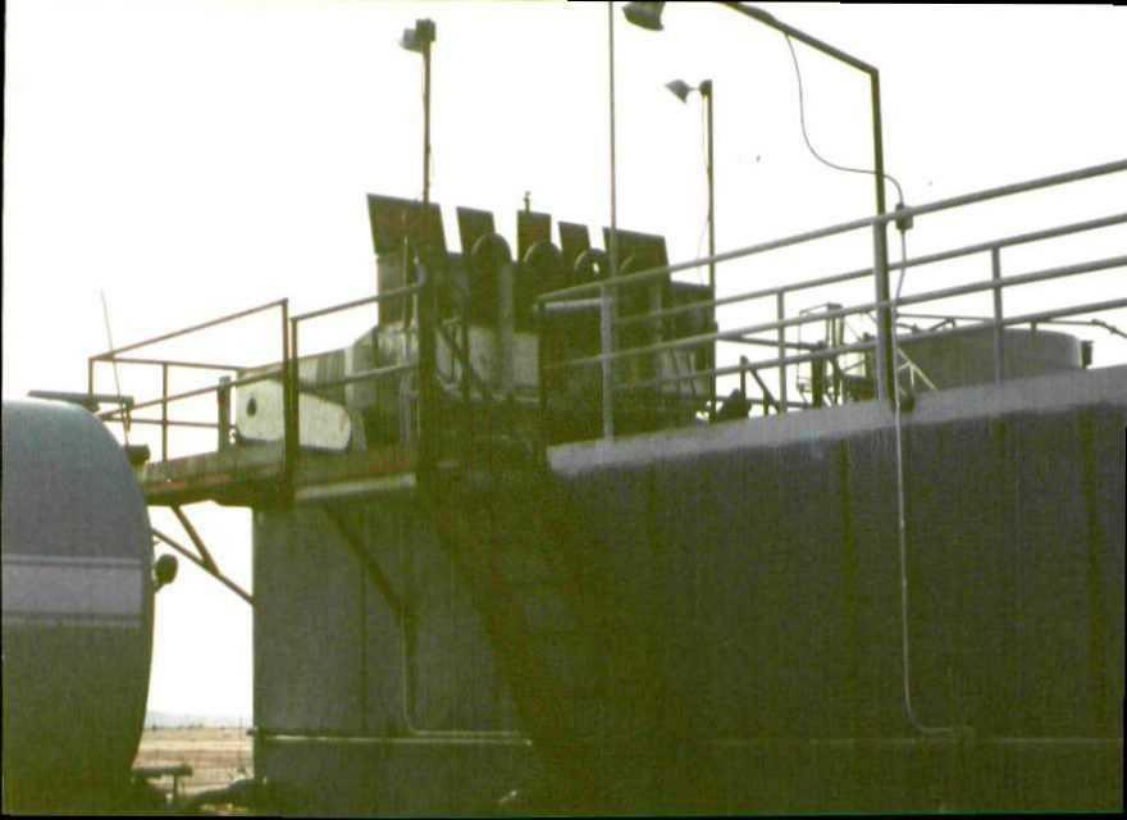
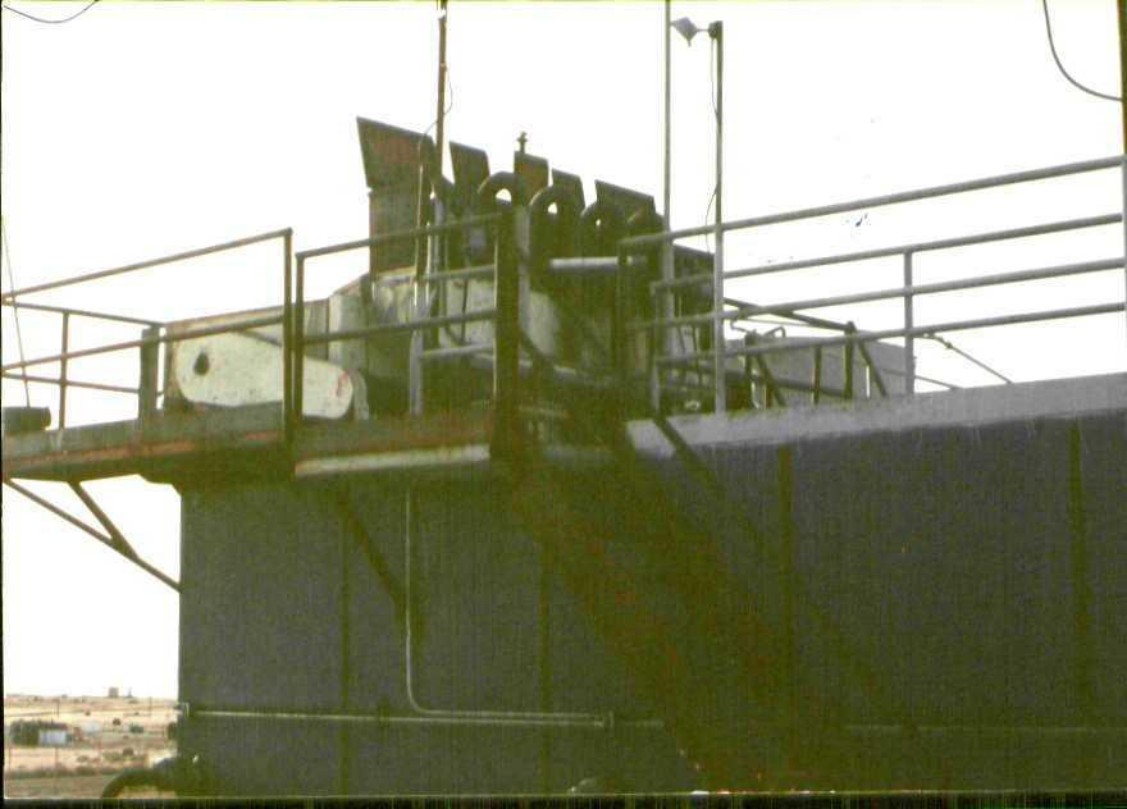
In reference to your request concerning our Double Shale Shaker at our
OCD Rule 711 permitted disposal facility, I submit the following:

1. PIT DESIGN: As we discussed I have enclosed photos for your file.
2. DISPOSITION OF SOLIDS: These dried solids will be taken to Tierra
Land Farm for disposal.
3. SOLIDS ANALYSIS: As we discussed in our meeting, we shall annually
sample the area beneath the burned pits where the solids are to be
dried.

Solids Shaker

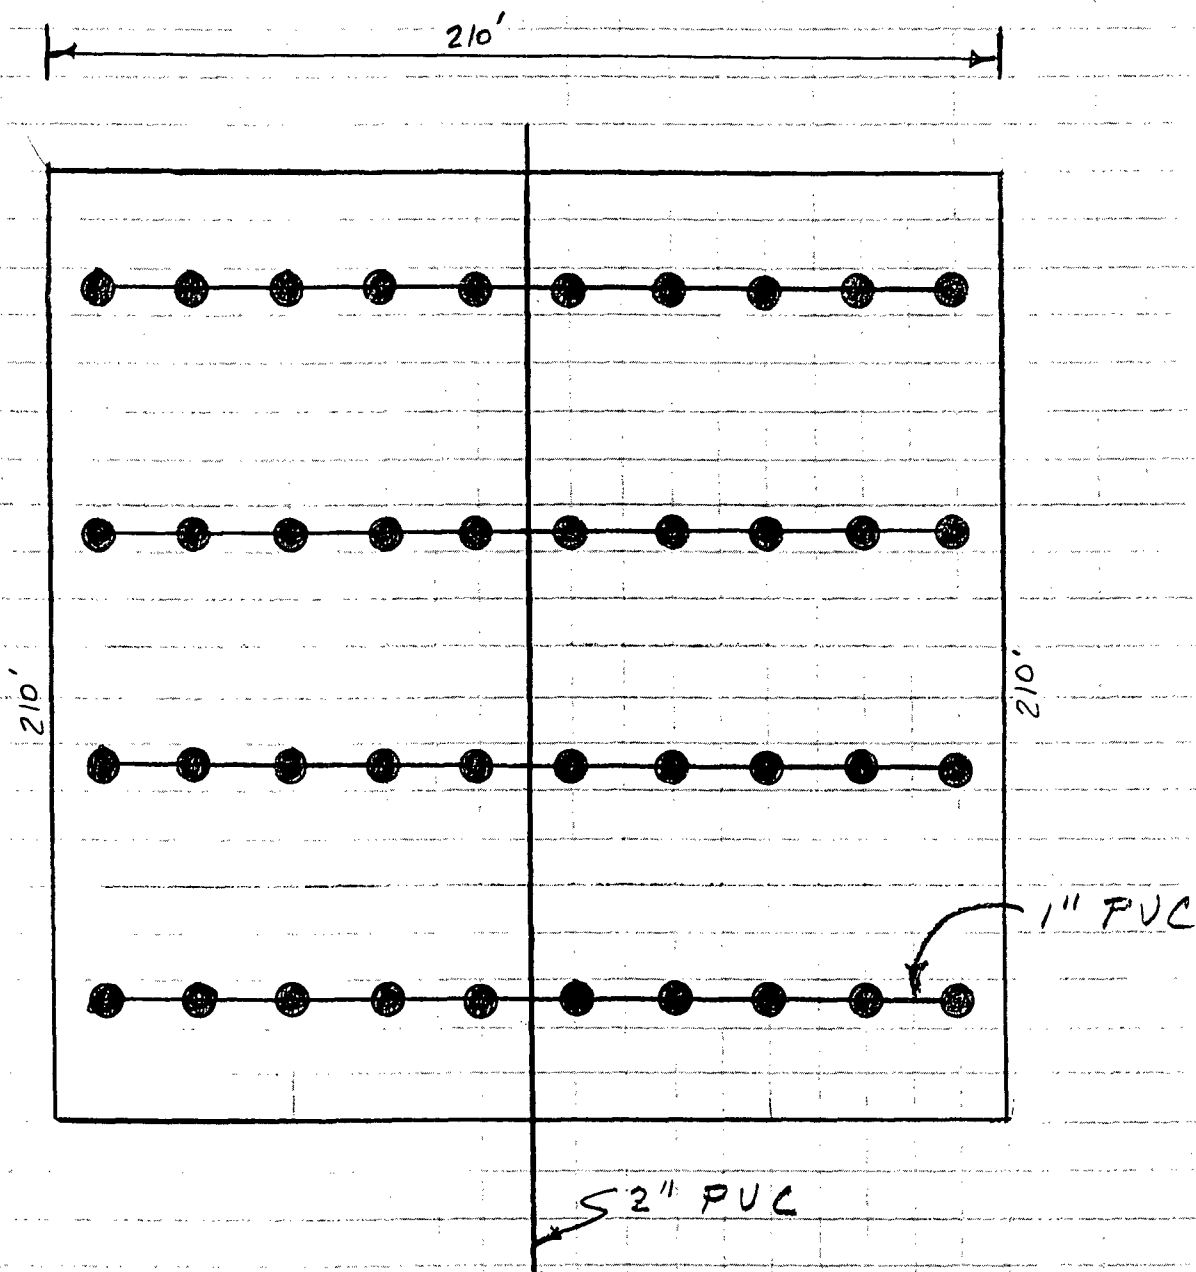
POND DEPTH OF H_2O VARIES 3'-15'

● REPRESENTS 8 - $\frac{3}{16}$ " HOLES @ 2" SPACING

NEED 100 - 450 CFM HEAD NEEDS ONLY
 TO OVERCOME f LOSS AND DEPTH OF H_2O

INSIDE TOP OF DIKE AND LINER
ALL SPRAYER NOZZLES TO EXTEND
1' MIN. BEYOND POND LINER W/30 MIL.
XR-5 WEAR PAD UNDER EACH NOZZLE

It will be noted from pressure drop calculations that the orifice is the most crucial part of the project. We have assumed a friction factor for the pipe but as can be noted the pipe has a relatively small influence on the total pressure required. Included are the following calculations: orifice, lateral and main calculations using an orifice size of 1/32-inch for air only, 3/16-inch for air and one with 3/16-inch for water.
