Final Report

RICE OPERATING COMPANY
JUNCTION BOX FINAL REPORT

Vacuum Phillips 'B' Santa Fe EOL

Unit 'O', Sec. 30, T17S, R35E

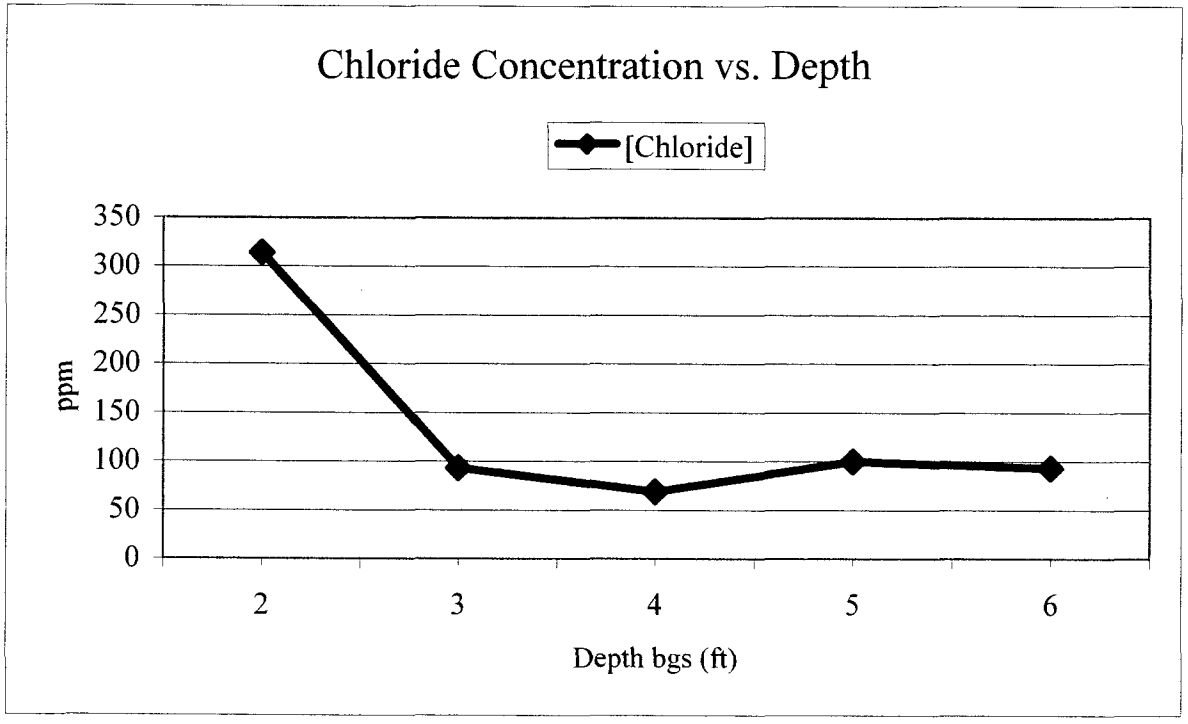
Vertical Delineation at Junction

Depth bgs (ft)	[Cl⁻] ppm
2	314
3	93
4	69
5	100
6	93

Groundwater = 117 ft
