SITE CHARACTERIZATION AND CLOSURE REPORT

DEVON ENERGY CORPORATION
RIO BLANCO 4 CTB
LEA COUNTY, NEW MEXICO
SECTION 4, TOWNSHIP 23 SOUTH, RANGE 34 EAST
LATITUDE 32.334977° N, LONGITUDE 103.485458° W

SEPTEMBER 2019

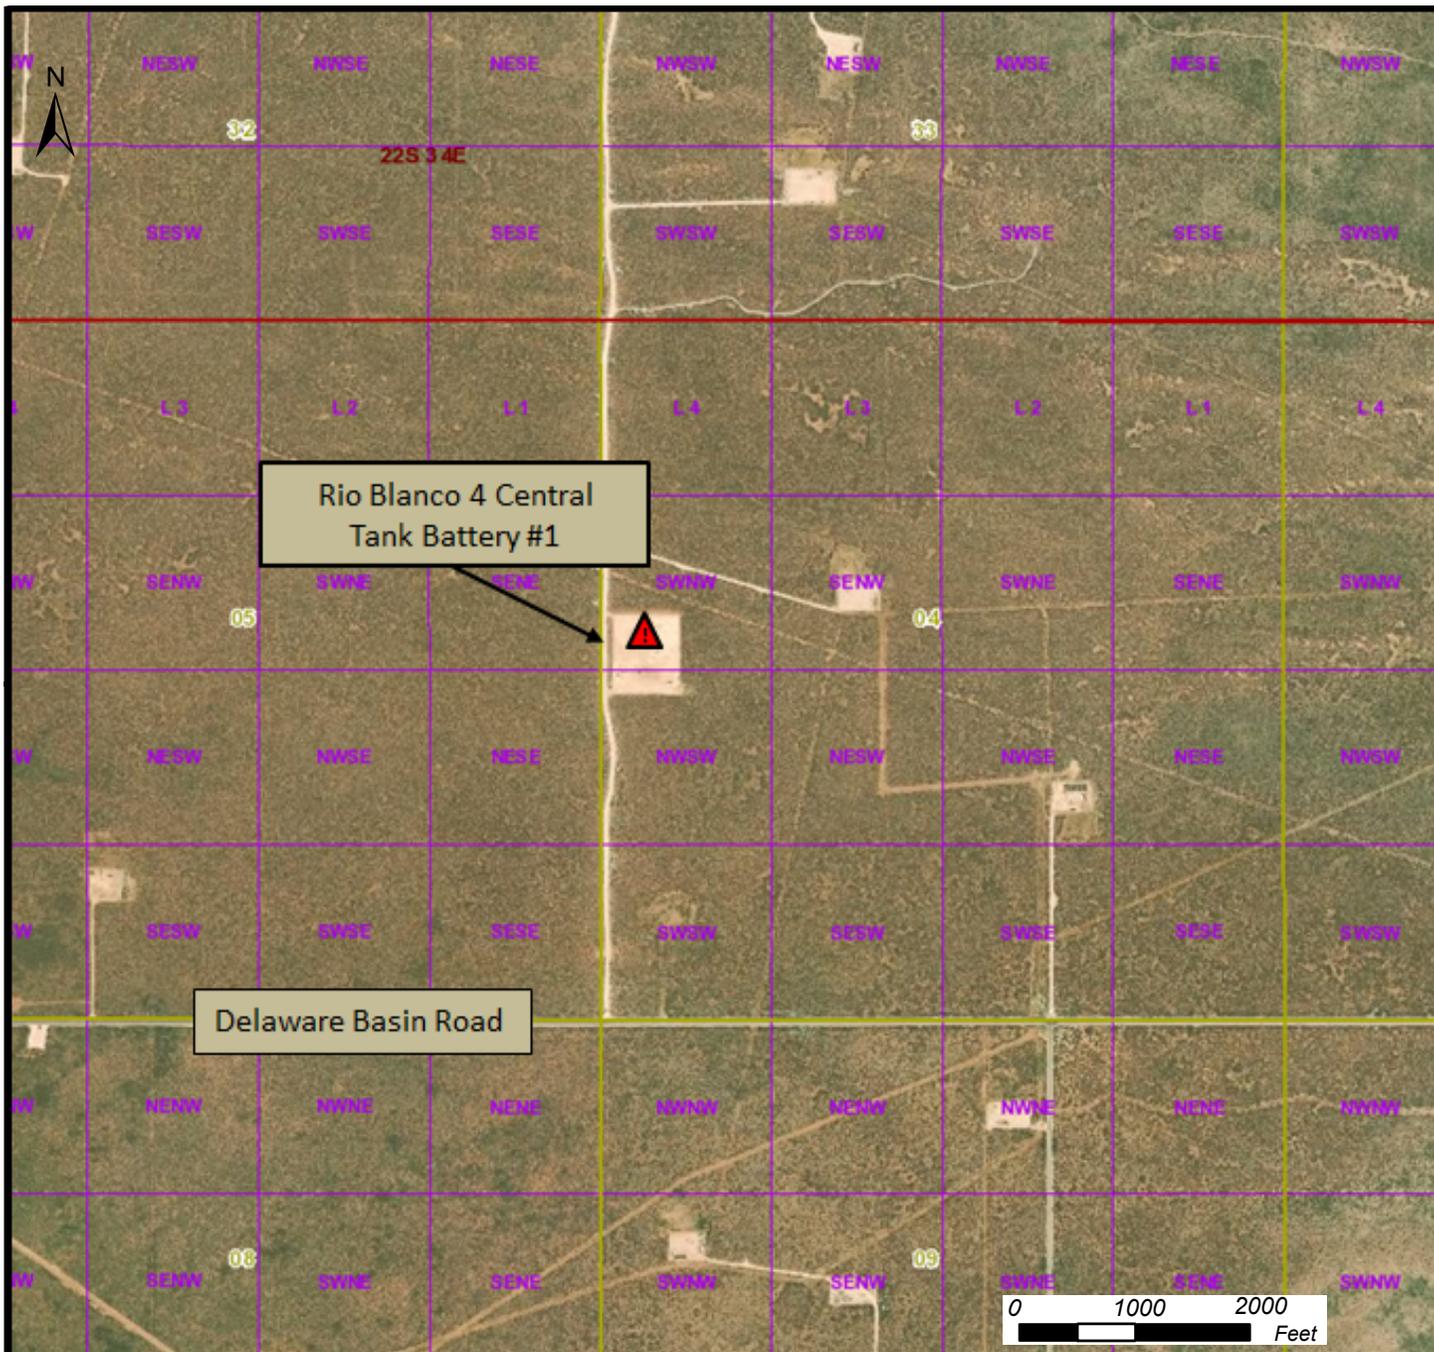
Figure 1

Site Location Map
Rio Blanco 4 Central Tank Battery
 32.33451 -103.4825
 Section 4 Township 23 South, Range 34 East

The Rio Blanco 4 CTB is located on Federally-owned land on the west side of Section 4, Township 23 South, Range 34 East in Lea County (Figure 1). This location is within the Permian Basin in southeast New Mexico and has historically been used for oil and gas exploration and production, and range land.
