Pit, Below-Grade Tank, or Proposed Alternative Method Permit or Closure Plan Application

ConocoPhillips Company
San Juan Basin
Below Grade Tank Closure Report

Lease Name: San Juan 28-7 Unit 19
API No.: 3003907317

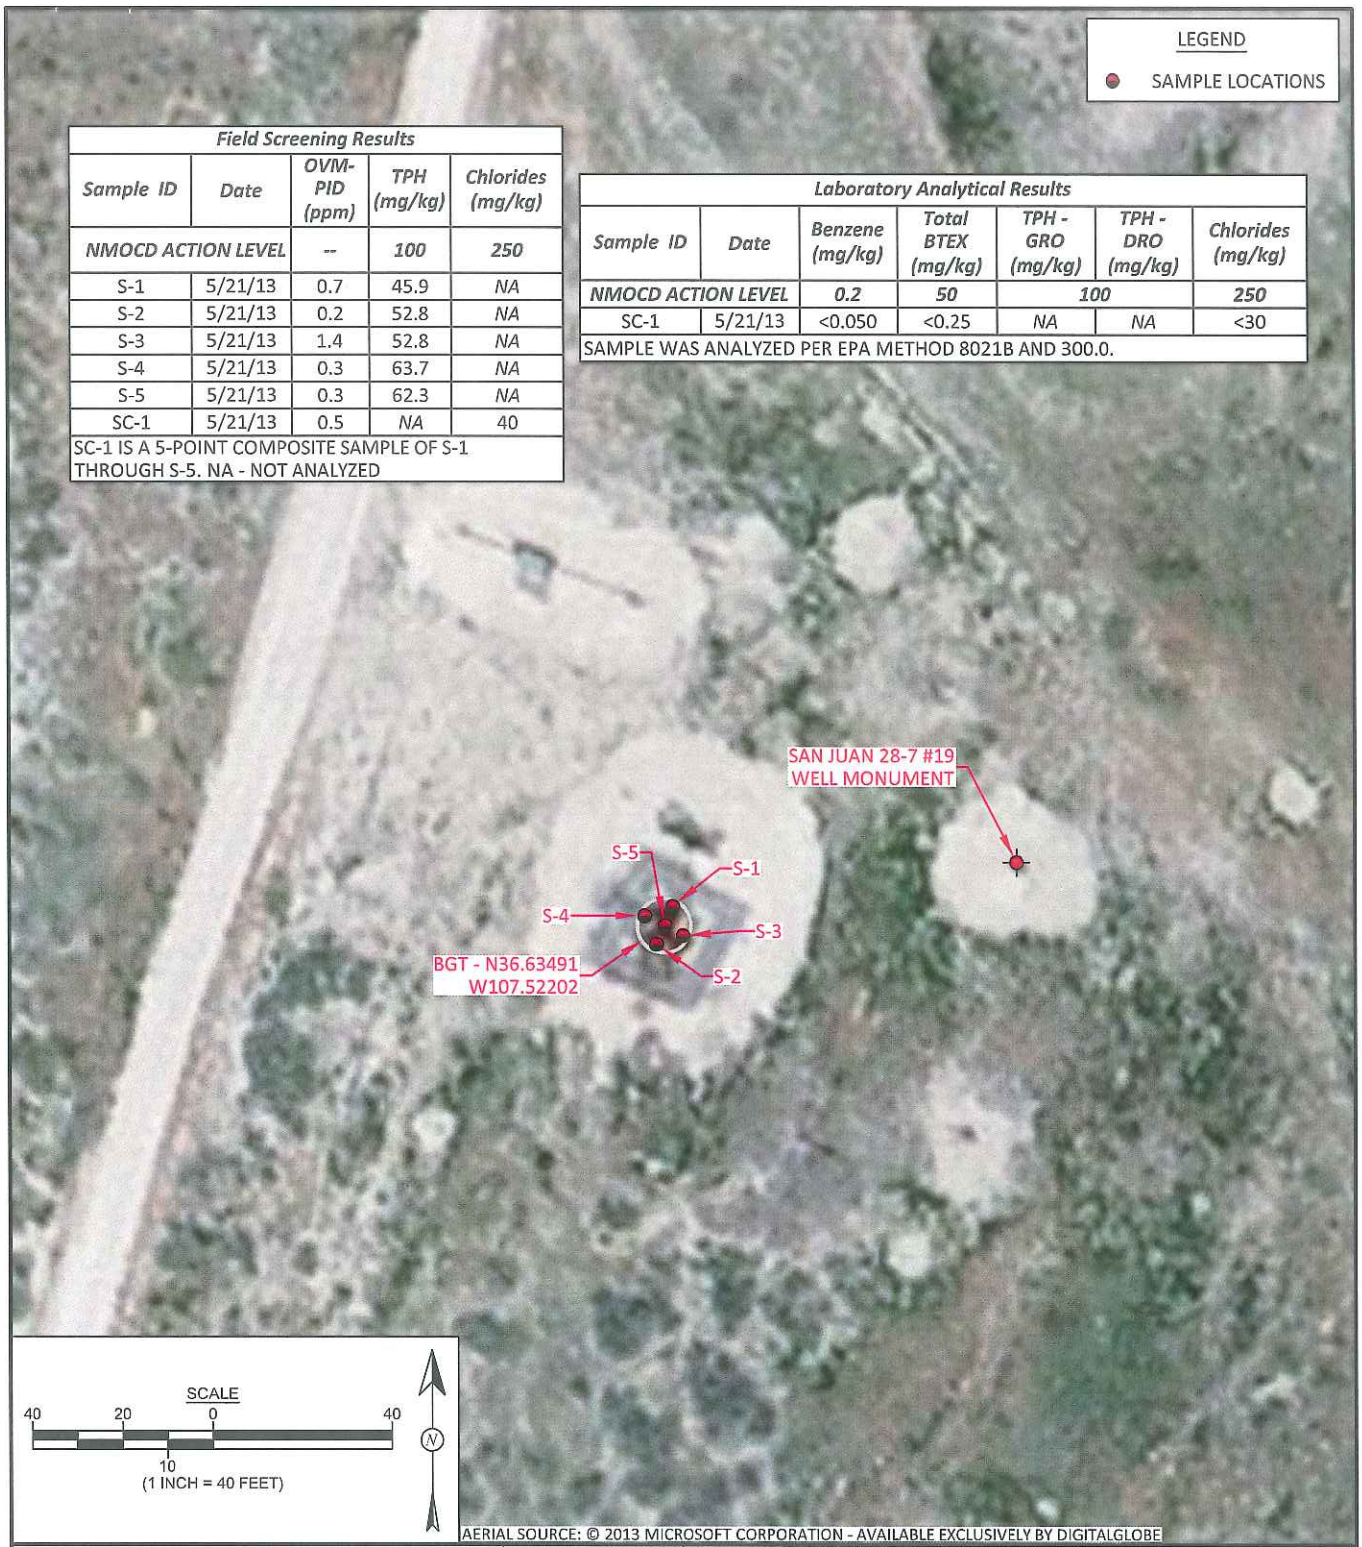
Field Screening Results

Sample ID	Date	OVM-PID (ppm)	TPH (mg/kg)	Chlorides (mg/kg)
NMOCD ACTION LEVEL		--	100	250
S-1	5/21/13	0.7	45.9	NA
S-2	5/21/13	0.2	52.8	NA
S-3	5/21/13	1.4	52.8	NA
S-4	5/21/13	0.3	63.7	NA
S-5	5/21/13	0.3	62.3	NA
SC-1	5/21/13	0.5	NA	40
