Pit, Closed-Loop System, Below-Grade Tank, or Proposed Alternative Method Permit or Closure Plan Application

RE: BELOW-GRADE TANK CLOSURE DOCUMENTATION FOR THE RINCON #186M WELL SITE, RIO ARRIBA COUNTY, NEW MEXICO

BELOW GRADE TANK (BGT) CLOSURE PLAN

Site Photography
Chevron North America
Rincon #186M Well Site
Below Grade Tank Closure
Project Number 92270-0824
August 5, 2011

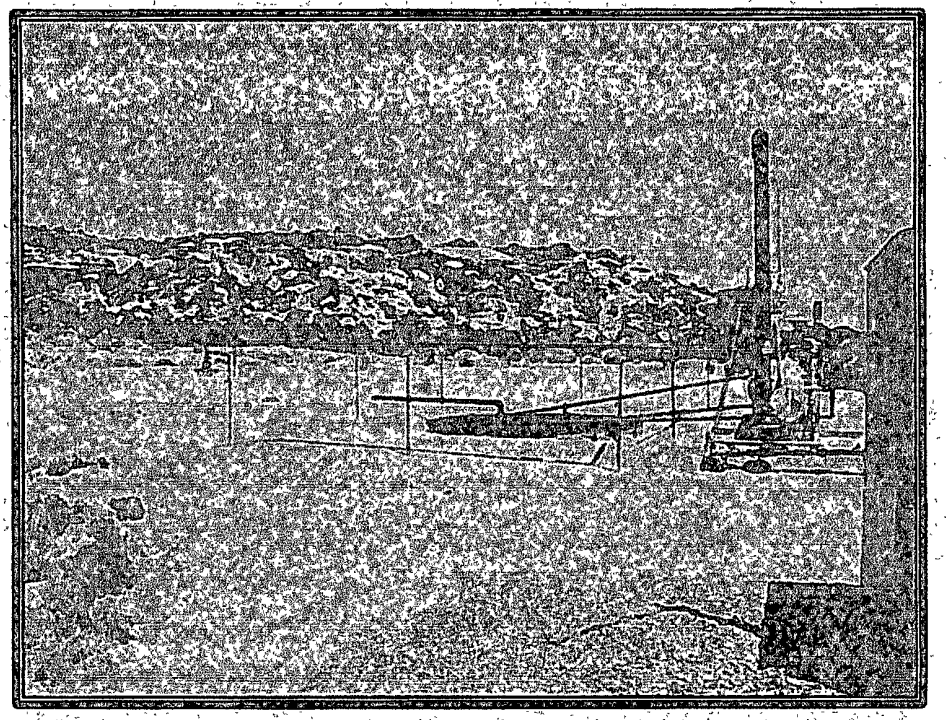
Picture 1: Former Below Grade Tank

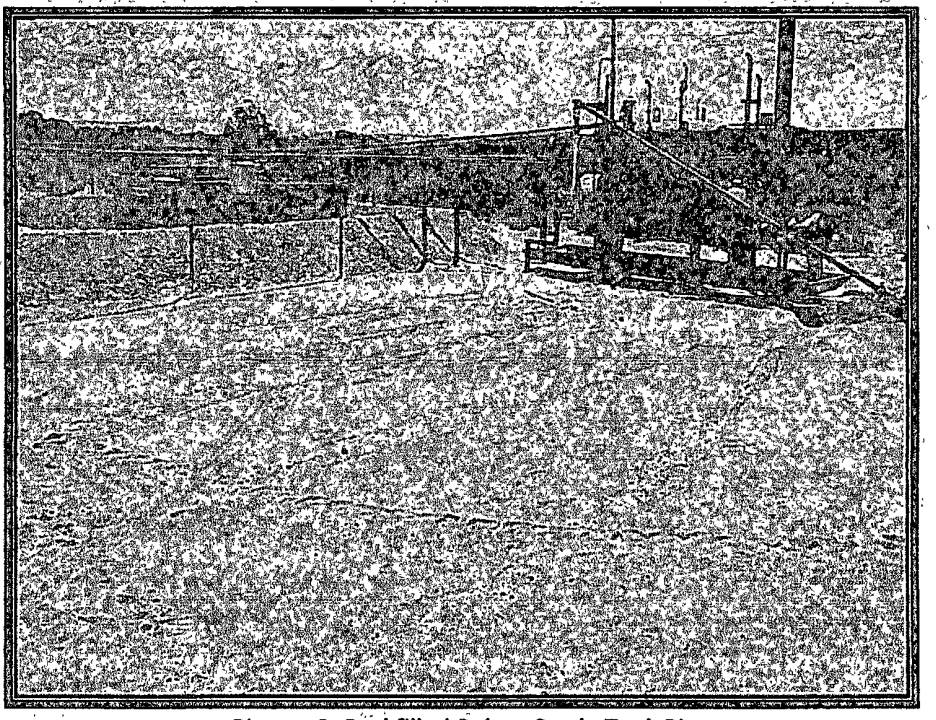
Picture 2: Backfilled Below Grade Tank Pit
