From: Bob Asher <Bob_Asher@eogresources.com>
Sent: Tuesday, April 3, 2018 2:38 PM
To: Yu, Olivia, EMNRD <Olivia.Yu@state.nm.us>
Cc: Yvette Moore <Yvette_Moore@eogresources.com>
Subject: Waylon BMD State #8 Characterization Plan (Part 4)

EOG Resources, Inc.
Artesia Division Office
104 S. 4th Street
Artesia, N. M. 88210

Waylon BMD State #8

Section 14, T11S-R34E
Lea County, New Mexico

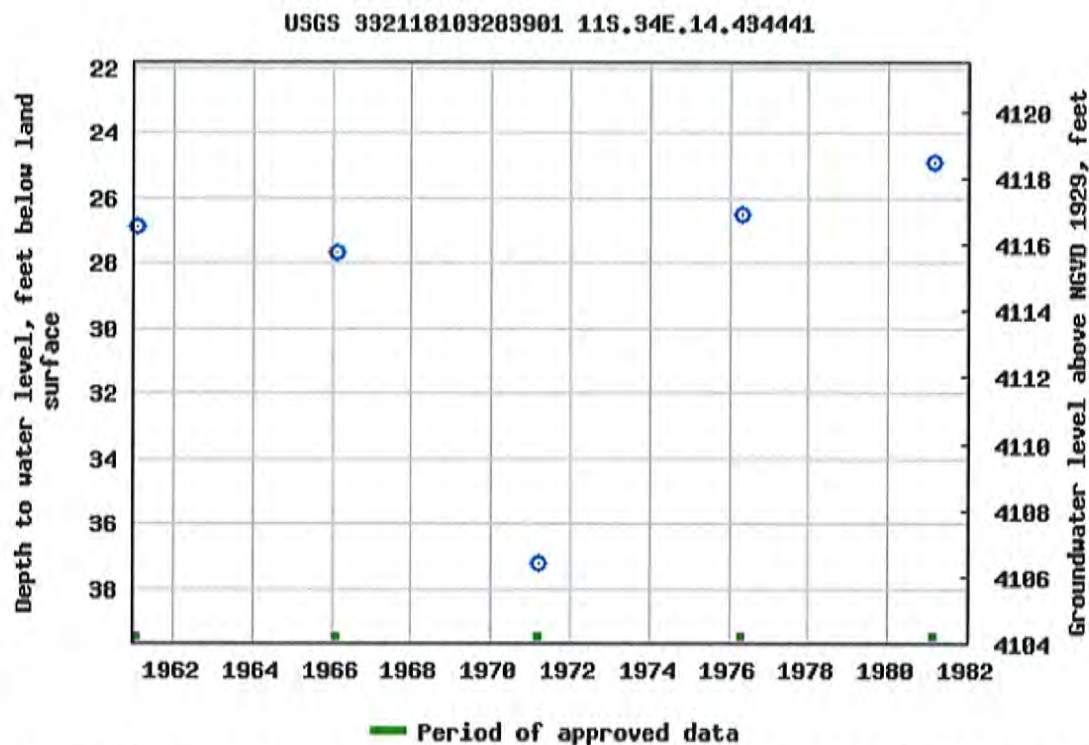
Breaks in the plot represent a gap of at least one year between field measurements.
