NM1-57

Volume 4, Part 1 of 3: Siting and Hydrogeology

**IN THE MATTER OF THE
APPLICATION OF DNCS
PROPERTIES, LLC FOR A
SURFACE WASTE MANAGEMENT
FACILITY PERMIT**

VOLUME IV: SITING AND HYDROGEOLOGY

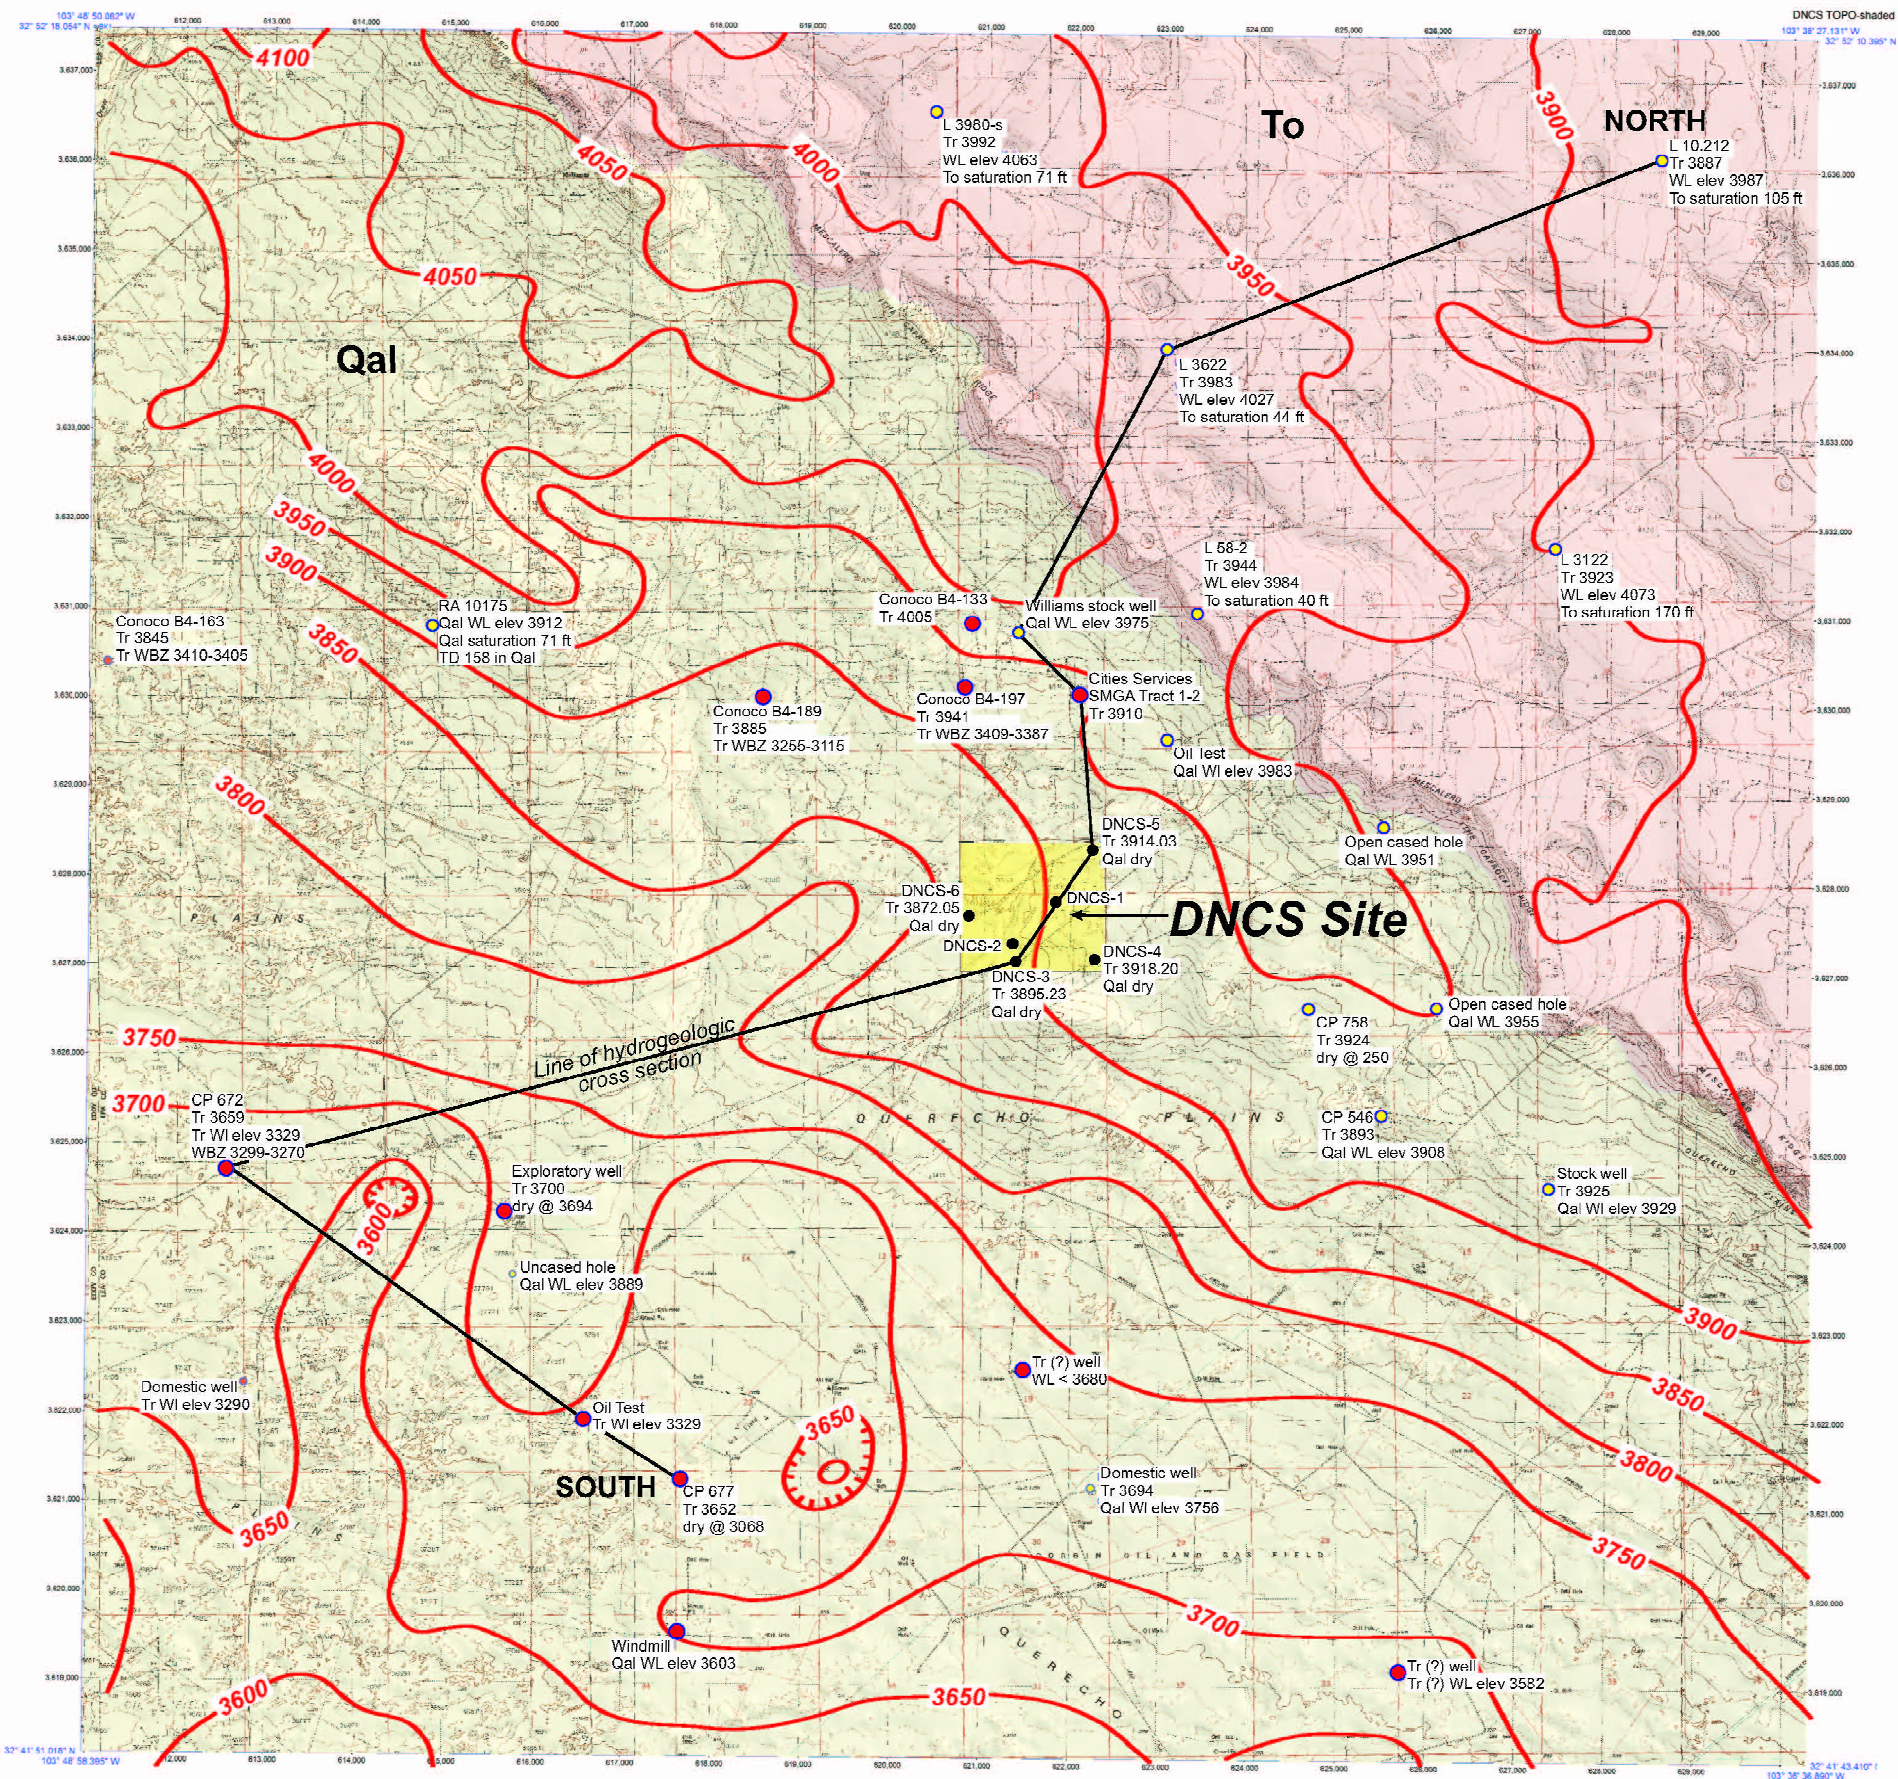
Gordon Environmental, Inc. Consulting Engineers			213 S. Camino del Pueblo Bernalillo, New Mexico, USA Phone: 505-867-6990 Fax: 505-867-6991
DATE: 11/04/2013	CAD: UPDATED FIGURE 2.dwg	PROJECT #: 542.01.01	
DRAWN BY: DMI	REVIEWED BY: GEI	FIGURE IV.1.3	
APPROVED BY: IKG	gei@gordonenvironmental.com

- Location of well having Triassic bedrock top elevation or Triassic water bearing zones and/or water levels
- Location of well completed in alluvium or Ogallala Formation
- Location of hydrogeologic boring on the DNCS site
- 3600— Isopleth on line of equal elevation (feet above MSL) on the top of Triassic bedrock units (from Nicholson and Clebsch, 1961)

To Outcrop of Tertiary Ogallala Formation

Qal Outcrop of Quaternary alluvium

SURFACE GEOLOGY AND WELL LOCATIONS

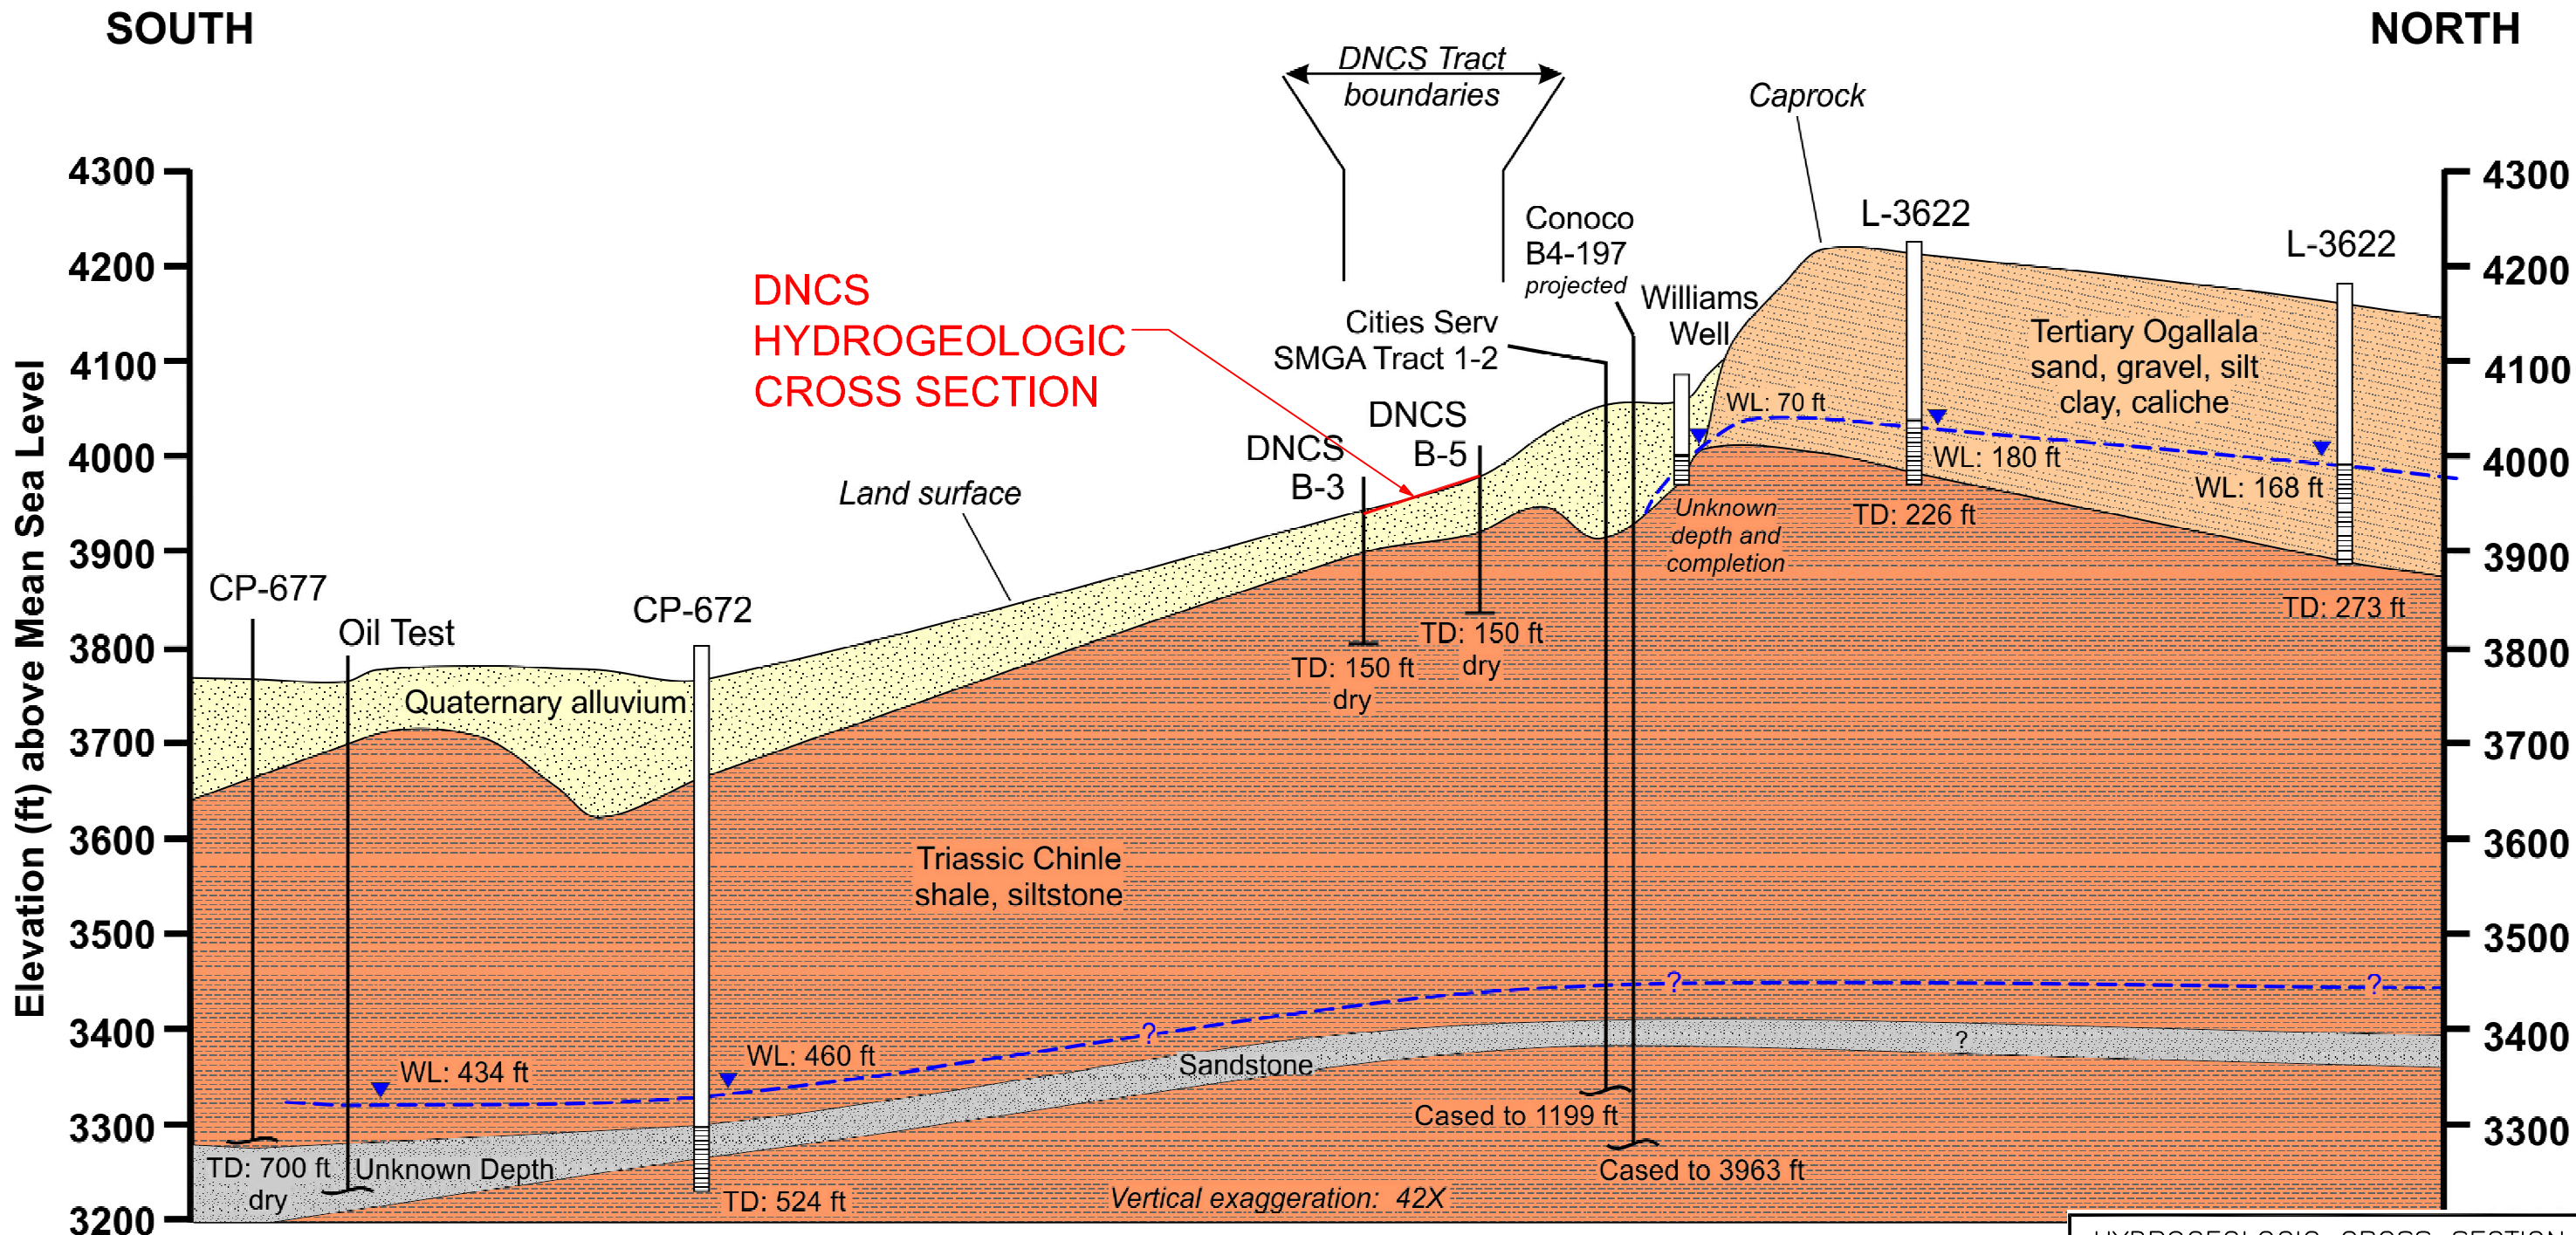
DATE: 09/24/2013	CAD: FIGURE 3.dwg	PROJECT #: 542.01.01
DRAWN BY: DMI	REVIEWED BY: GEI	
APPROVED BY: IKG	gei@gordonenvironmental.com	FIGURE IV.1.4

Hydrogeologic Cross Section DNCS Permit Site, Lea County, New Mexico

HYDROGEOLOGIC CROSS SECTION
THROUGH THE DNCS SITE
DNCS ENVIRONMENTAL SOLUTIONS
LEA COUNTY, NEW MEXICO

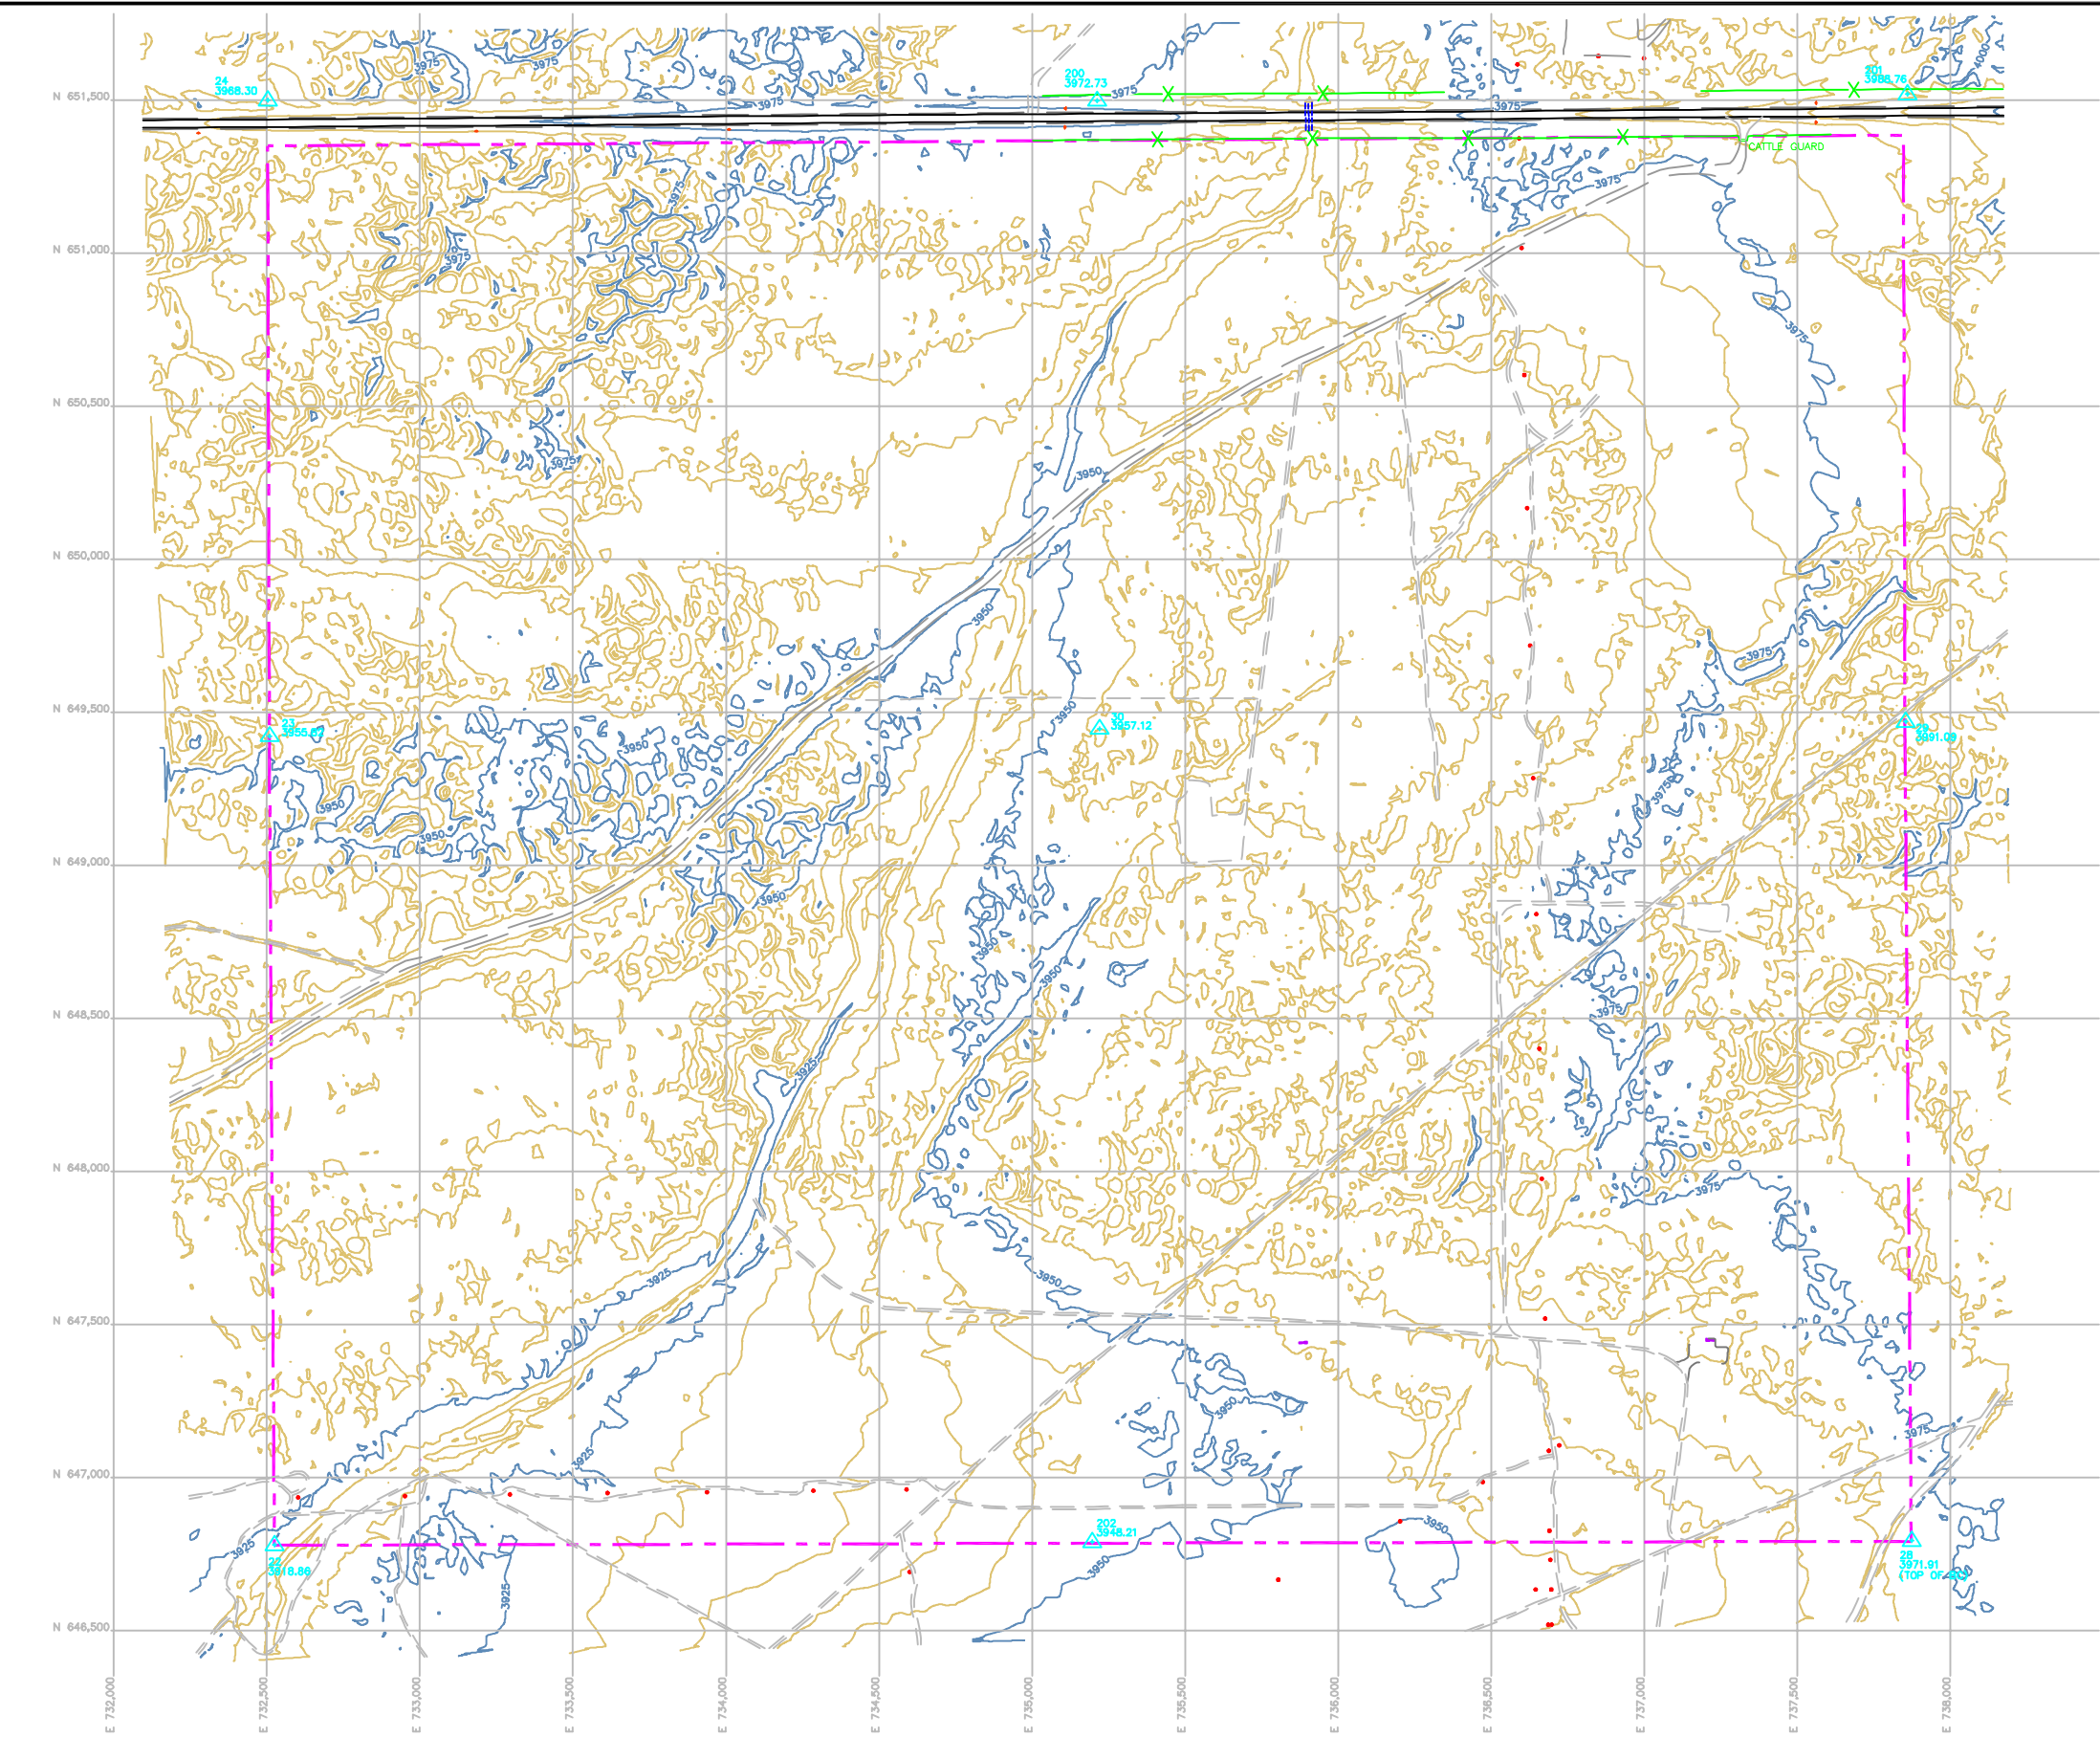
DATE: 10/11/2013	CAD: SITE TOPO.dwg	PROJECT #: 542.01.01
DRAWN BY: DMI	REVIEWED BY: DRT	
APPROVED BY: IKG	gei@gordonenvironmental.com	FIGURE IV.1.5

- LEGEND**
- SITE BOUNDARY (562 ACRES±)
 - 25' TOPOGRAPHIC CONTOUR
 - 5' TOPOGRAPHIC CONTOUR
 - EXISTING FENCE
 - == PAVED ROAD AND SHOULDER (NM 529)
 - == GRAVEL ROAD/TRAIL
 - POWER POLE
 - == CULVERTS
 - ⌒ CATTLE GUARD
 - ROAD SIGN
 - ABANDONED WELL
 - △ SURVEY CONTROL POINT
 - SITE GRID

AERIAL SURVEY BY DALLAS AERIAL SURVEYS, INC. (D.A.S.)
MAPPING AND SURVEYING
10220 Forest Lane
Dallas, Texas 75243
(214)349-2200 (800)862-2190
(214)349-2193 Fax
www.dasmaps.com
D.A.S. JOB No. 13113
DATE OF PHOTOGRAPHY: 02-28-2013

SITE TOPOGRAPHY
