Pit, Closed-Loop System, Below-Grade Tank, or Proposed Alternative Method Permit or Closure Plan Application

1.
Operator: BP AMERICA PRODUCTION COMPANY OGRID #: 778
Address: 200 Energy Court, Farmington, NM 87401
Facility or well name: GALLEGOS CANYON UNIT COM B 143E
API Number: 3004524284 OCD Permit Number:
U/L or Qtr/Qtr M Section 25.0 Township 29.0N Range 12W County: San Juan County
Center of Proposed Design: Latitude 36.69341 Longitude -108.05567 NAD: ☐ 1927 ☒ 1983
Surface Owner: ☐ Federal ☐ State ☒ Private ☐ Tribal Trust or Indian Allotment

Release Notification and Corrective Action

FIELD REPORT:

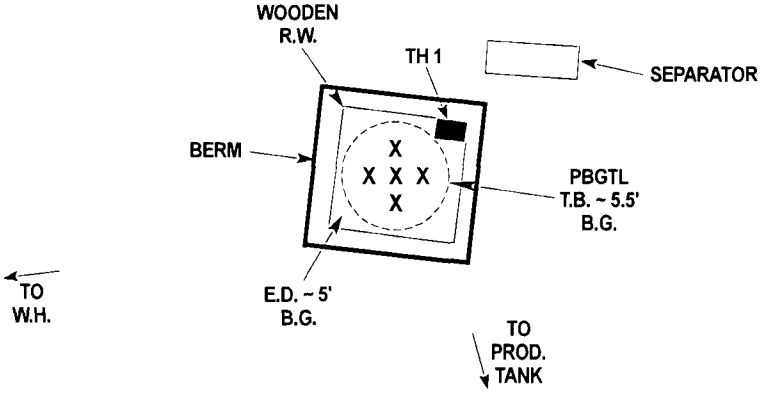
SITE SKETCH

DISCOLORATION/STAINING OBSERVED: YES / NO EXPLANATION - BETWEEN 5.5' - 7.5' BELOW GRADE (DARKER SHADE OF OLIVE GRAY), CLEARED UP TO 11', BUT STILL REMAINED IMPACTED WITH SIMILAR OVM. READING.

APPARENT EVIDENCE OF A RELEASE OBSERVED AND/OR OCCURRED : YES / NO EXPLANATION : DISCOLORED SOIL IN NE CORNER OF WOODEN

ADDITIONAL COMMENTS: IMPACTS DISCOVERED DO NOT APPEAR TO RESULT FROM BGT LOSS INTEGRITY, BUT RETAINING WALL. RATHER FROM PIPING FROM SEPARATOR TO BGT.

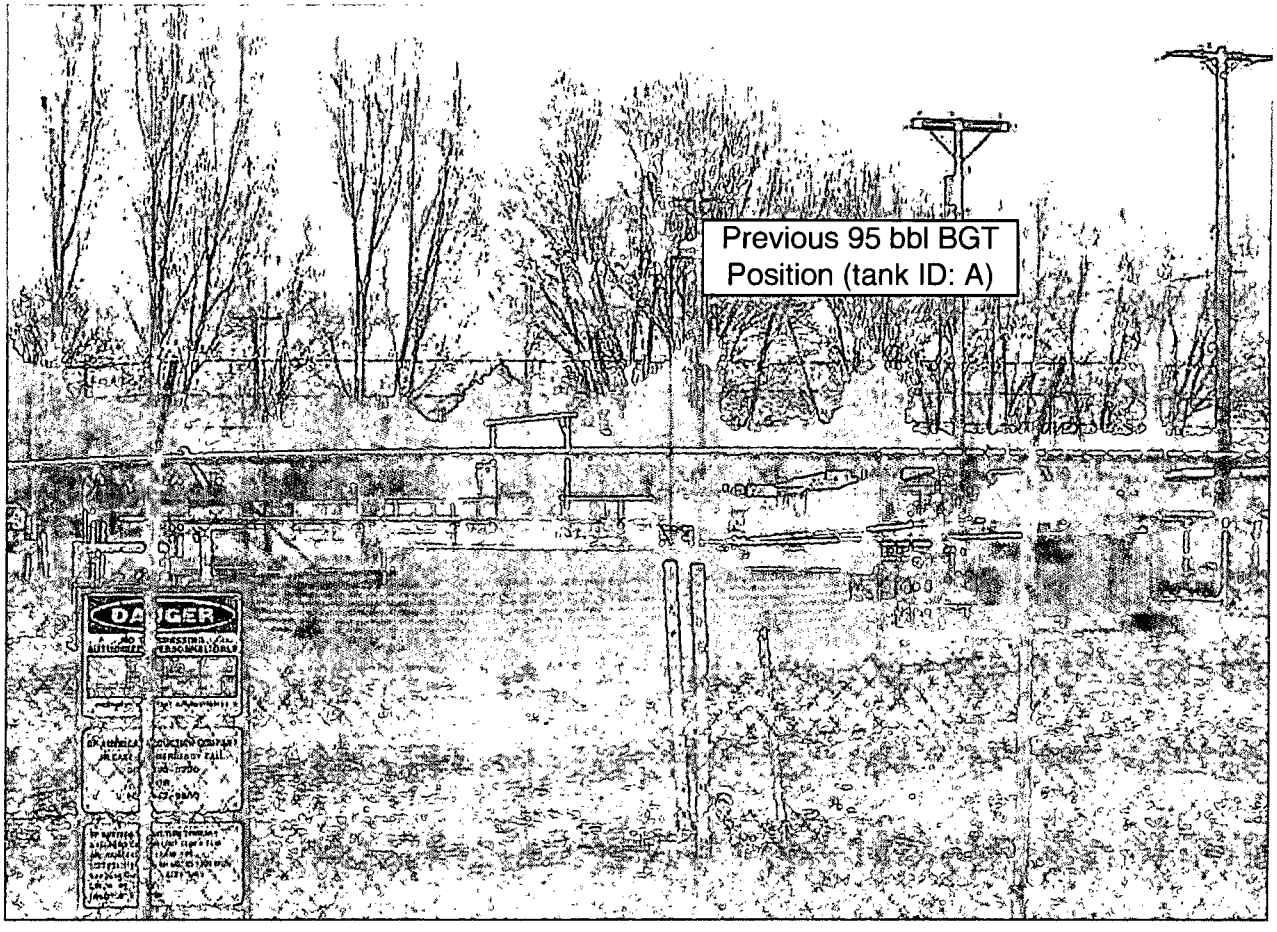
Previous 95 bbl BGT
Position (tank ID: A)
DANGER
