Pit, Closed-Loop System, Below-Grade Tank, or Proposed Alternative Method Permit or Closure Plan Application

1.
Operator: BP AMERICA PRODUCTION COMPANY OGRID #: 778
Address: 200 Energy Court, Farmington, NM 87401
Facility or well name: GALLEGOS CANYON UNIT 008E
API Number: 3004526191 OCD Permit Number: _____
U/L or Qtr/Qtr J Section 22.0 Township 28.0N Range 12W County: San Juan County
Center of Proposed Design: Latitude 36.64514 Longitude -108.09558 NAD: ☐1927 ☒1983
Surface Owner: ☒ Federal ☐ State ☐ Private ☐ Tribal Trust or Indian Allotment

FIELD REPORT:

SITE NAME: GCU # 8E

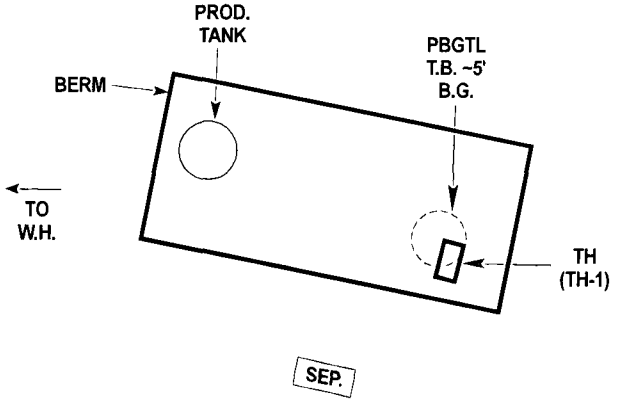
SITE SKETCH

DISCOLORATION/STAINING OBSERVED: [YES] / NO EXPLANATION - BLACK STAINED SOIL @ TH-1 POSITION DIRECTLY BENEATH BGT.

APPARENT EVIDENCE OF A RELEASE OBSERVED AND/OR OCCURRED : [YES] / NO EXPLANATION : BASED ON DISCOLORATION NOTED ABOVE.

ADDITIONAL COMMENTS: WILL BE REQUIRED TO ESTABLISH VERTICAL & LATERAL EXTENT. INITIAL ASSESSMENT OF IMPACTS: ~ 15' X 15' X >10'.
