Souder, Miller & Associates ♦ 201 S. Halagueno St. ♦ Carlsbad, NM 88220
(575) 689-7040

**RE: LINER INSPECTION REPORT (NRM2023050058)
HOGNOSE VIPER 23 FED #1H CENTRAL TANK BATTERY**

Souder, Miller & Associates (SMA) is pleased to submit this letter report on behalf of Devon Energy Production (Devon) summarizing the liner inspection that occurred due to the Hognose Viper #1H Central Tank Battery release. The site is located in Unit Letter M, Section 23, T23S, R33E (N32.283423/W-103.549435) Lea County, New Mexico, on BLM land.

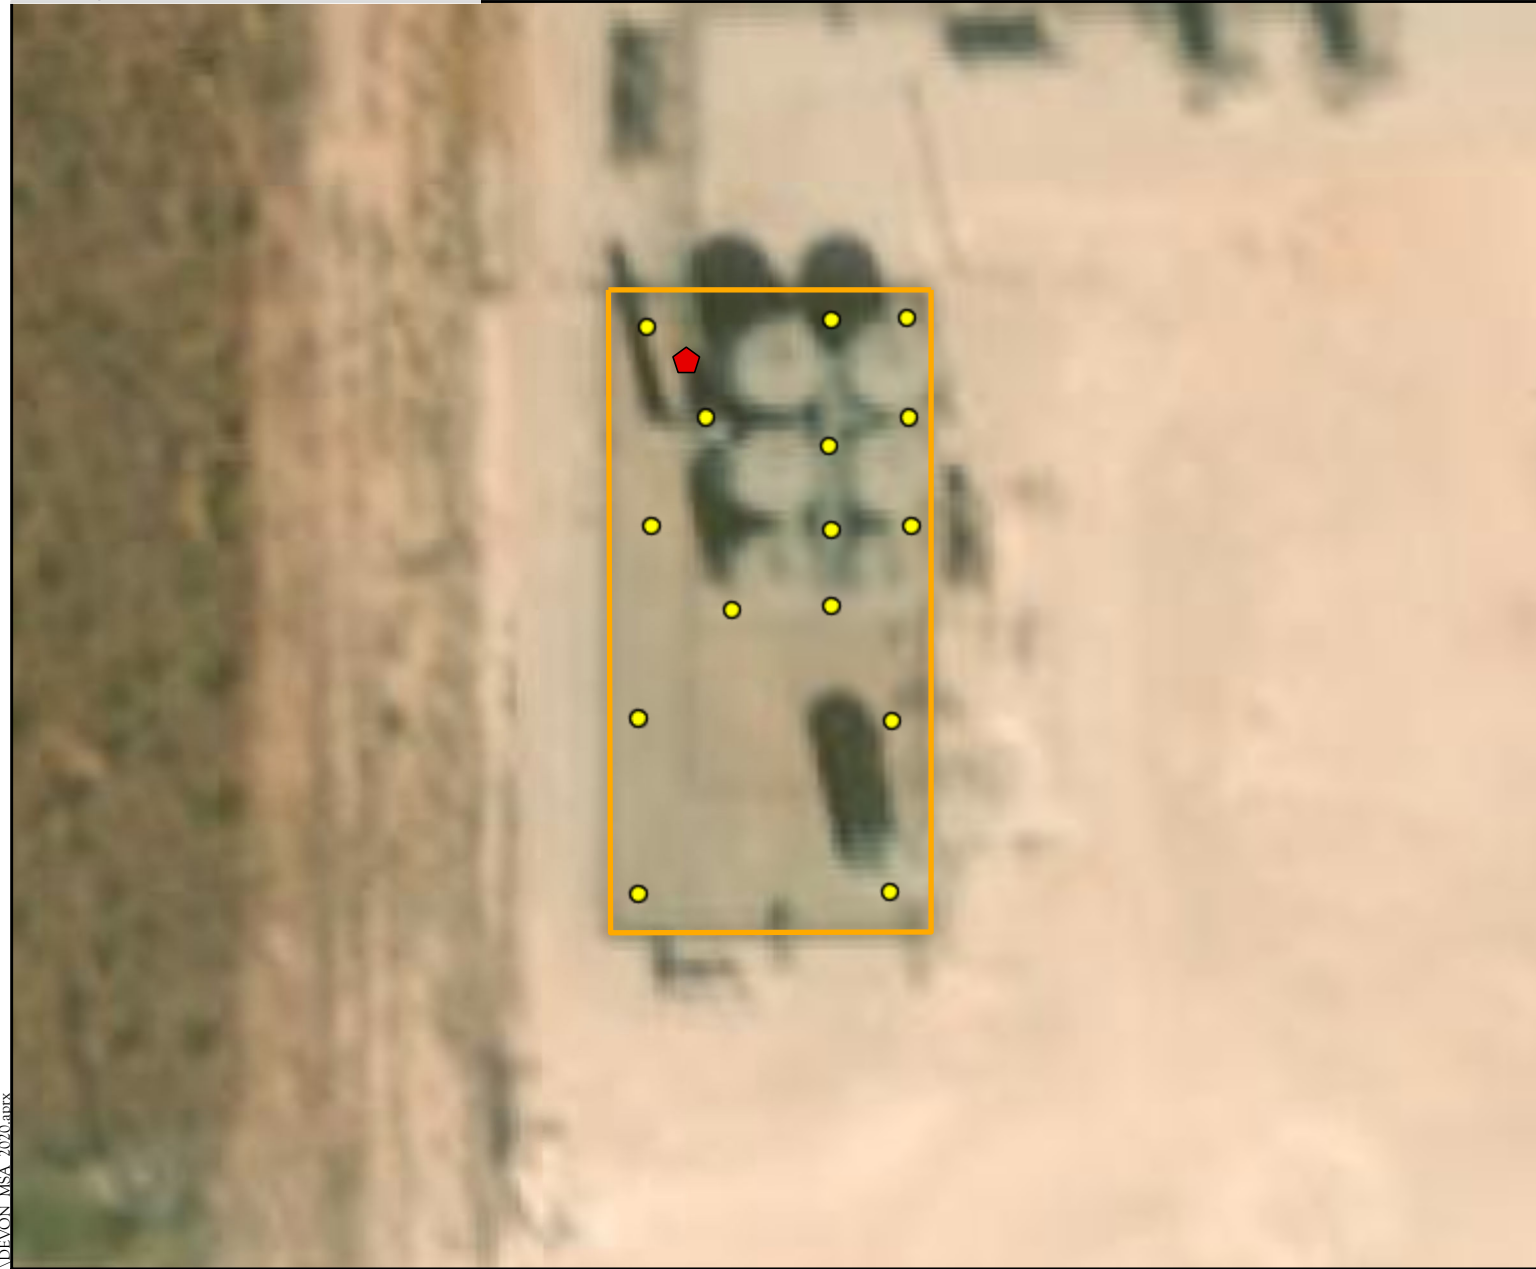
Figure 3

- Secondary Containment
- Photograph Location
- ⬠ Point of Release

Site and Photograph Location Map
Hognose Viper 23 Federal 1H - Devon Energy Production Company
UL: M S: 23 T: 23S R: 33E - Lea County, New Mexico

- Arrived at Scheduled time of 9am.
 - Waited 15 minutes to see if OCD would arrive
 - OCD did not arrive, continued with inspection
- Walked to POR and examined if release was fully contained.
 - Release did stay in secondary confinement.
- Searched for tears and other potential compromises throughout containment.
 - No failures
 - Liner remained intact
 - Verified that outside of containment was not compromised.
- Took photos of Containment.
- Mapped Containment and Photograph locations
- Left Site
