Pit, Closed-Loop System, Below-Grade Tank, or Proposed Alternative Method Permit or Closure Plan Application

1.
Operator: BP AMERICA PRODUCTION COMPANY OGRID #: 778
Address: 200 Energy Court, Farmington, NM 87401
Facility or well name: GALLEGOS CANYON UNIT 005
API Number: 3004507466 OCD Permit Number:
U/L or Qtr/Qtr H Section 13.0 Township 28.0N Range 13W County: San Juan County
Center of Proposed Design: Latitude 36.66386 Longitude -108.1649 NAD: ☐ 1927 ☒ 1983
Surface Owner: ☒ Federal ☐ State ☐ Private ☐ Tribal Trust or Indian Allotment

Release Notification and Corrective Action

FIELD REPORT:

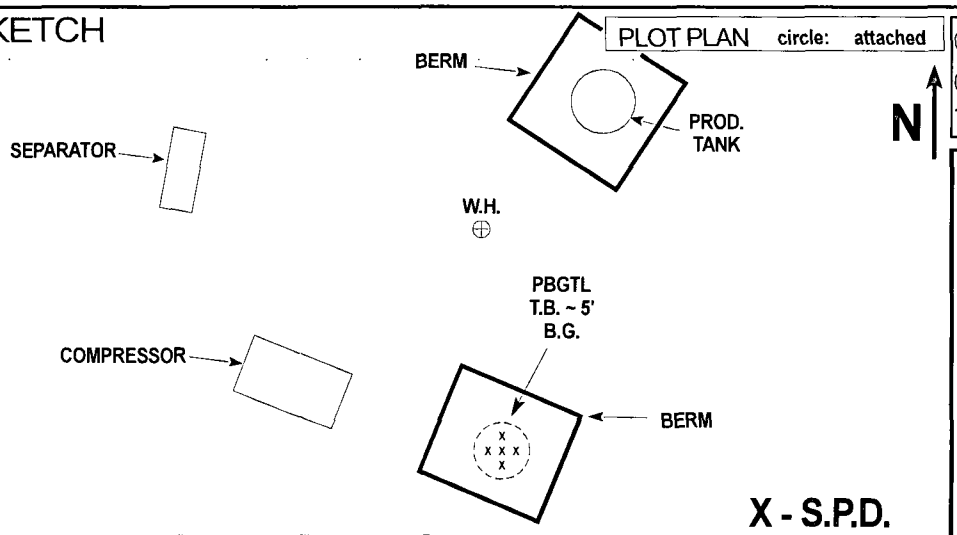
SITE SKETCH

1)	9 BGT (SW/SB)	GPS COORD.:	36.66386 X 108.16490	DISTANCE/BEARING FROM W.H.:	39', S11E
2)		GPS COORD.:		DISTANCE/BEARING FROM W.H.:	
3)		GPS COORD.:		DISTANCE/BEARING FROM W.H.:	
4)		GPS COORD.:		DISTANCE/BEARING FROM W.H.:

ADDITIONAL COMMENTS: BGT CONSTRUCTED OF FIBERGLASS.
