Remediation Report and Closure Request  
El Cedro Tank Overflow  
Section: 31 Township: 29N Range: 5W  
Lat: 36.688047 Long: -107.402200  
Rio Arriba County, New Mexico

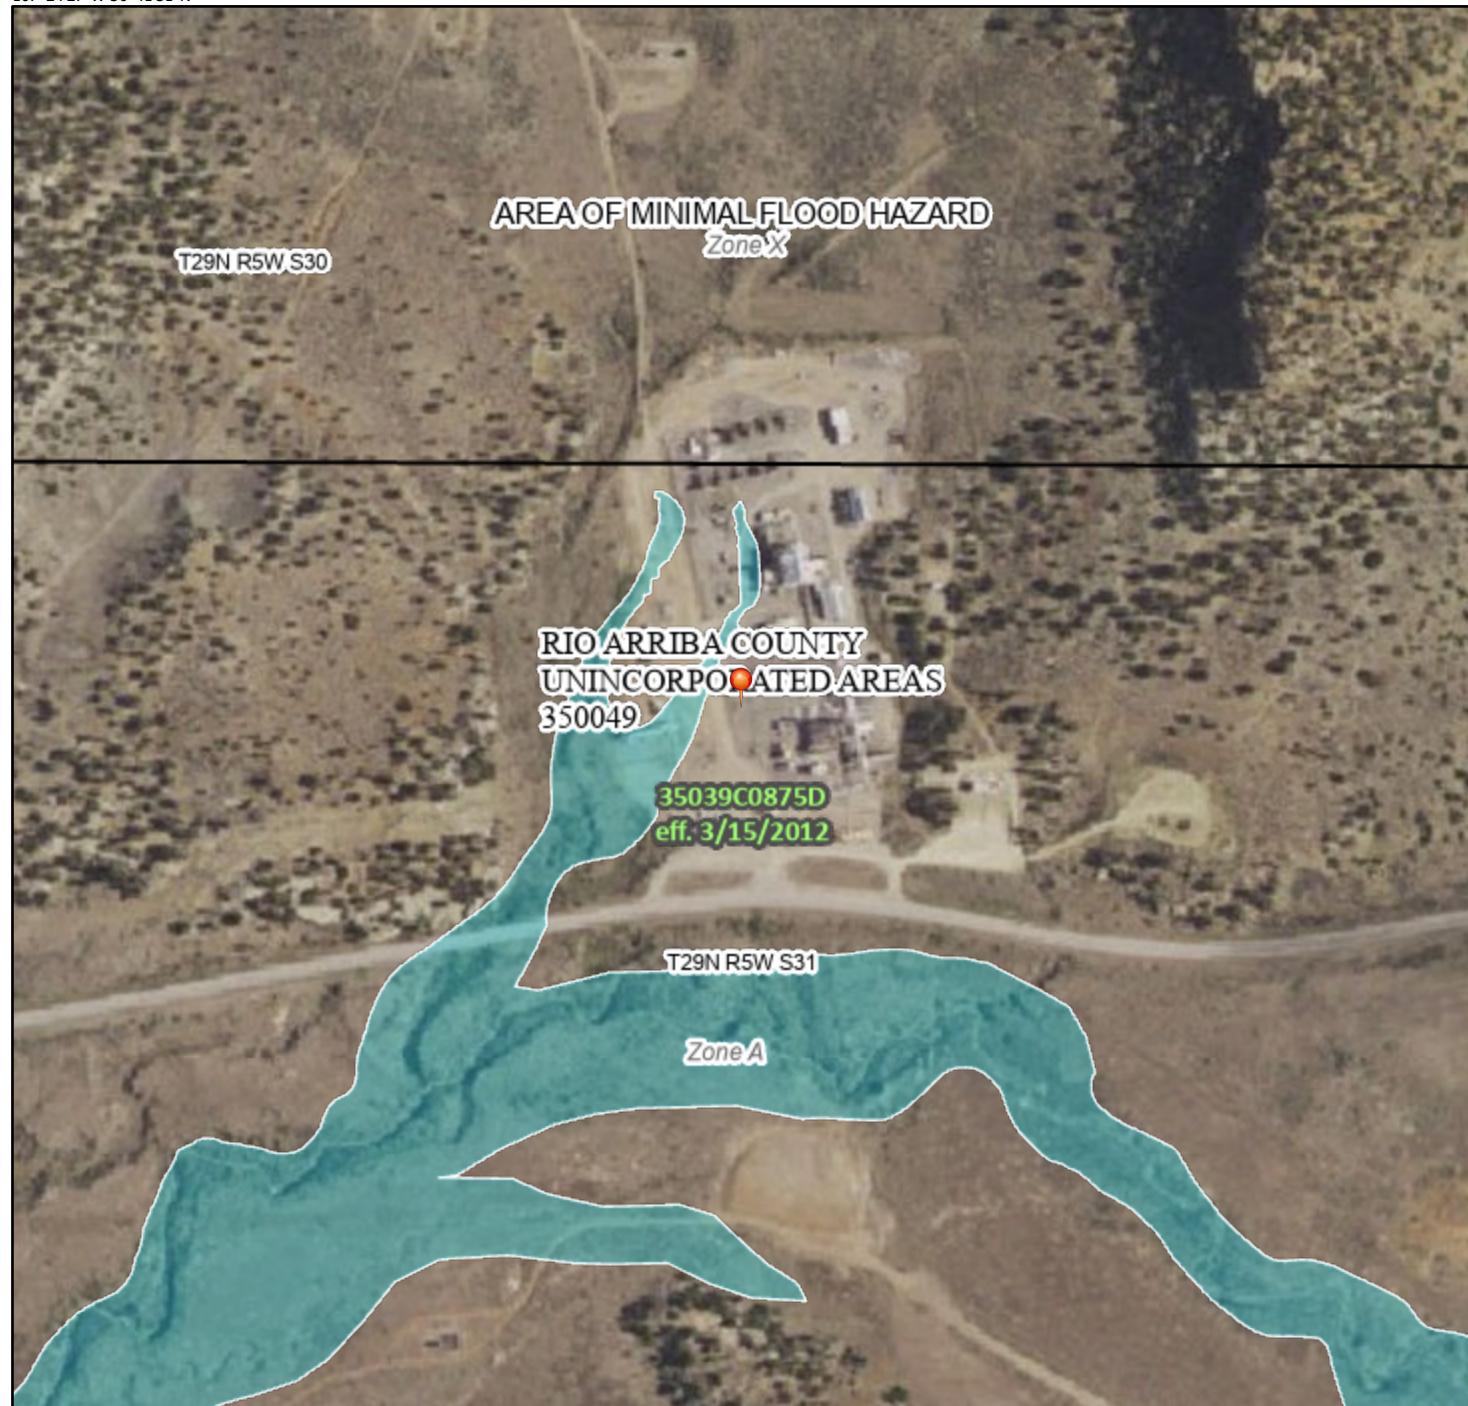
# National Flood Hazard Layer FIRMette

The flood hazard information is derived directly from the authoritative NFHL web services provided by FEMA. This map was exported on 12/15/2025 at 2:38 PM and does not reflect changes or amendments subsequent to this date and time. The NFHL and effective information may change or become superseded by new data over time.
