SUBJECT: Liner Inspection and Closure Report for Horn 22-27-34 East Pad– July 24, 2026 Site Visit

Incident ID: nAPP2616625412  
Facility ID (Name): fAPP2332566148 (HORN 22-27-34 EAST PAD)  
Facility Location: Unit P of Section 15, Township 26 South, Range 29 East, New Mexico  
Facility GPS Coordinates: 32.037976, -103.966386  
Eddy County, New Mexico

# Environmental Liner Inspection Field Notes & Photolog Report

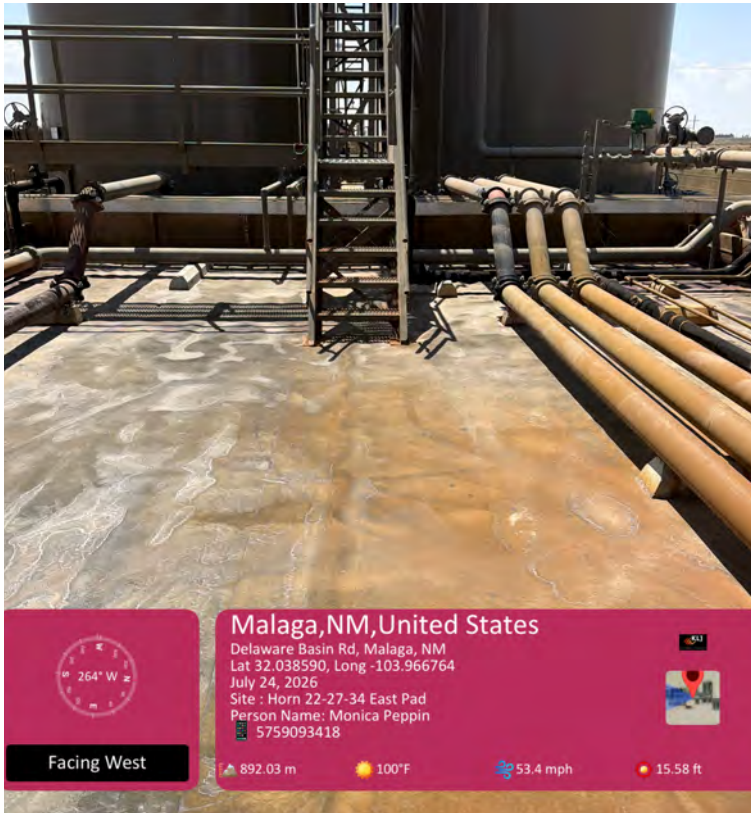
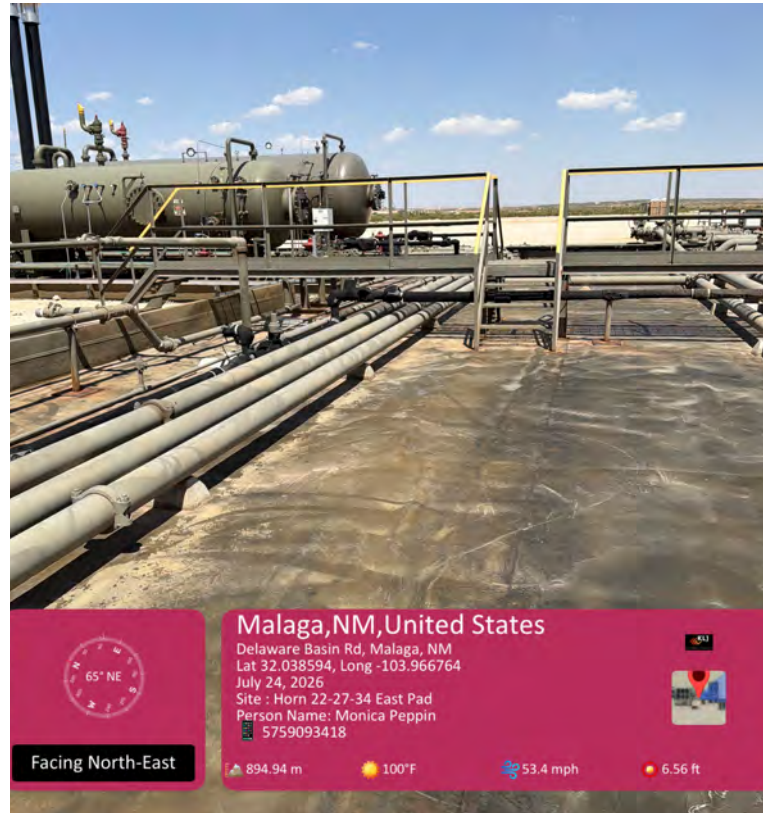
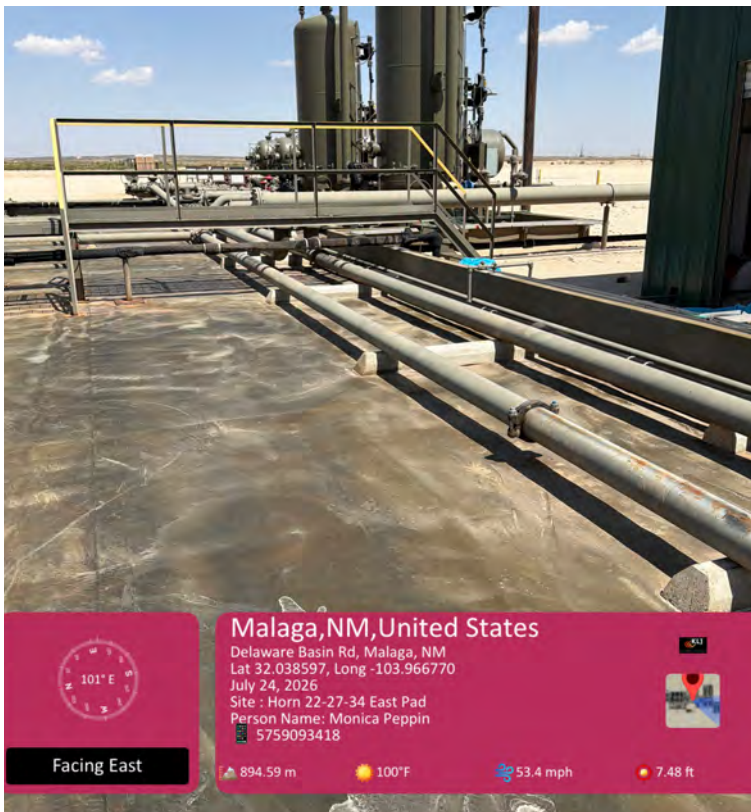
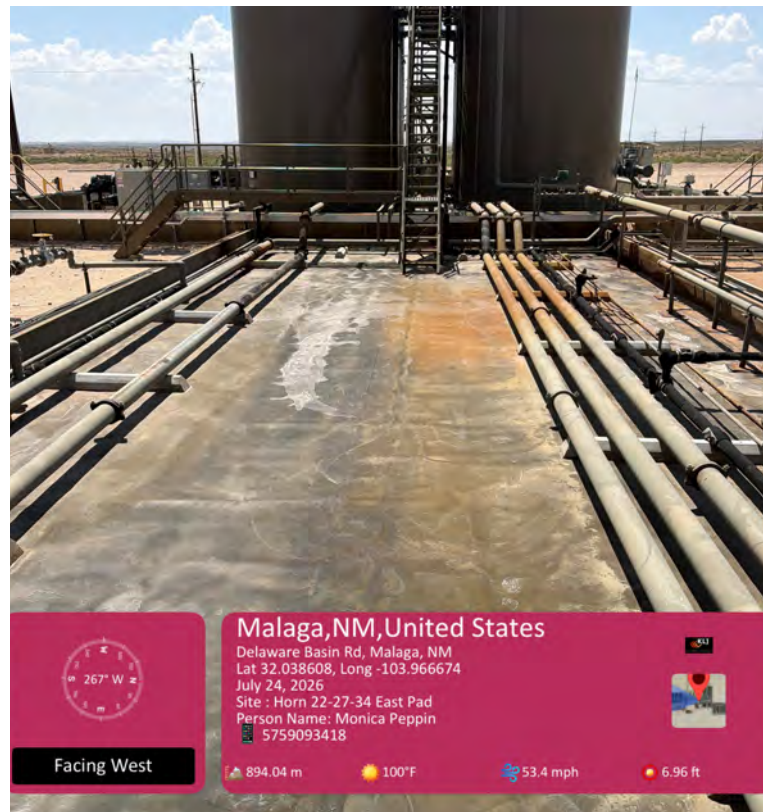
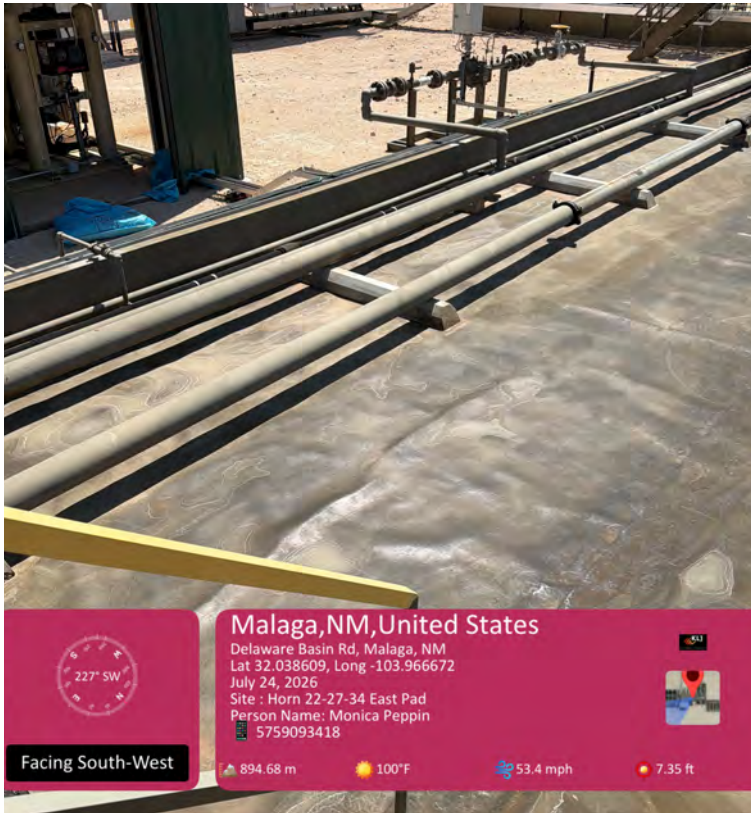
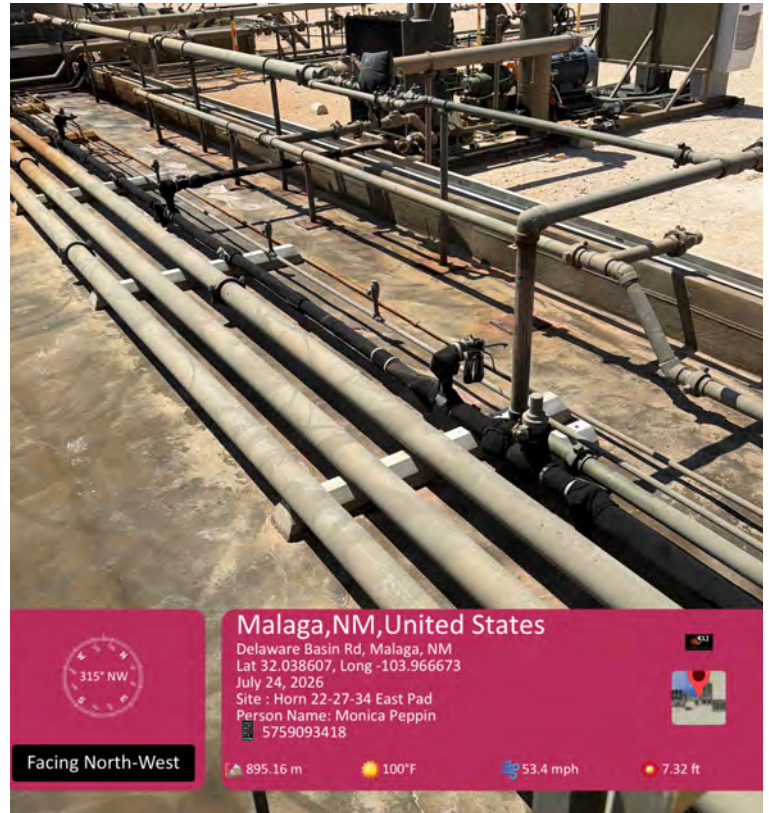
# Photolog

- Arrive on site, check surroundings.
- Begin inspection
- Walk containment area and check for any points where a potential breach may occur outside of the secondary containment
- Photos taken at all different angles and each cardinal direction.
- Check liner for rips, cuts, tears, UV damage or brittle areas.
- No signs of weathering or perforation in liner.
- Secondary containment is capable of withholding fluids
- Passes inspection

During the visit on July 24, 2026, KLJ personnel conducted a visual inspection of the secondary containment to verify liner integrity. Observations included checks for perforations, tears, cuts, or weathering that could compromise containment performance. The liner was confirmed to be intact, with no observed integrity issues or conditions requiring repair or replacement. Photographic documentation is included in the Liner Inspection Field Notes & Photolog Report (**Appendix A**).

- Visual observation of liner is complete.
- Liner integrity confirmed and passes inspection.
- Upload field notes and photos for field report for supporting documentation.
- No additional recommendations or further actions required.

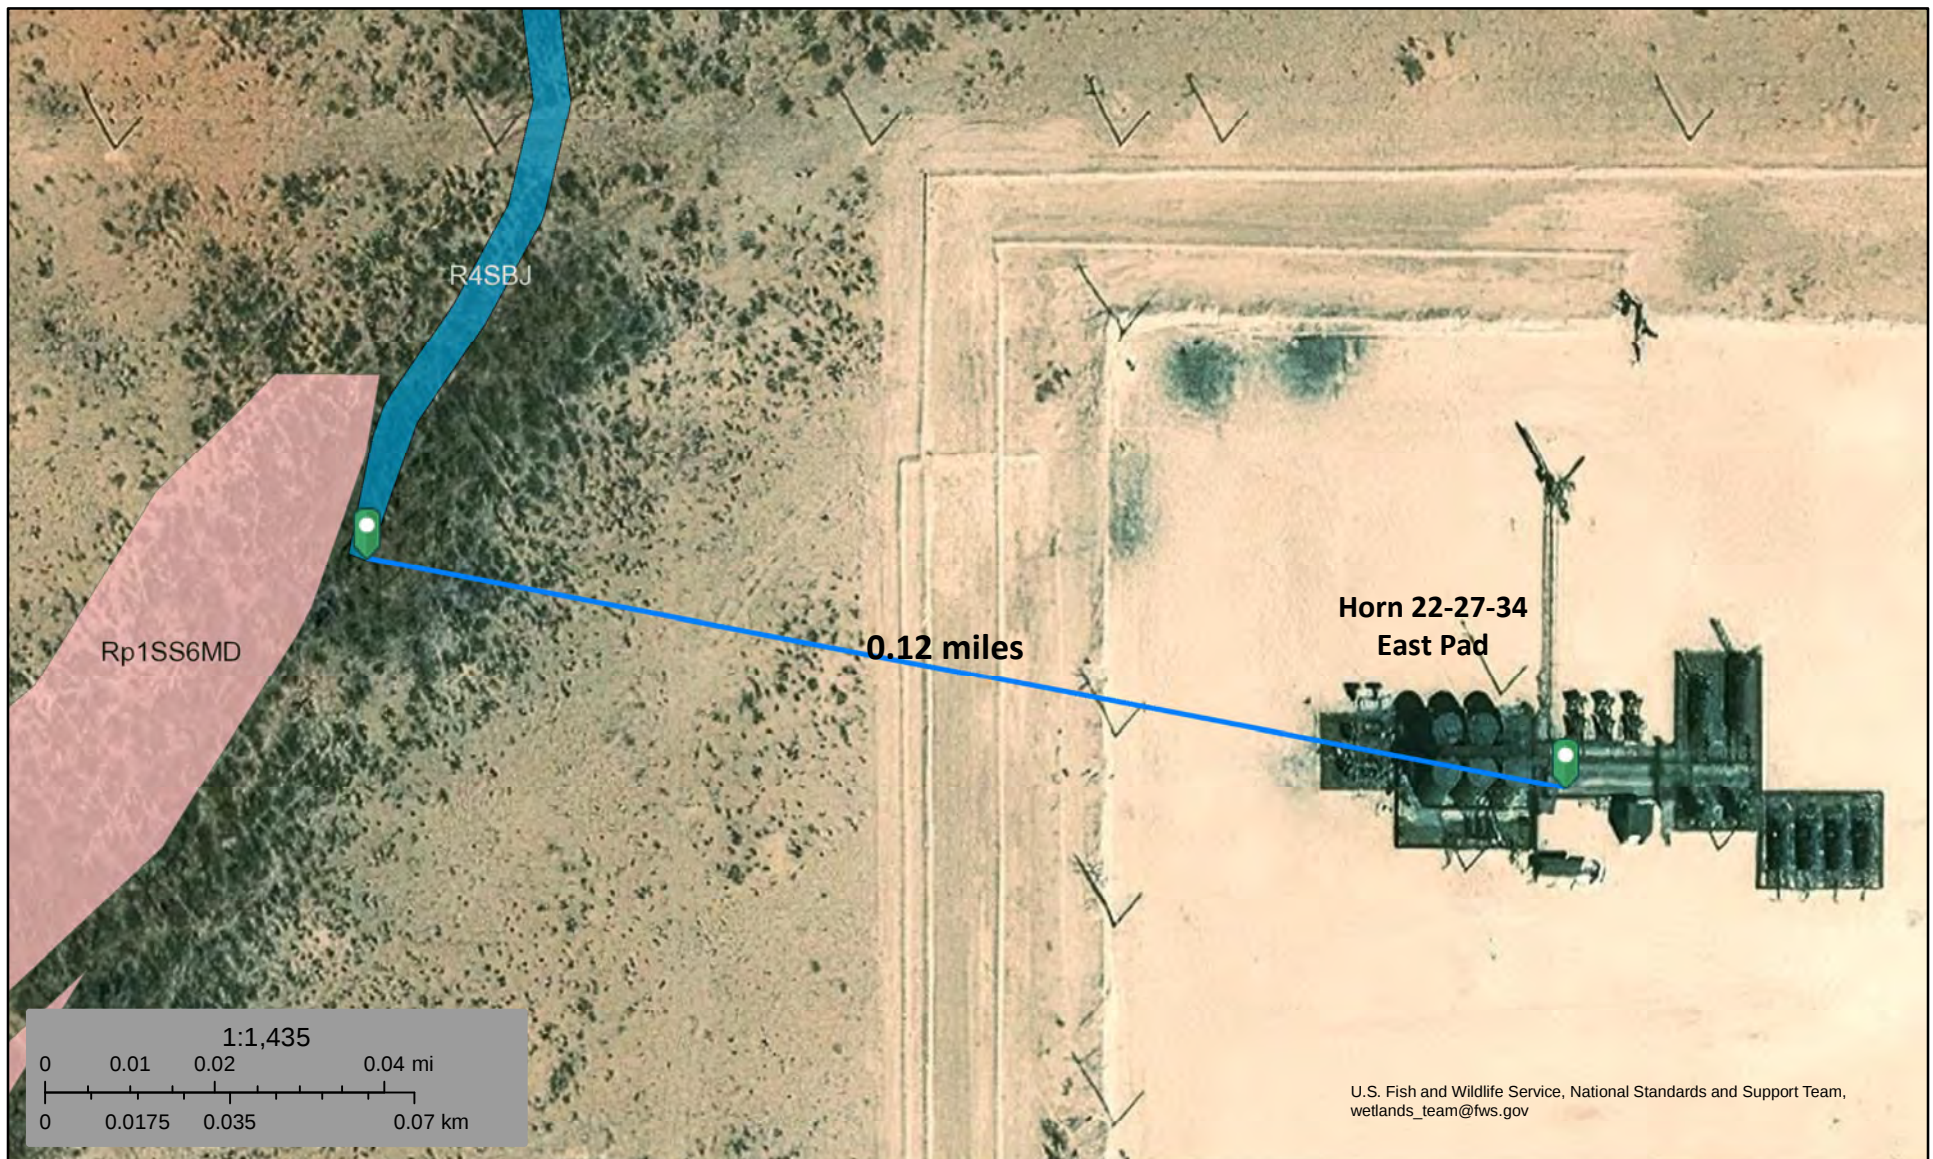
# Horn 22-27-34 East Pad Riverine

Nearest Significant Watercourse & Wetlands: Riverine  
Distance: 0.12 miles

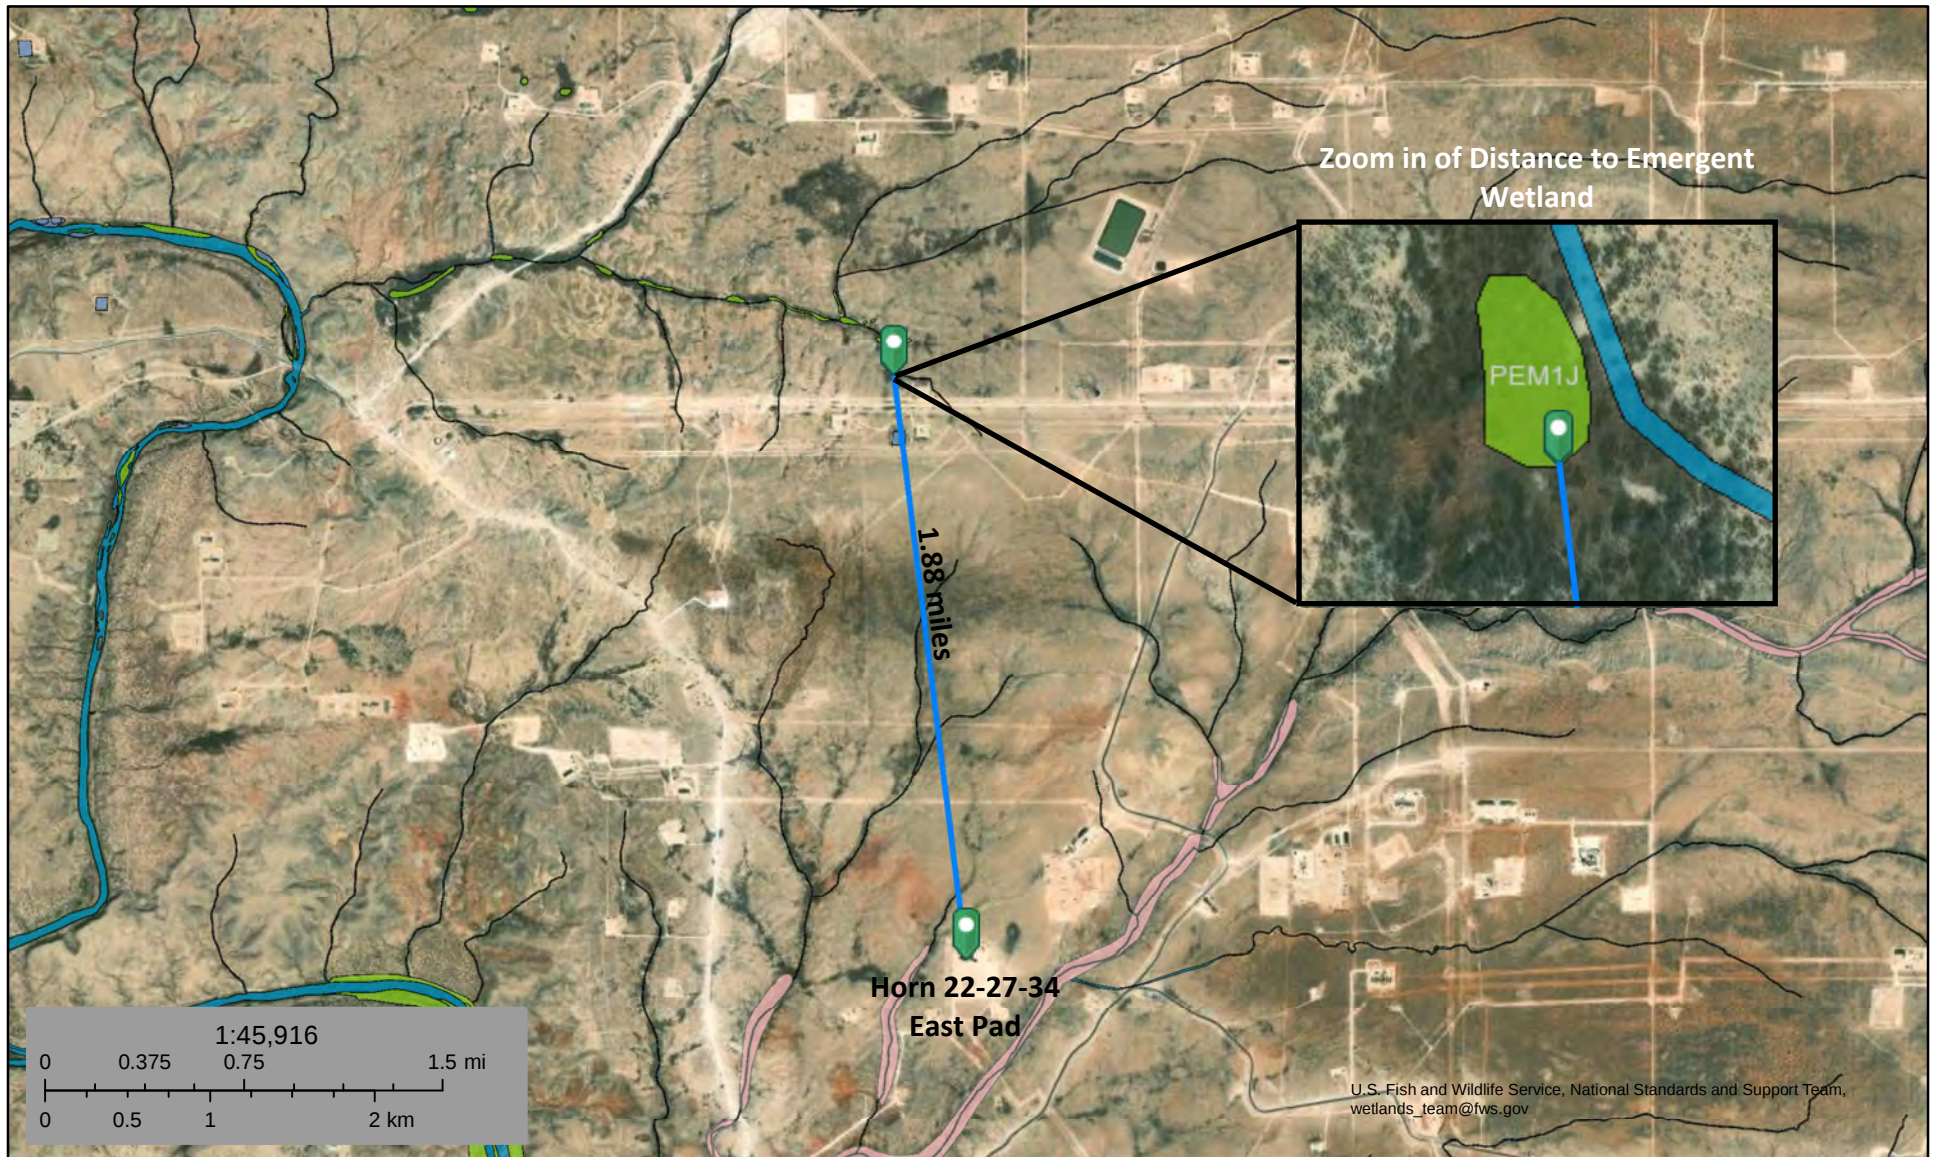
Nearest Playa: Freshwater Emergent Wetland

Distance: 1.88 miles

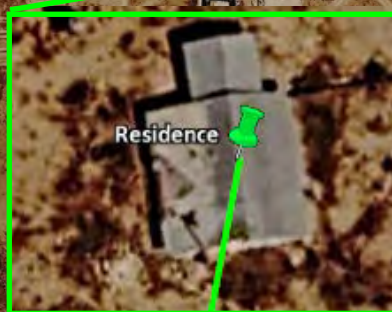
Zoom in of Distance to  
Nearest Residence

1.81 miles
