Pit, Closed-Loop System, Below-Grade Tank, or Proposed Alternative Method Permit or Closure Plan Application

1.
Operator: BP AMERICA PRODUCTION COMPANY OGRID #: 778
Address: 200 Energy Court, Farmington, NM 87401
Facility or well name: GALLEGOS CANYON UNIT COM 094
API Number: 3004508057 OCD Permit Number:
U/L or Qtr/Qtr F Section 23.0 Township 29.0N Range 13W County: San Juan County
Center of Proposed Design: Latitude 36.71366 Longitude -108.17793 NAD: ☐ 1927 ☒ 1983
Surface Owner: ☐ Federal ☐ State ☒ Private ☐ Tribal Trust or Indian Allotment

Release Notification and Corrective Action

FIELD REPORT:

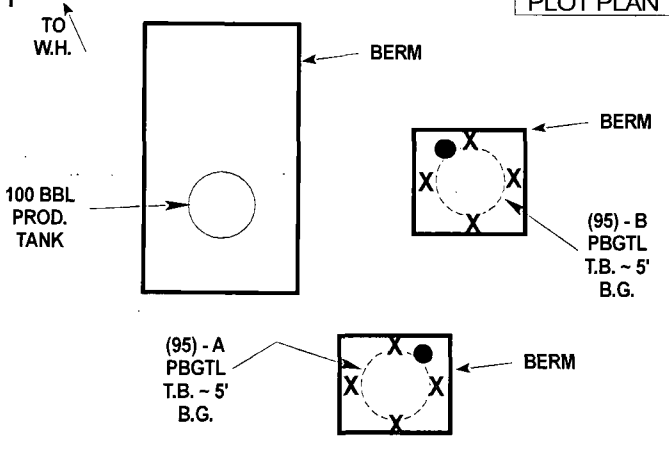
SITE SKETCH

1) 95 BGT (SW/DB) - A	GPS COORD.: 36.71366 X 108.17793	DISTANCE/BEARING FROM W.H.:	171', S38E
2) 95 BGT (SW/DB) - B	GPS COORD.: 36.71379 X 108.17786	DISTANCE/BEARING FROM W.H.:	147.5', S55.5E
3)	GPS COORD.:	DISTANCE/BEARING FROM W.H.:	
4)	GPS COORD.:	DISTANCE/BEARING FROM W.H.:

ANY AREAS DISPLAYING WETNESS: YES / NO EXPLANATION - GROUNDWATER EXPOSED AT 5 FT. BELOW GRADE.

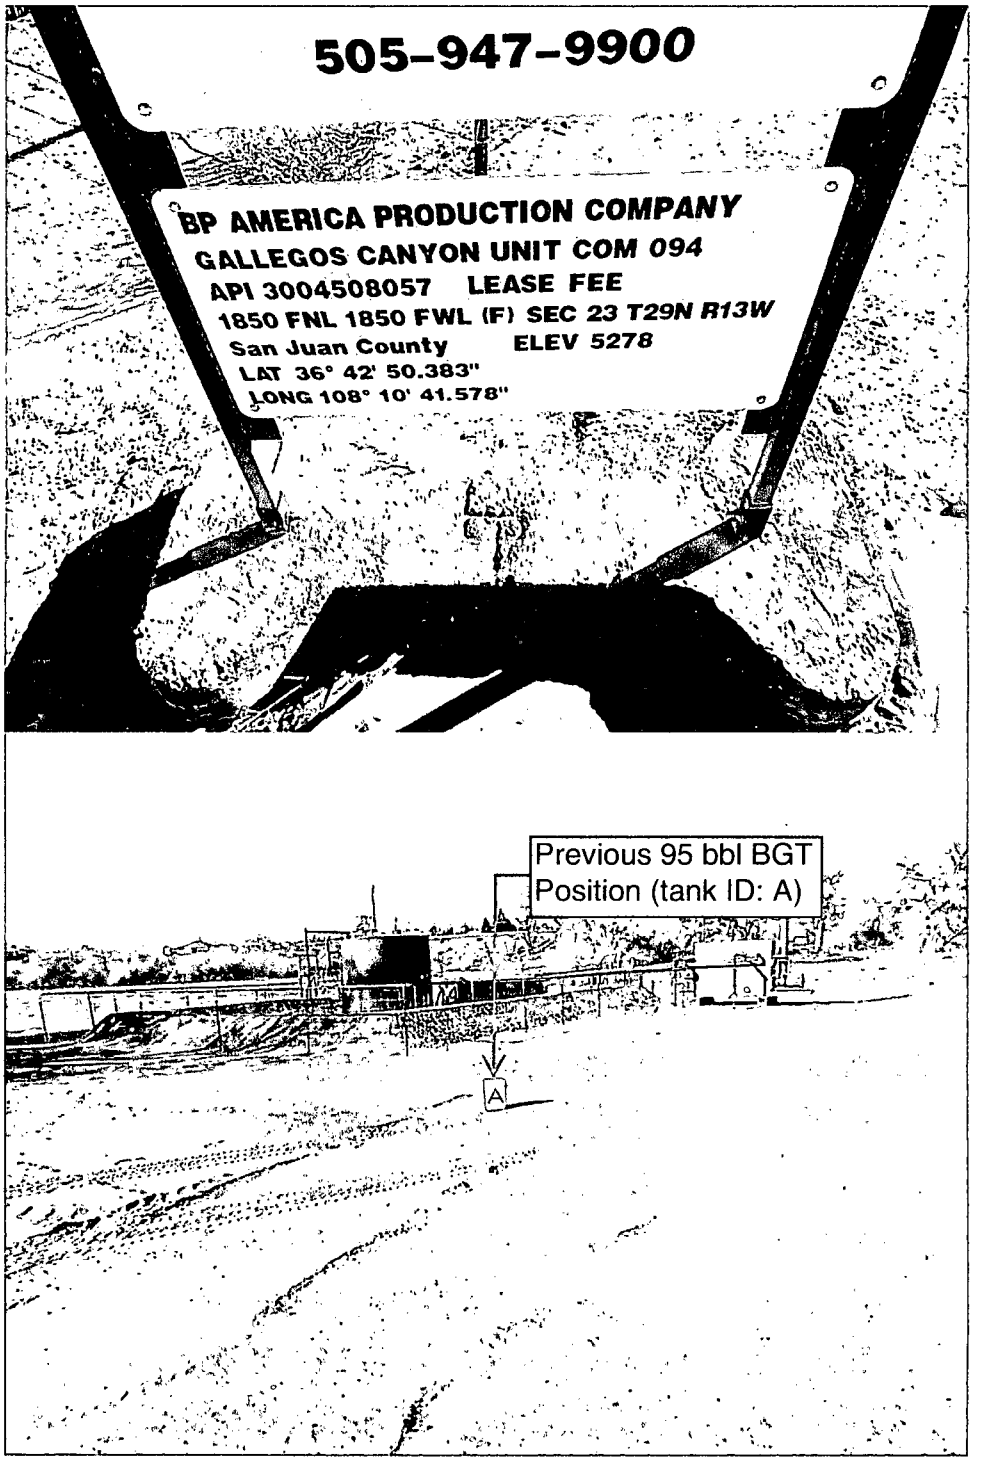
505-947-9900
BP AMERICA PRODUCTION COMPANY
GALLEGOS CANYON UNIT COM 094
API 3004508057 LEASE FEE
1850 FNL 1850 FWL (F) SEC 23 T29N R13W
San Juan County ELEV 5278
LAT 36° 42' 50.383"
LONG 108° 10' 41.578"
Previous 95 bbl BGT
Position (tank ID: A)
A
