Pit, Closed-Loop System, Below-Grade Tank, or Proposed Alternative Method Permit or Closure Plan Application

1.
Operator: BP AMERICA PRODUCTION COMPANY OGRID #: 778
Address: 200 Energy Court, Farmington, NM 87401
Facility or well name: GALLEGOS CANYON UNIT 168E
API Number: 3004524863 OCD Permit Number:
U/L or Qtr/Qtr C Section 19.0 Township 28.0N Range 11W County: San Juan County
Center of Proposed Design: Latitude 36.65241 Longitude -108.04866 NAD: ☐1927 ☒ 1983
Surface Owner: ☒ Federal ☐ State ☐ Private ☐ Tribal Trust or Indian Allotment

BELOW-GRADE TANK CLOSURE PLAN

Gallegos Canyon Unit 168E
API No. 3004524863
Unit Letter C, Section 19, T28N, R11W

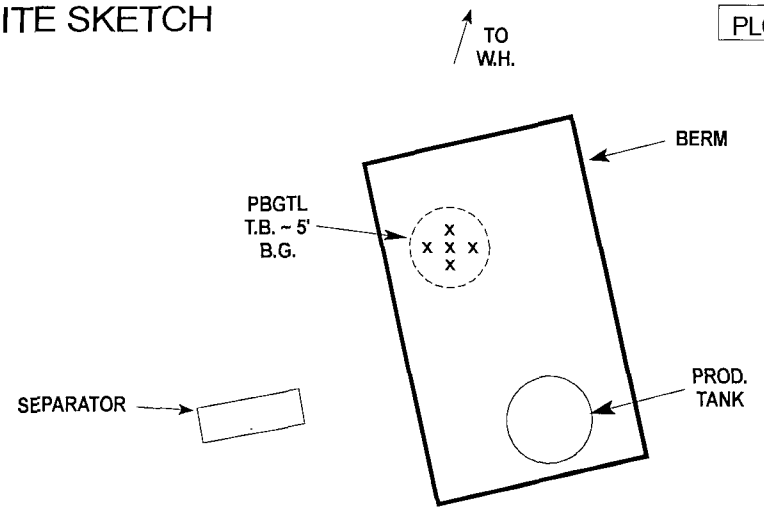
SITE SKETCH

DISCOLORATION/STAINING OBSERVED: YES / [NO] EXPLANATION -

APPARENT EVIDENCE OF A RELEASE OBSERVED AND/OR OCCURRED : YES / [NO] EXPLANATION :

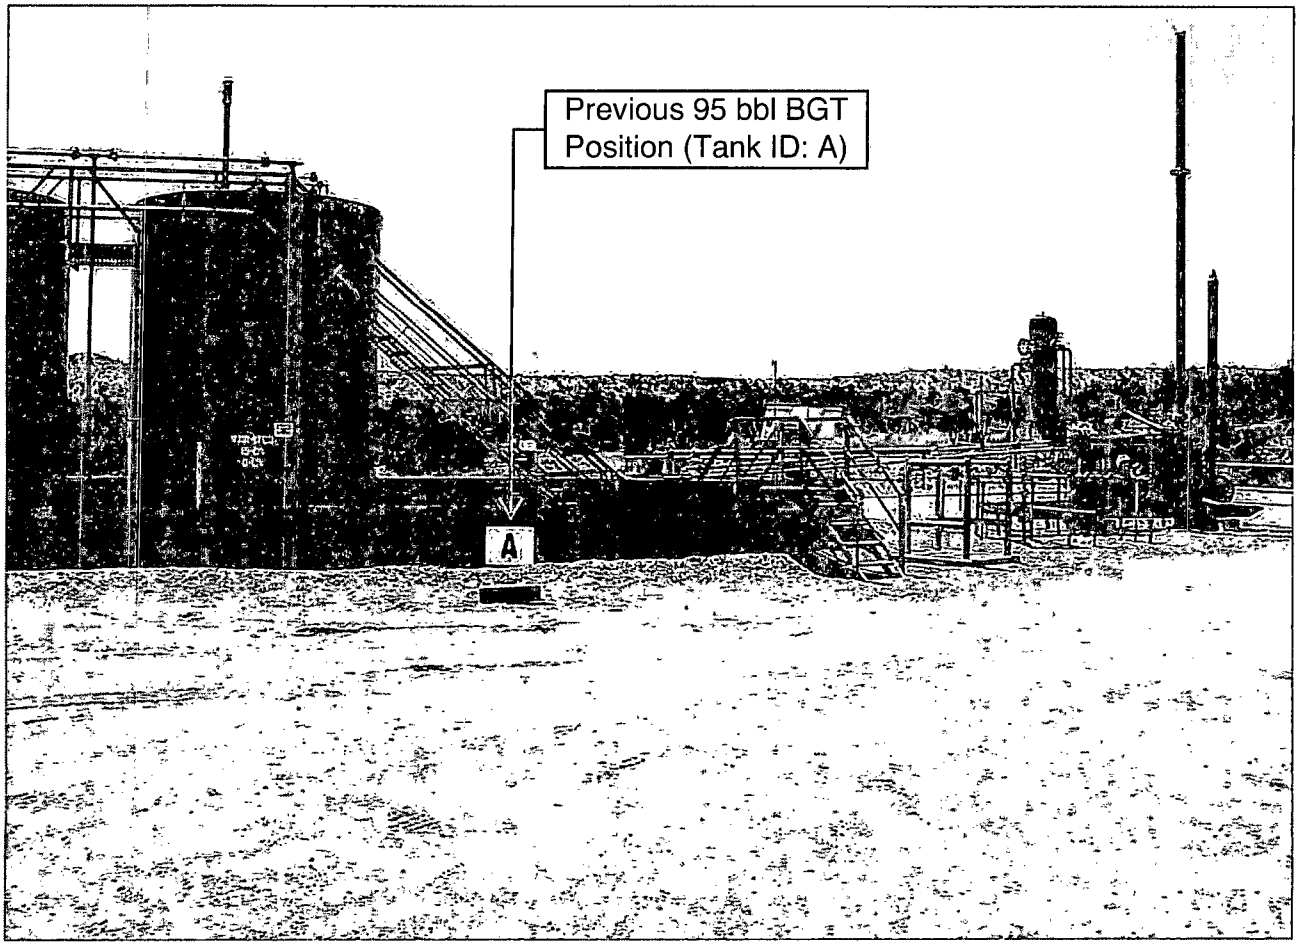
Previous 95 bbl BGT
Position (Tank ID: A)
A

Describe Area Affected and Cleanup Action Taken.* BGT was removed and the area underneath the BGT was sampled. The area under the BGT was backfilled and compacted and is still within the active well area.
