Pit, Below-Grade Tank, or Proposed Alternative Method Permit or Closure Plan Application

Facility or well name: Florance 27

BELOW-GRADE TANK CLOSURE PLAN

Florance 27, Tank B (95 bbl)
API No. 3004524126
Unit Letter C, Section 27, T29N, R9W

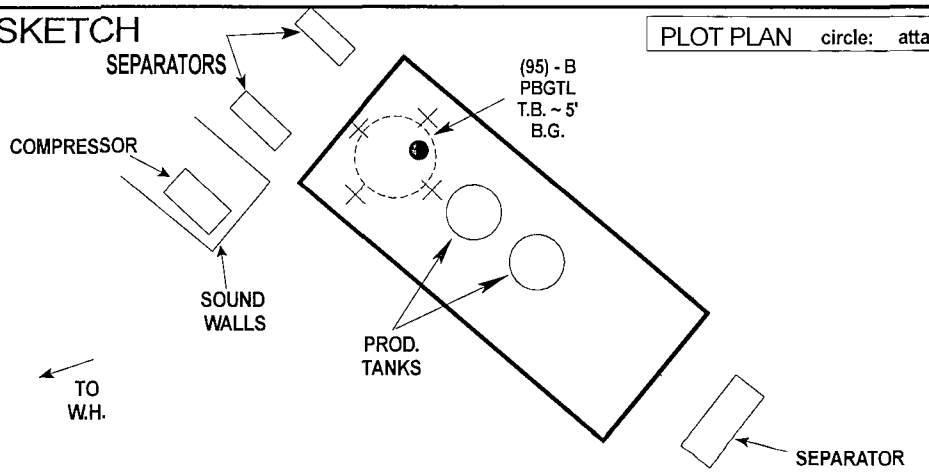
SITE SKETCH

● - S.P.D. (WATER) X - S.P.D. (SOIL)

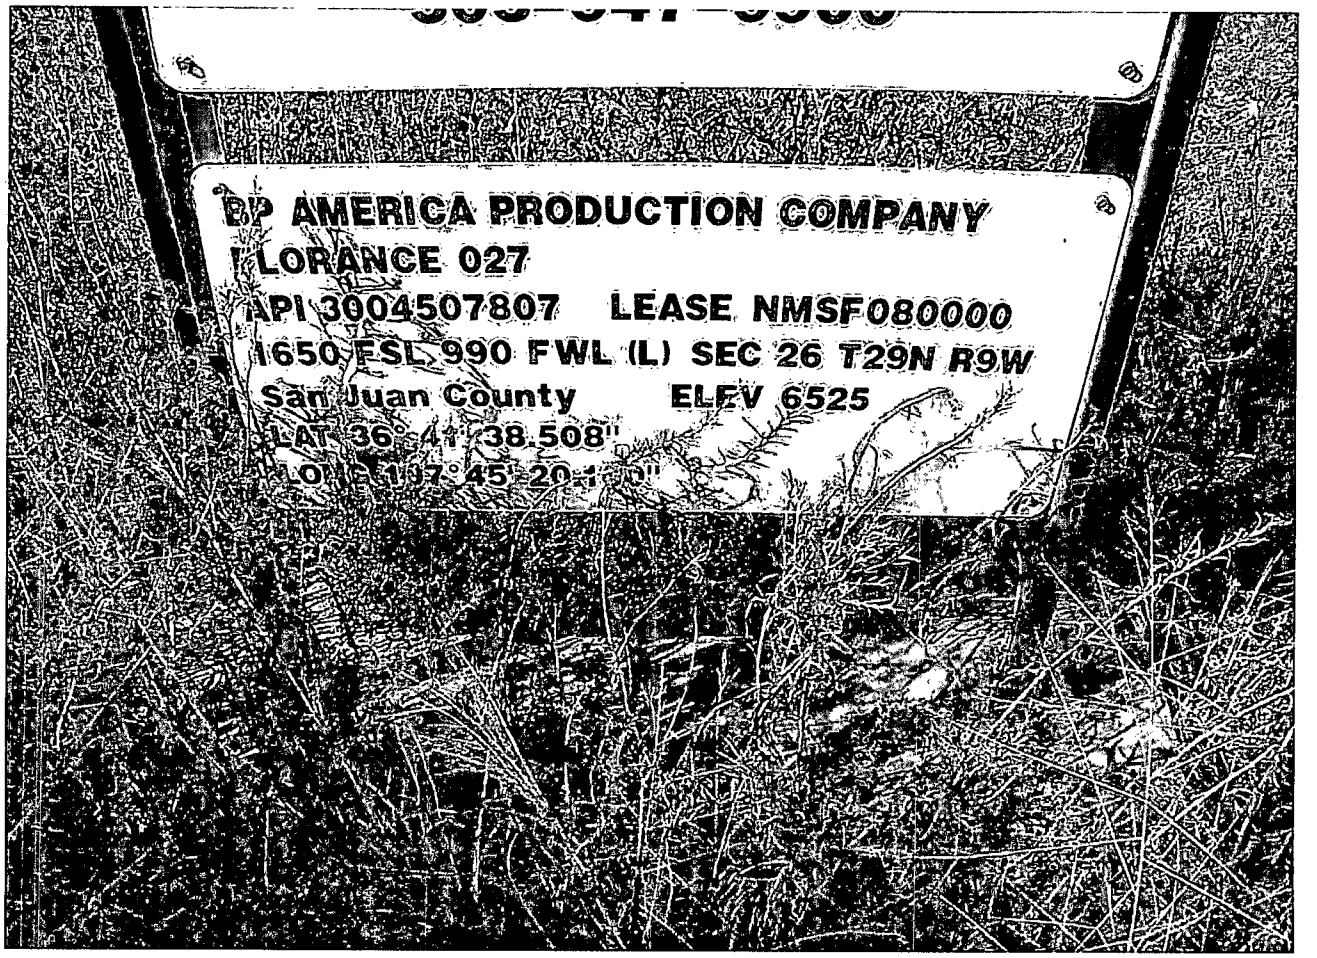
BP AMERICA PRODUCTION COMPANY
LORANCE 027
API 3004507807 LEASE NMSF080000
1650 FSL 990 FWL (L) SEC 26 T29N R9W
San Juan County ELEV 6525
LAT 36° 41' 38.508"

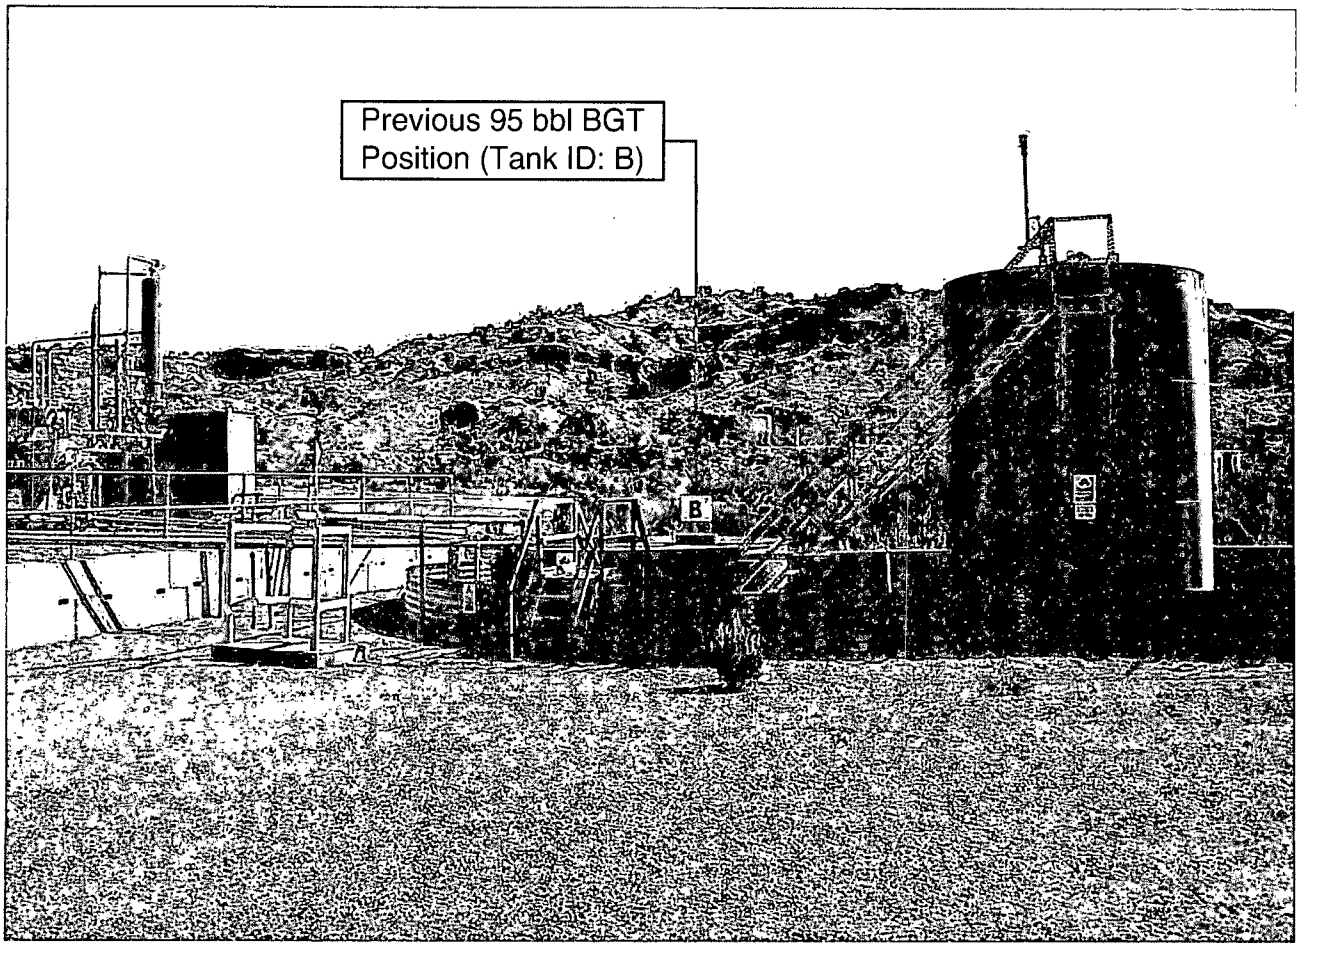
Previous 95 bbl BGT
Position (Tank ID: B)
B

9. If the sampling demonstrates that a release has not occurred or that any release does not exceed the concentrations specified above, then BP shall backfill the excavation, with compacted, non-waste containing, earthen material; construct a division-prescribed soil cover, re-contour and re-vegetate the location. The location will be reclaimed if it is not with in the active process area
   The area under the BGT was backfilled with clean soil. It is still within the active well area and is covered by the LPT.

10. BP shall reclaim the BGT location and all areas associated with the BGT including associated access roads to a safe and stable condition that blends with the surrounding undisturbed area. BP shall substantially restore the impacted surface area to the condition that existed prior to oil and gas operations by placement of the soil cover as provided in Subsection H of 19.15.17.13 NMAC, re-contour the location and associated areas to a contour that approximates the original contour and blends with the surrounding topography and re-vegetate according to Subsection I of 19.15.17.13 NMAC.
    The area over the BGT is still within the active well area and is covered by the LPT. This area will be reclaimed when the well is plugged and abandoned as part of final reclamation.
