Pit, Below-Grade Tank, or Proposed Alternative Method Permit or Closure Plan Application

Facility or well name: Florance J 48A

BELOW-GRADE TANK CLOSURE PLAN

Florance J 48A, Tank C (95 bbl)
API No. 3004522146
Unit Letter O, Section 23, T30N, R8W

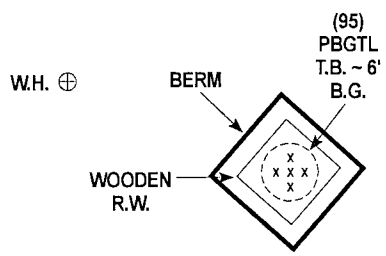
PLOT PLAN circle: attached

DISCOLORATION/STAINING OBSERVED: YES / NO EXPLANATION - BENEATH 18 BGT (MEDIUM GRAY)

APPARENT EVIDENCE OF A RELEASE OBSERVED AND/OR OCCURRED : YES / NO EXPLANATION: 18 BGT ONLY

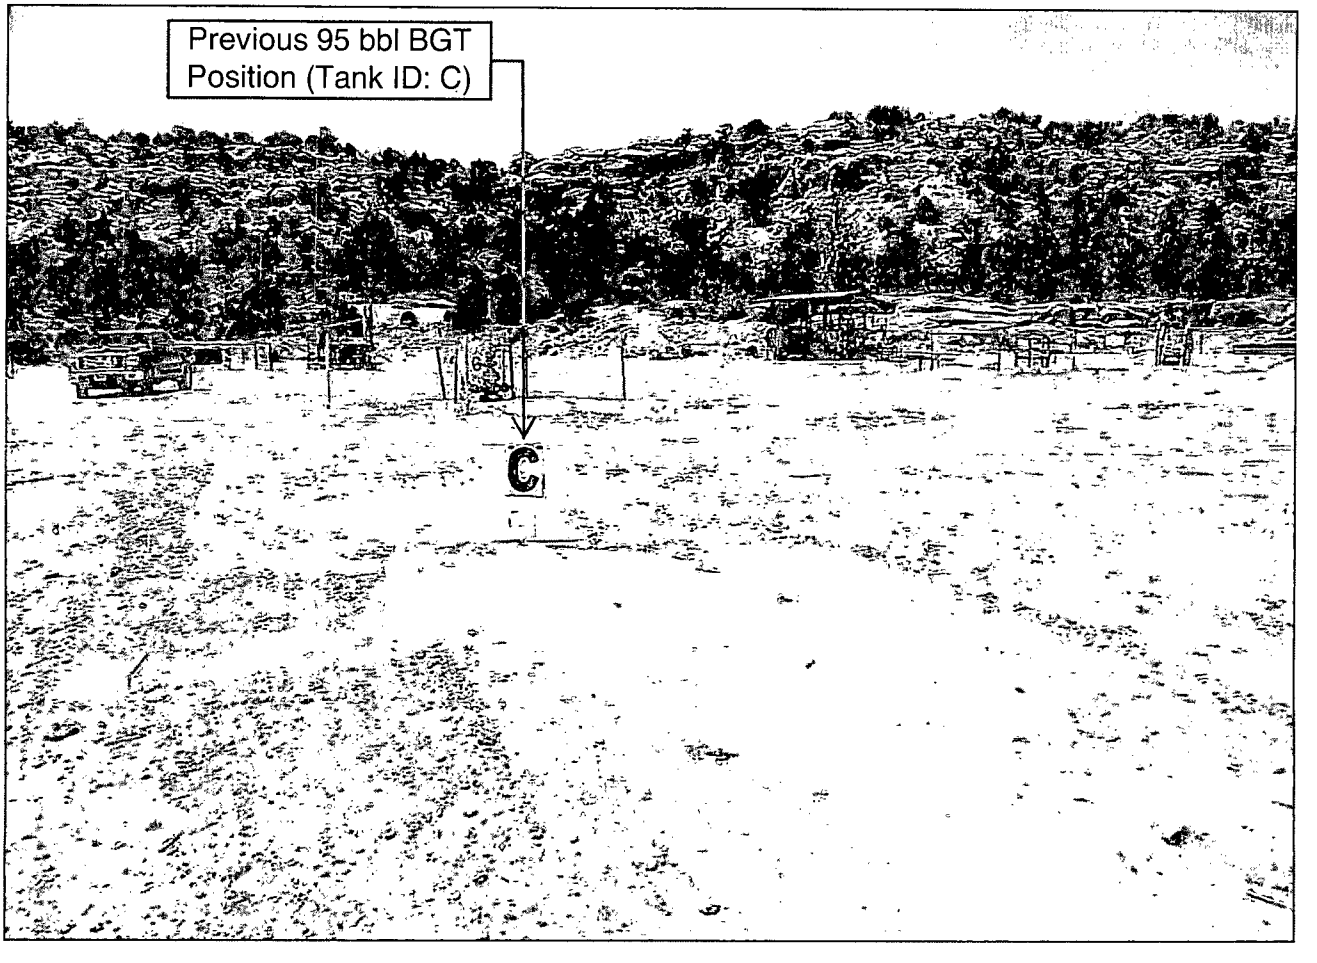
Previous 95 bbl BGT
Position (Tank ID: C)
C

9. If the sampling demonstrates that a release has not occurred or that any release does not exceed the concentrations specified above, then BP shall backfill the excavation, with compacted, non-waste containing, earthen material; construct a division-prescribed soil cover, re-contour and re-vegetate the location. The location will be reclaimed if it is not with in the active process area
The area under the BGT was backfilled with clean soil and is still within the active well area.
