Pit, Below-Grade Tank, or Proposed Alternative Method Permit or Closure Plan Application

Facility or well name: Riddle C 5 JUL 21 2014

BELOW-GRADE TANK CLOSURE PLAN

Riddle C 5
API No. 3004526788
Unit Letter P, Section 29, T31N, R9W

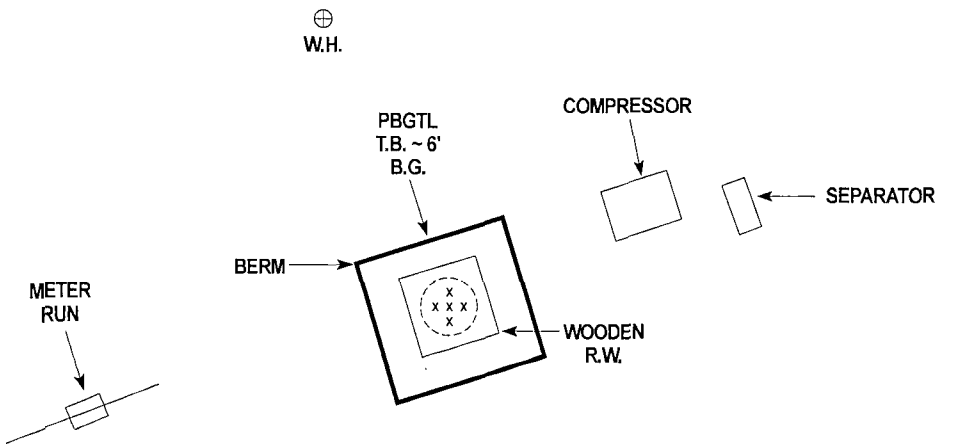
PLOT PLAN circle: attached

BGT Located : off / [on] site

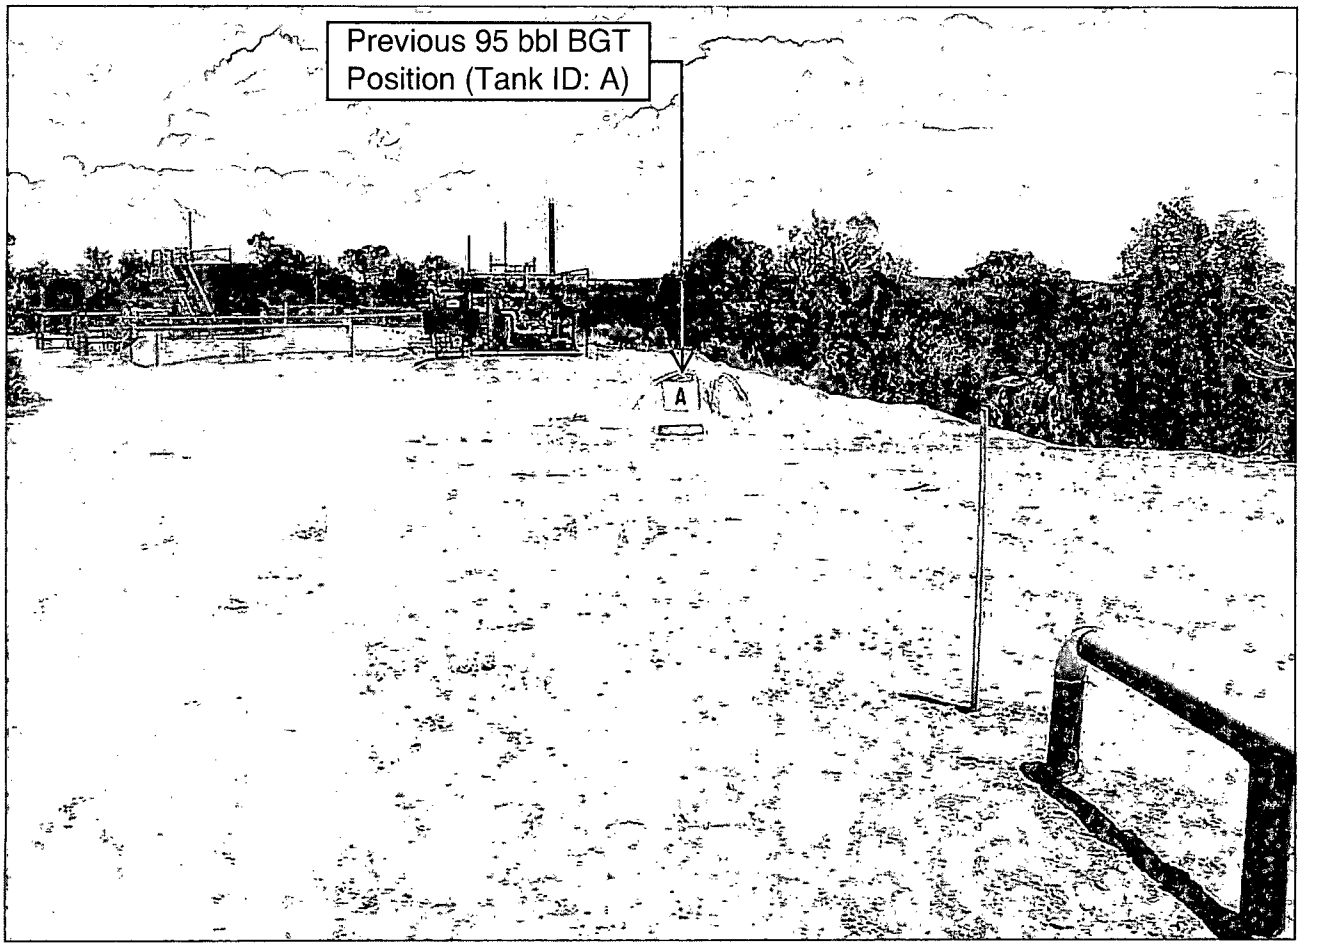
Previous 95 bbl BGT
Position (Tank ID: A)
A

9. If the sampling demonstrates that a release has not occurred or that any release does not exceed the concentrations specified above, then BP shall backfill the excavation, with compacted, non-waste containing, earthen material; construct a division-prescribed soil cover, re-contour and re-vegetate the location. The location will be reclaimed if it is not with in the active process area
The area under the BGT was backfilled with clean soil and is still within the active well area.

10. BP shall reclaim the BGT location and all areas associated with the BGT including associated access roads to a safe and stable condition that blends with the surrounding undisturbed area. BP shall substantially restore the impacted surface area to the condition that existed prior to oil and gas operations by placement of the soil cover as provided in Subsection H of 19.15.17.13 NMAC, re-contour the location and associated areas to a contour that approximates the original contour and blends with the surrounding topography and re-vegetate according to Subsection I of 19.15.17.13 NMAC.
The area over the BGT is still within the active well area. This area will be reclaimed when the well is plugged and abandoned as part of final reclamation.
