Highlander Environmental Corp.

February 10, 2006

Re: Work Plan for the Southwest Royalties, Inc., Cities Federal #2 SWD Facility, Located in Unit Letter M, Section 20, Township 22 South, Range 36 East, Lea County, New Mexico.

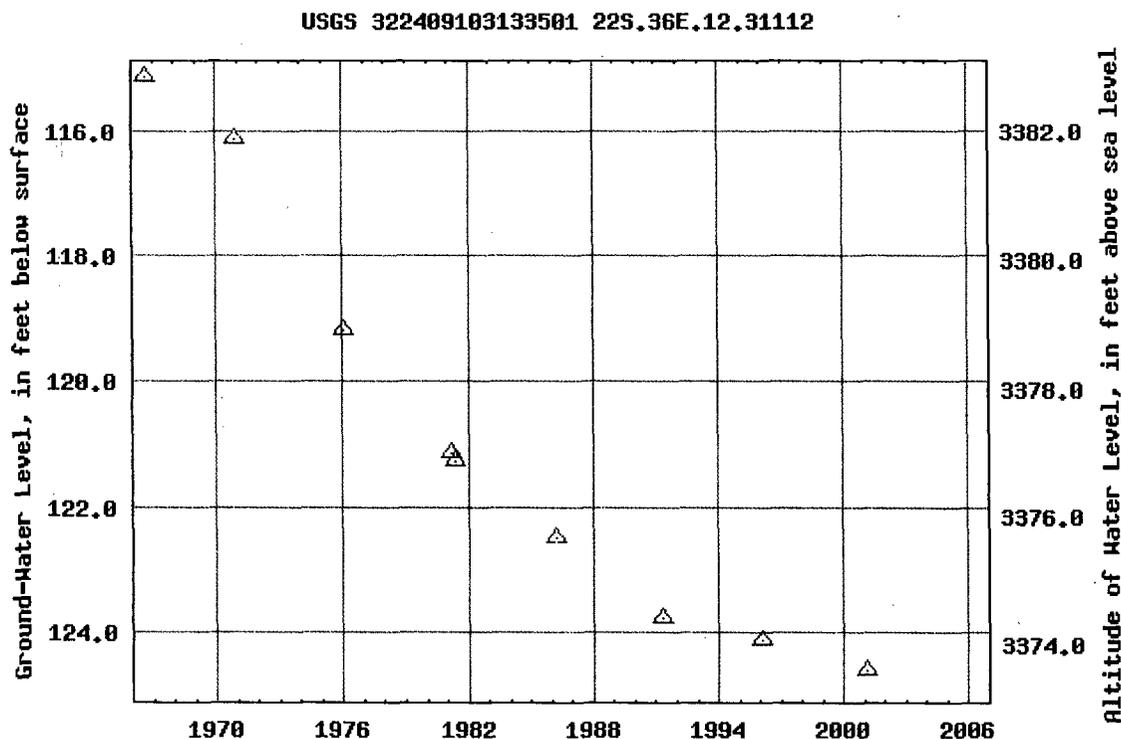
Breaks in the plot represent a gap of at least one calendar year between two consecutive points.

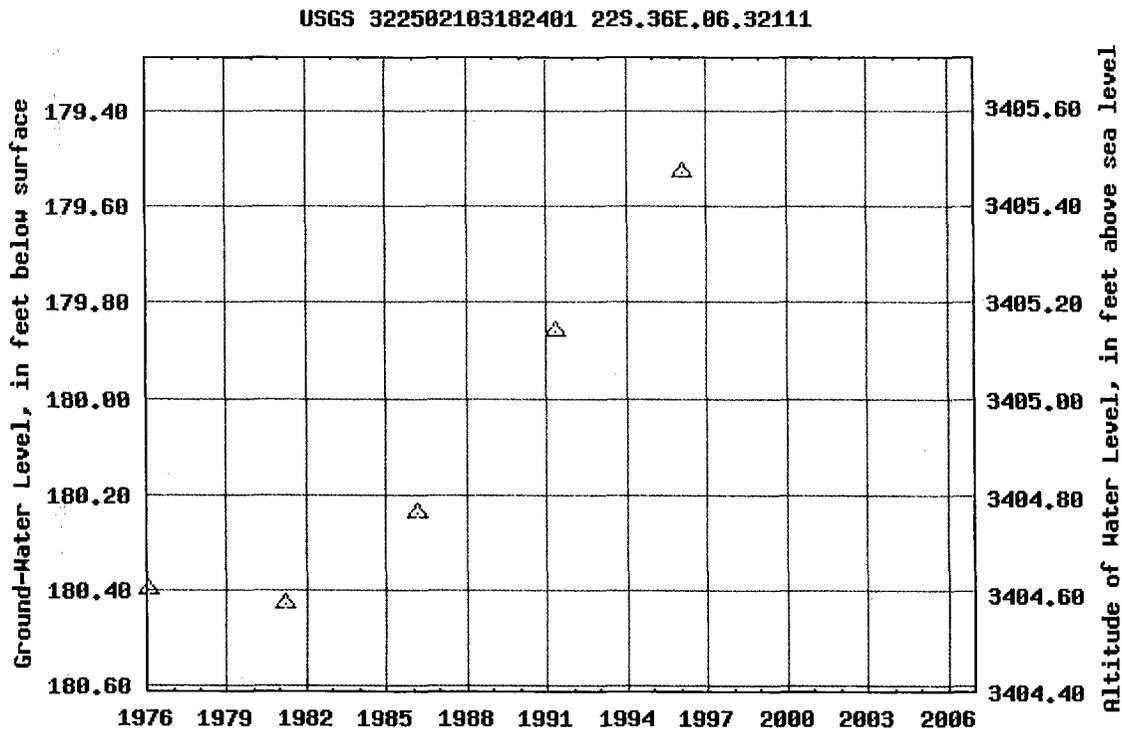
Breaks in the plot represent a gap of at least one calendar year between two consecutive points.

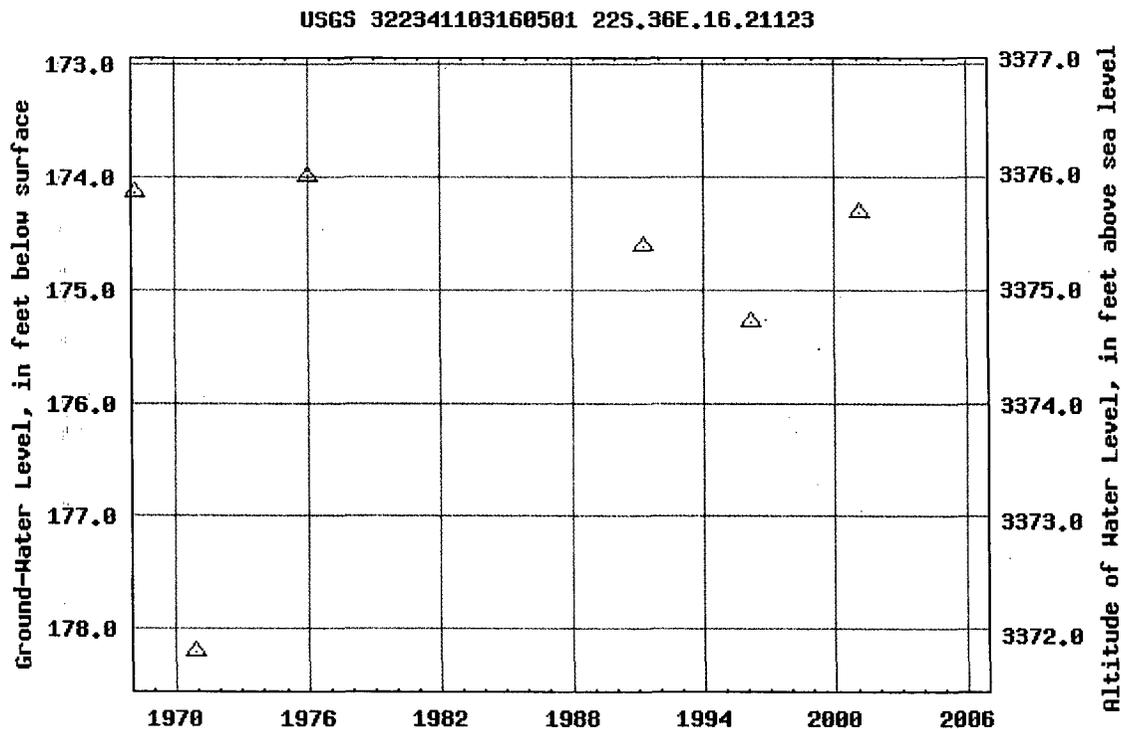
Breaks in the plot represent a gap of at least one calendar year between two consecutive points.

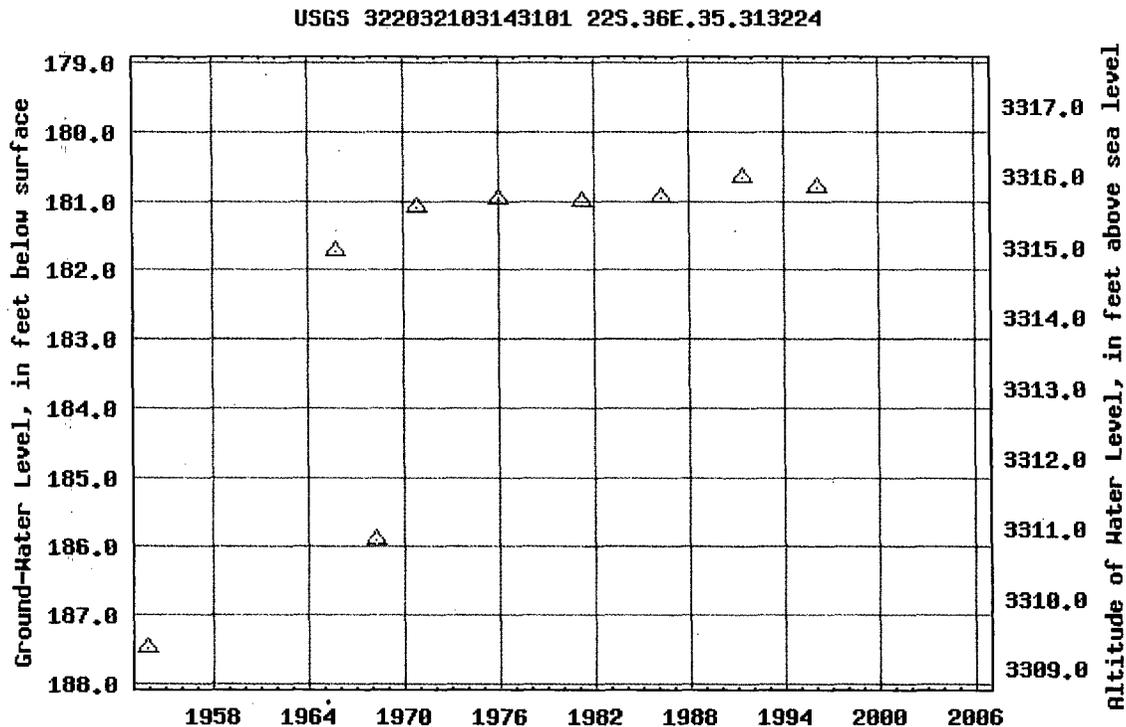
Breaks in the plot represent a gap of at least one calendar year between two consecutive points.

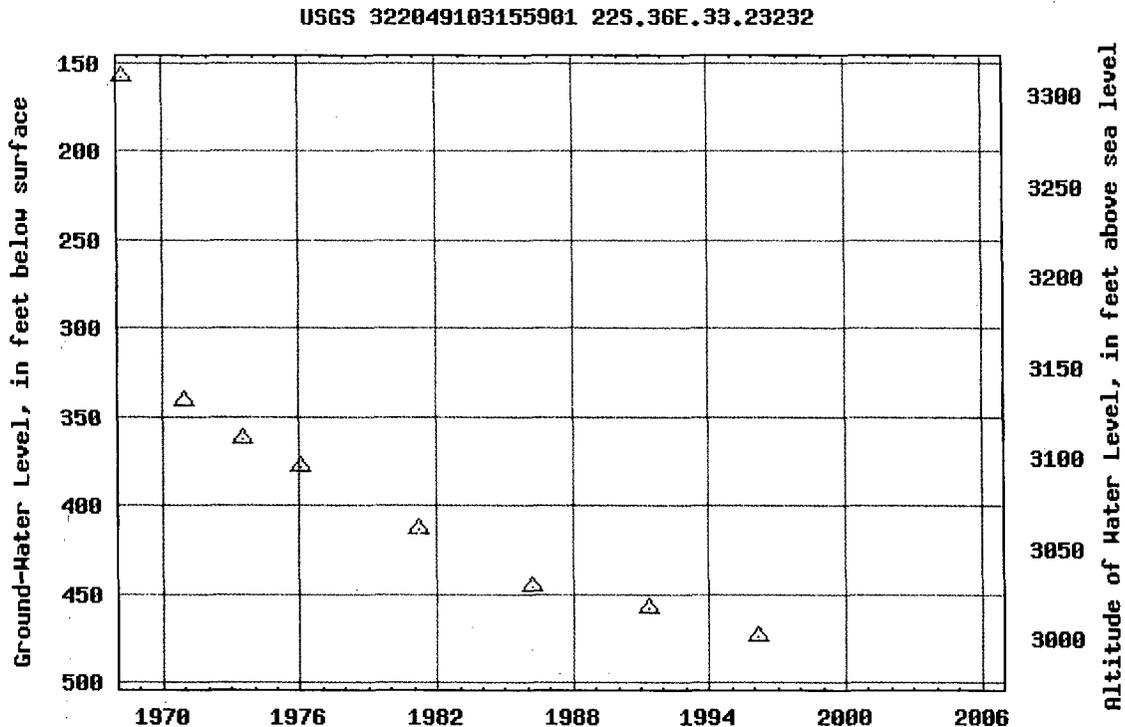
Breaks in the plot represent a gap of at least one calendar year between two consecutive points.

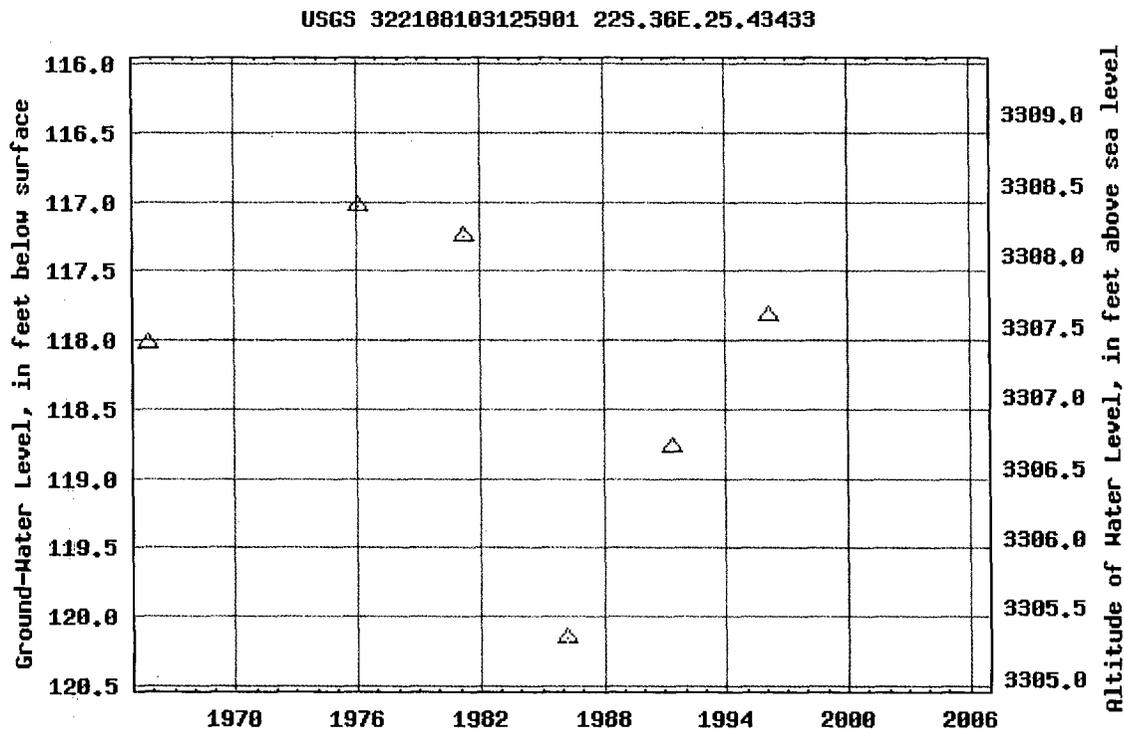
Breaks in the plot represent a gap of at least one calendar year between two consecutive points.
