**STAGE 1 ABATEMENT PLAN**

**SOUTH LANGLIE JAL UNIT**

**CONSISTING OF PORTIONS OF  
SECTIONS 7, 8, 17 & 18**

**TOWNSHIP 25 SOUTH – RANGE 37 EAST  
LEA COUNTY, NEW MEXICO**

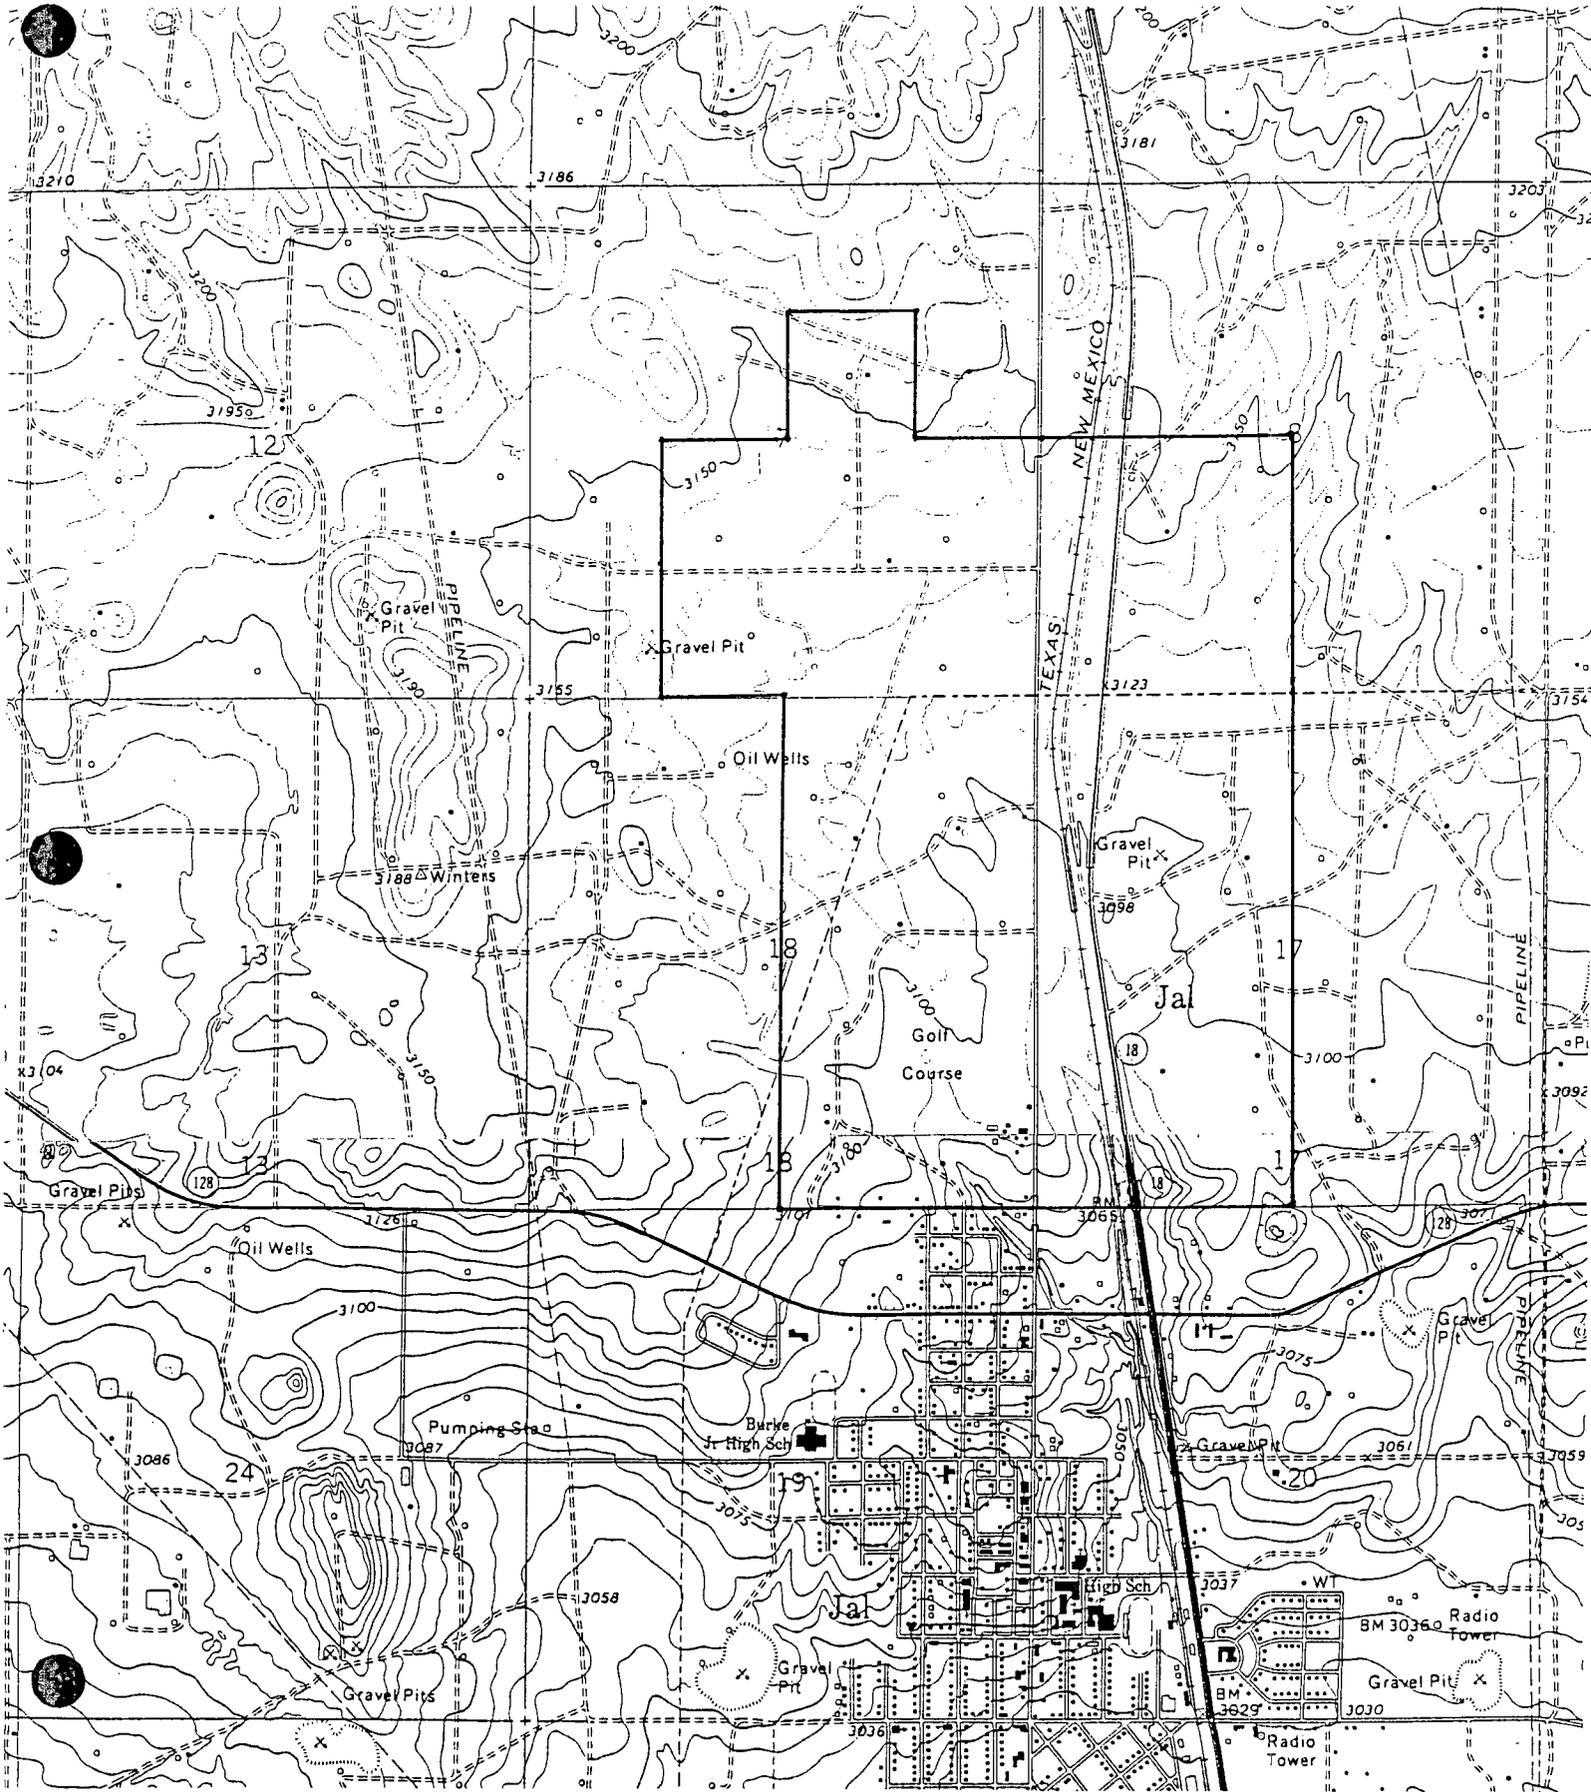
A.1 7.5 Minute Series (1:24,000 Scale) Topographic  
Map

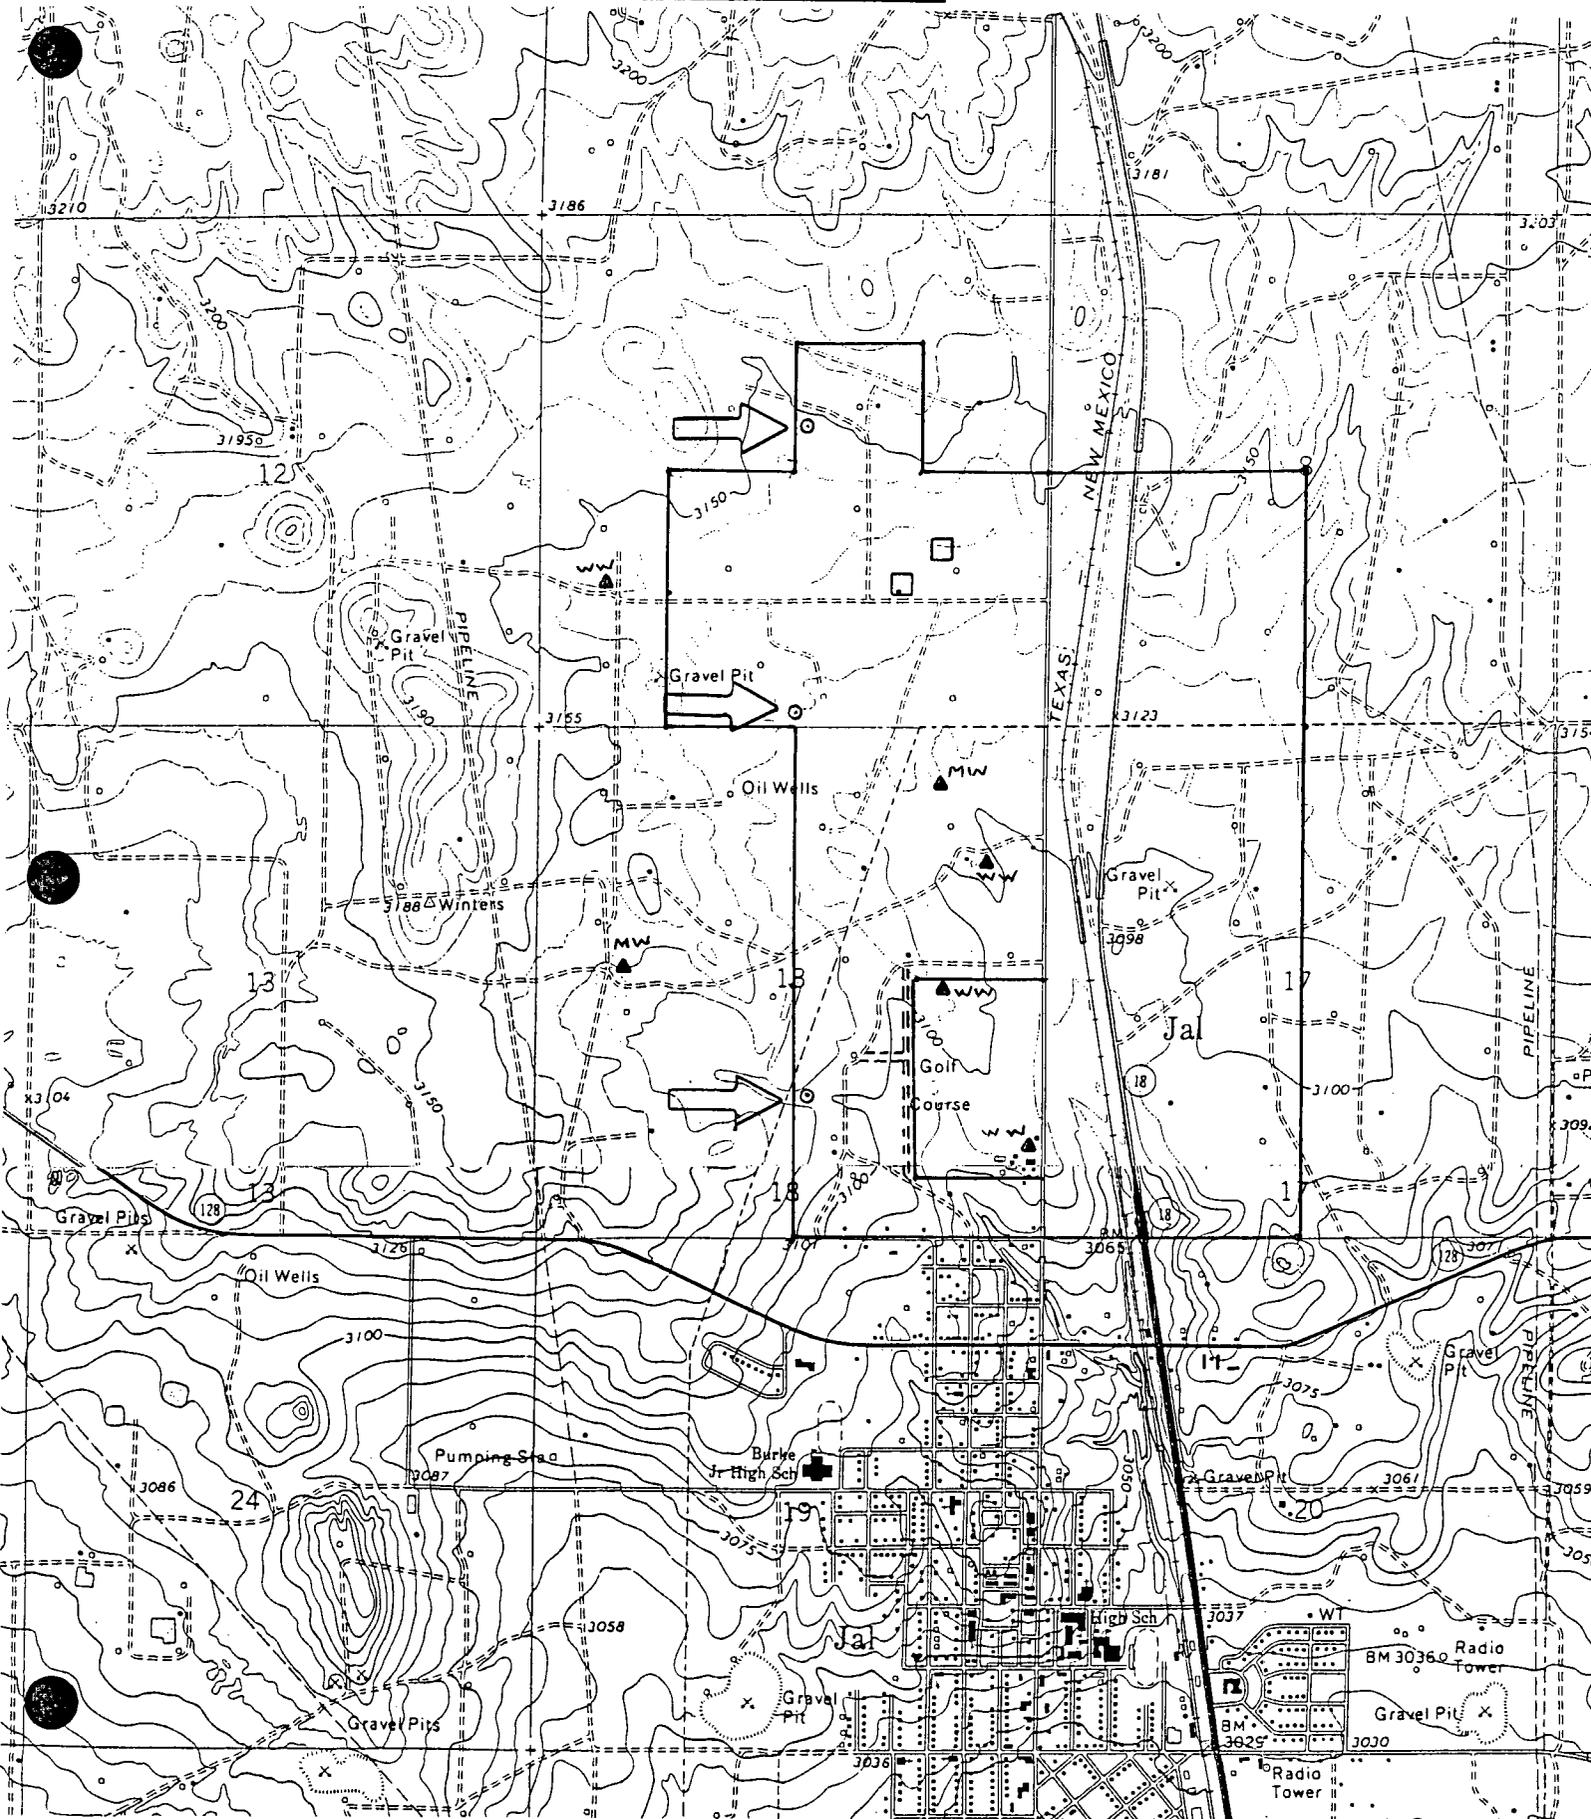
**A.3**      ***Map indicating the projected location for  
drilling new monitoring wells.***

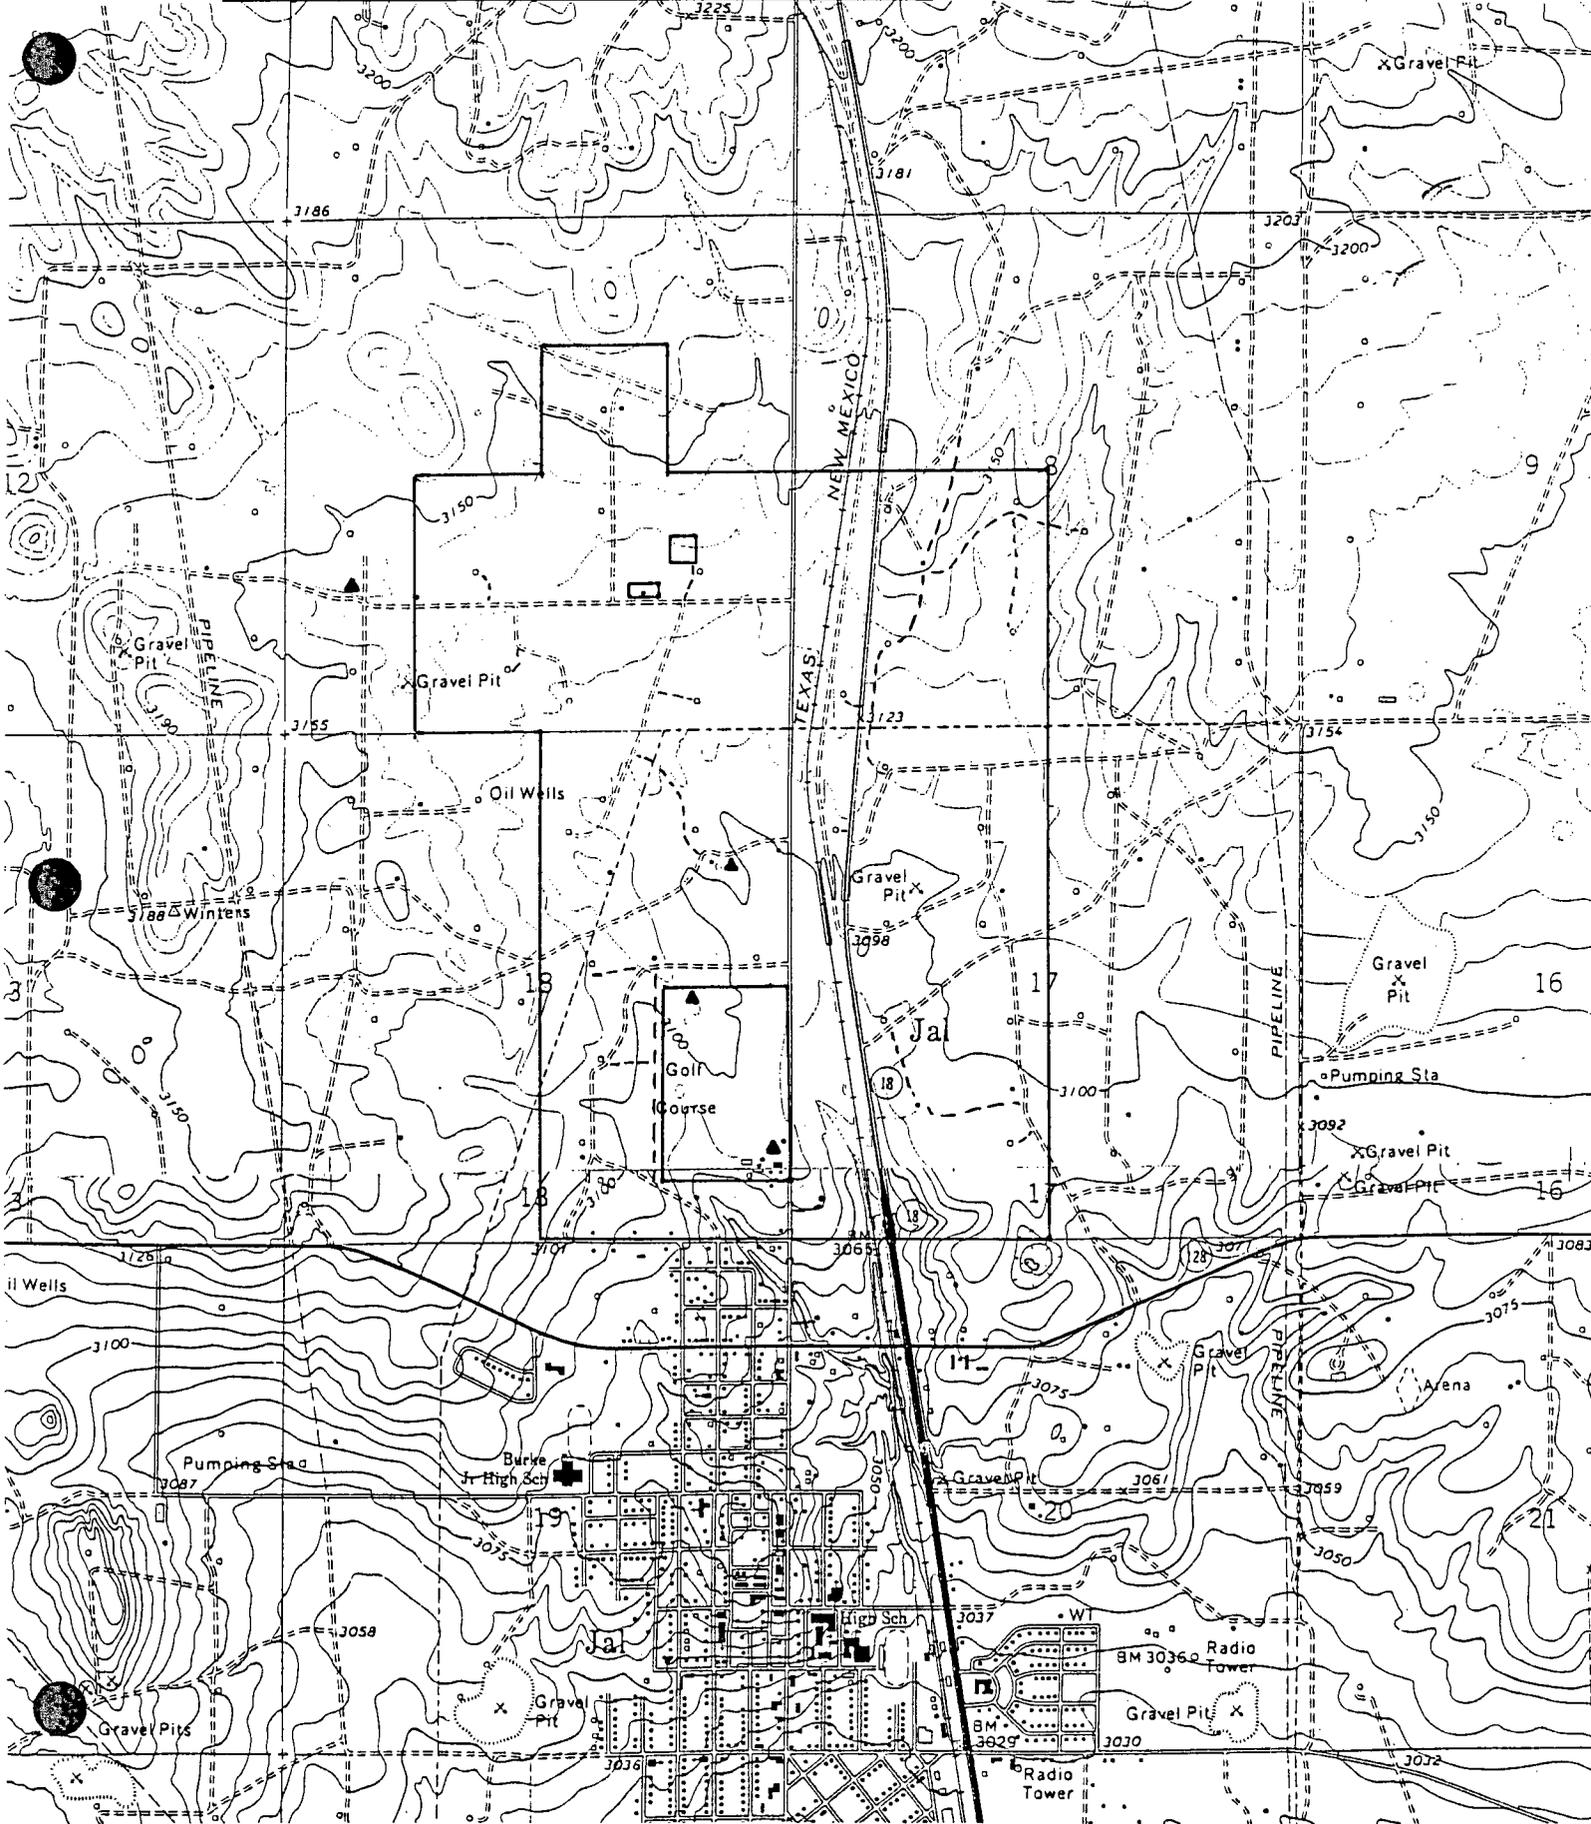
**A.4**      *Map showing known water wells within the confines of the unit. Where known, the chloride content of the water is given.*

At the present time Chaparral does not have any monitoring wells in place on this unit. A physical investigation of the unit revealed a monitoring well just north of the SLJU Well #13 WIW. Bristol reportedly put this in after a pipeline release in January 1999. Chaparral has no verifiable data from this well, but CERI states the well was drilled to a total depth of 52 feet with the top of the aquifer being found at 45 feet from surface. From other correspondence it appears SESI does have, or at least has had, several monitoring wells located south of the injection well (Well #13) now owned by Chaparral. A physical inspection of the unit failed to reveal any of the monitoring wells alleged to have been installed by SESI. The surface owner states he is not aware of any left behind by SESI and he has not been paying for any water testing by a laboratory, nor has he been invoiced by SESI for any water testing. A conversation with representatives of SESI confirms they plugged all of the test wells they dug. The well left behind by Bristol has not been tampered with since Chaparral took possession of the unit and it has not had its water tested for well over a year now. Once data has been received from Bristol as to this monitoring well Chaparral may use it to help monitor the ground water at this location.

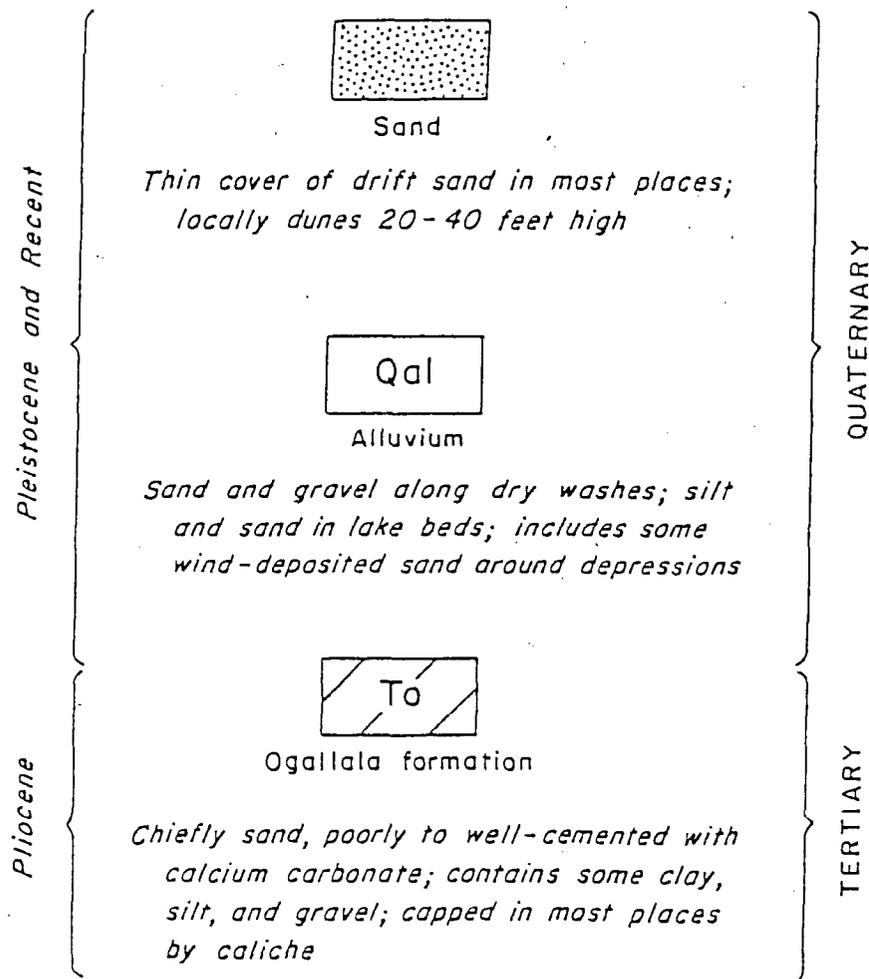
A.5 *Copy of a portion of the Geologic Map of Southern Lea County, New Mexico showing type of material on the surface as well as the age of that material*

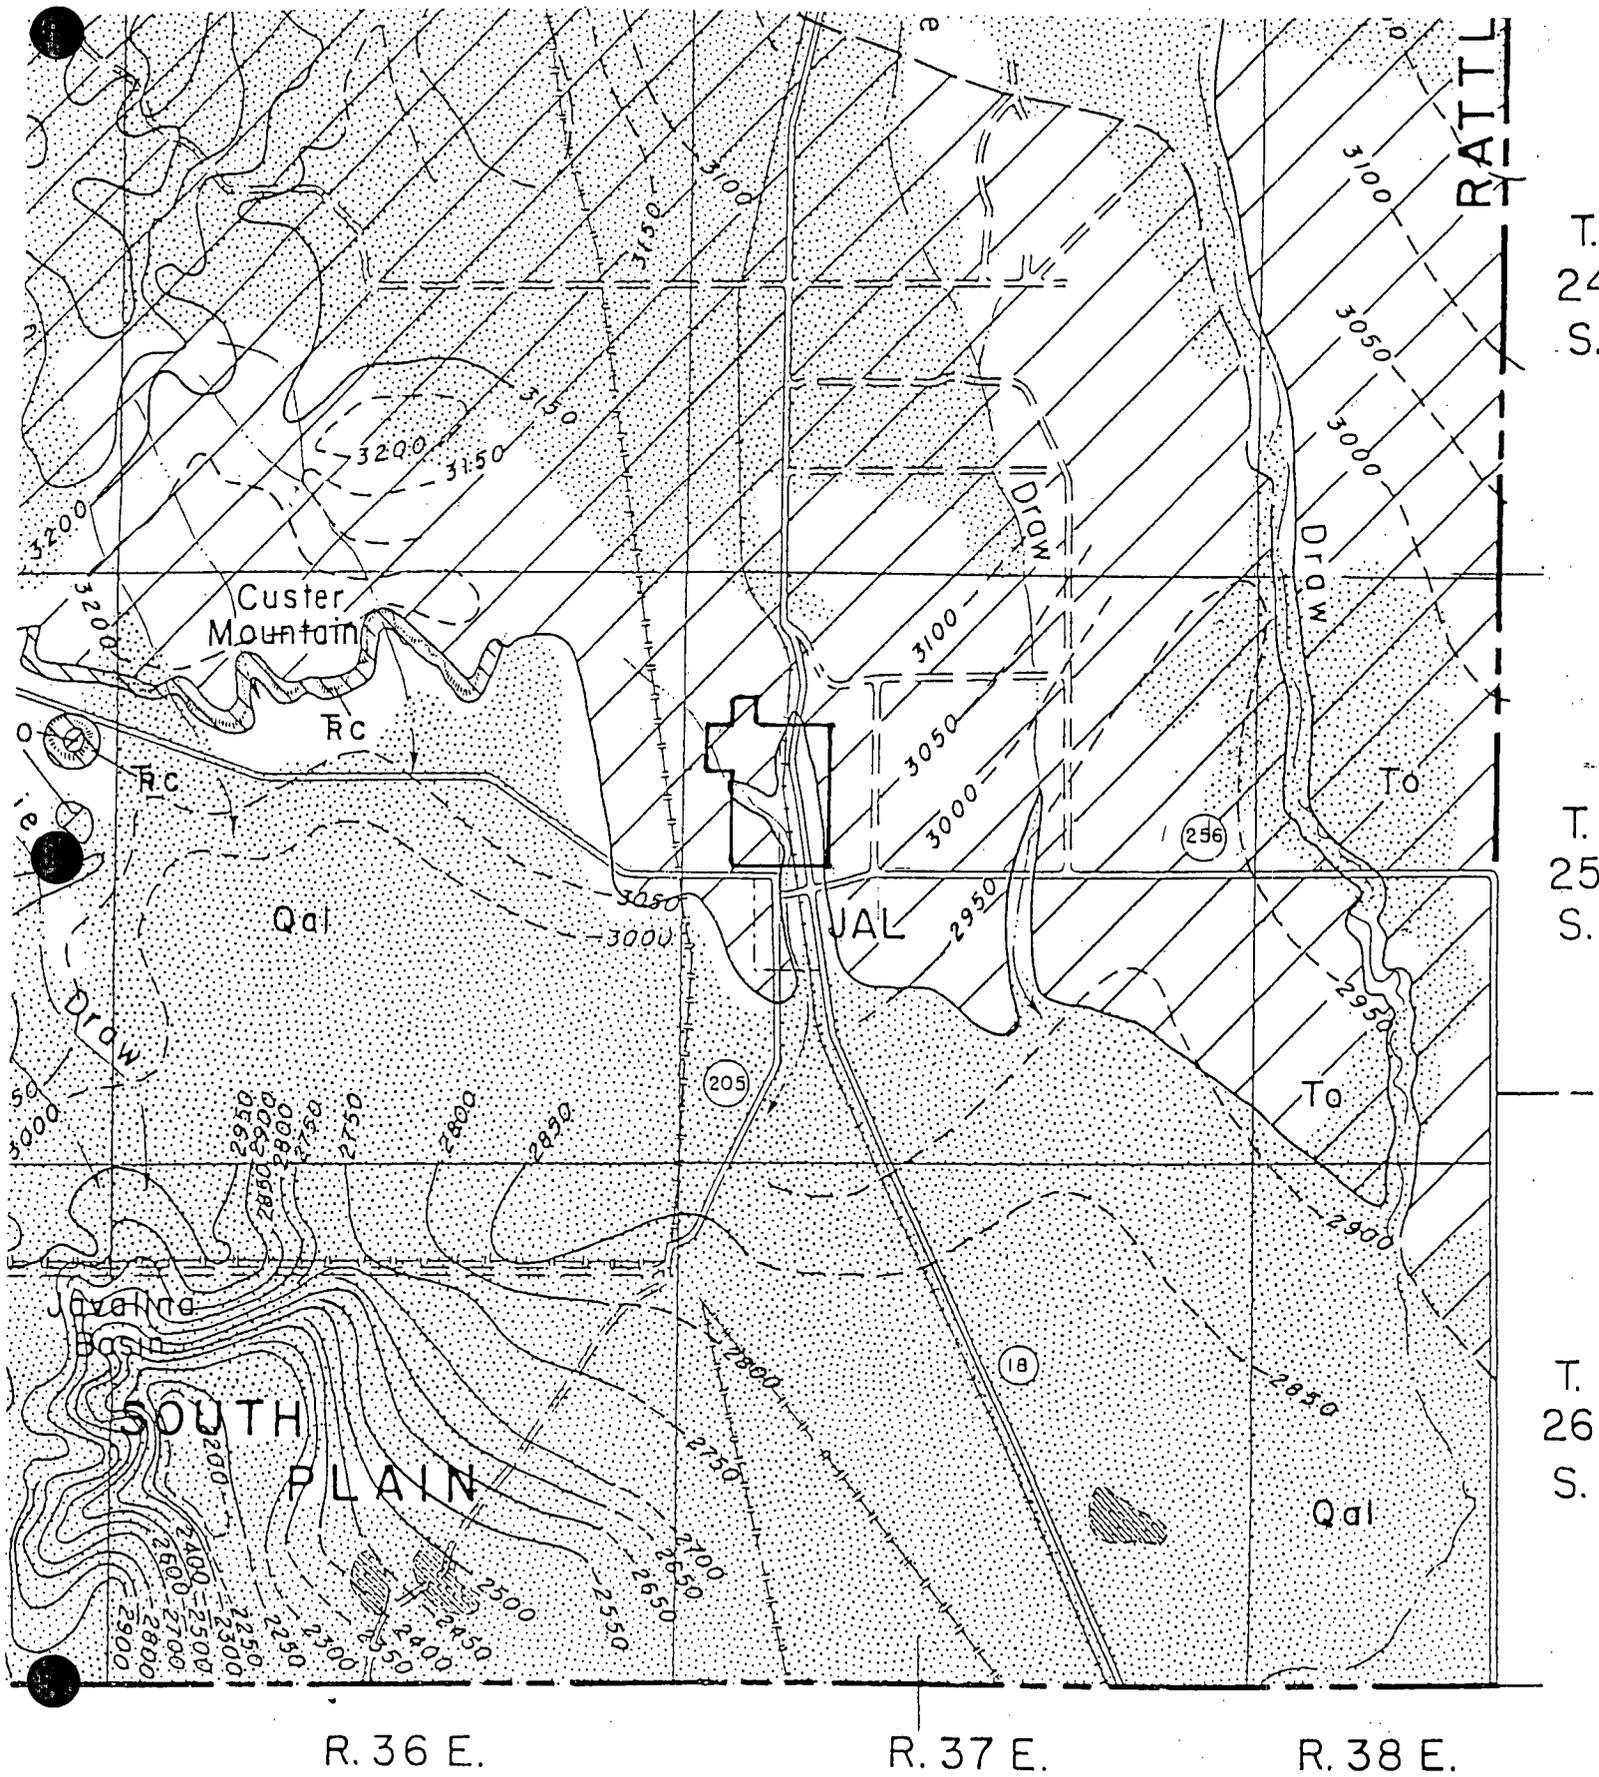
**A.6 Copy of a portion of the Ground-Water Map of Southern Lea County, New Mexico showing water-table contours, type of rock from which the water is found, depth to water, depth of well and whether the well is flowing or being pumped**

Previous borings and measurements appear to indicate groundwater is moving to the southeast, possibly from the hills located north and west of Jal, New Mexico. This flow crosses the unit and would cause pollution from sources west of the unit to pass underneath the property of the surface owner and the City of Jal, New Mexico. The proposed test wells should help confirm the direction of groundwater flow. In order to determine the direction of groundwater flow, all existing water wells used in this survey and all new wells put in by Chaparral shall be surveyed in, accurately spotted on a USGS Topographic Map and from this an accurate direction of contaminate migration determined.
