# Pit, Below-Grade Tank, or Proposed Alternative Method Permit or Closure Plan Application

1.
Operator: BP America Production Company OGRID #: 778
Address: 200 Energy Court, Farmington, NM 87401
Facility or well name: Houck Gas Com C 1E
API Number: 3004526137 OCD Permit Number: 9195
U/L or Qtr/Qtr C Section 6 Township 29N Range 9W County: San Juan
Center of Proposed Design: Latitude 36.758835 Longitude -107.822229 NAD: ☐ 1927 ☒ 1983
Surface Owner: ☒ Federal ☐ State ☐ Private ☐ Tribal Trust or Indian Allotment

BELOW-GRADE TANK CLOSURE PLAN

**Houck Gas Com C 1E**
**API No. 3004526137**
**Unit Letter C, Section 6, T29N, R9W**

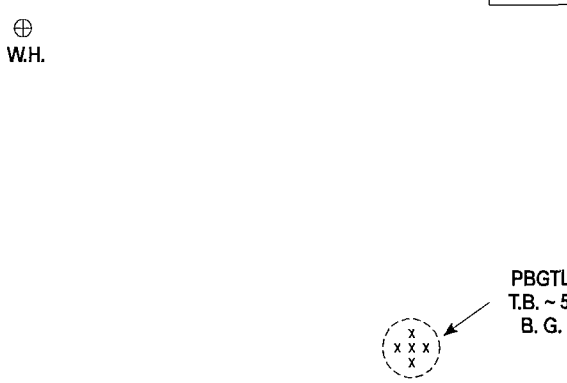
## SITE SKETCH

OVM CALIB. READ. = 53.0 ppm RF = 0.52
OVM CALIB. GAS = 100 ppm
TIME: 1:00 am/pm DATE: 11/13/12

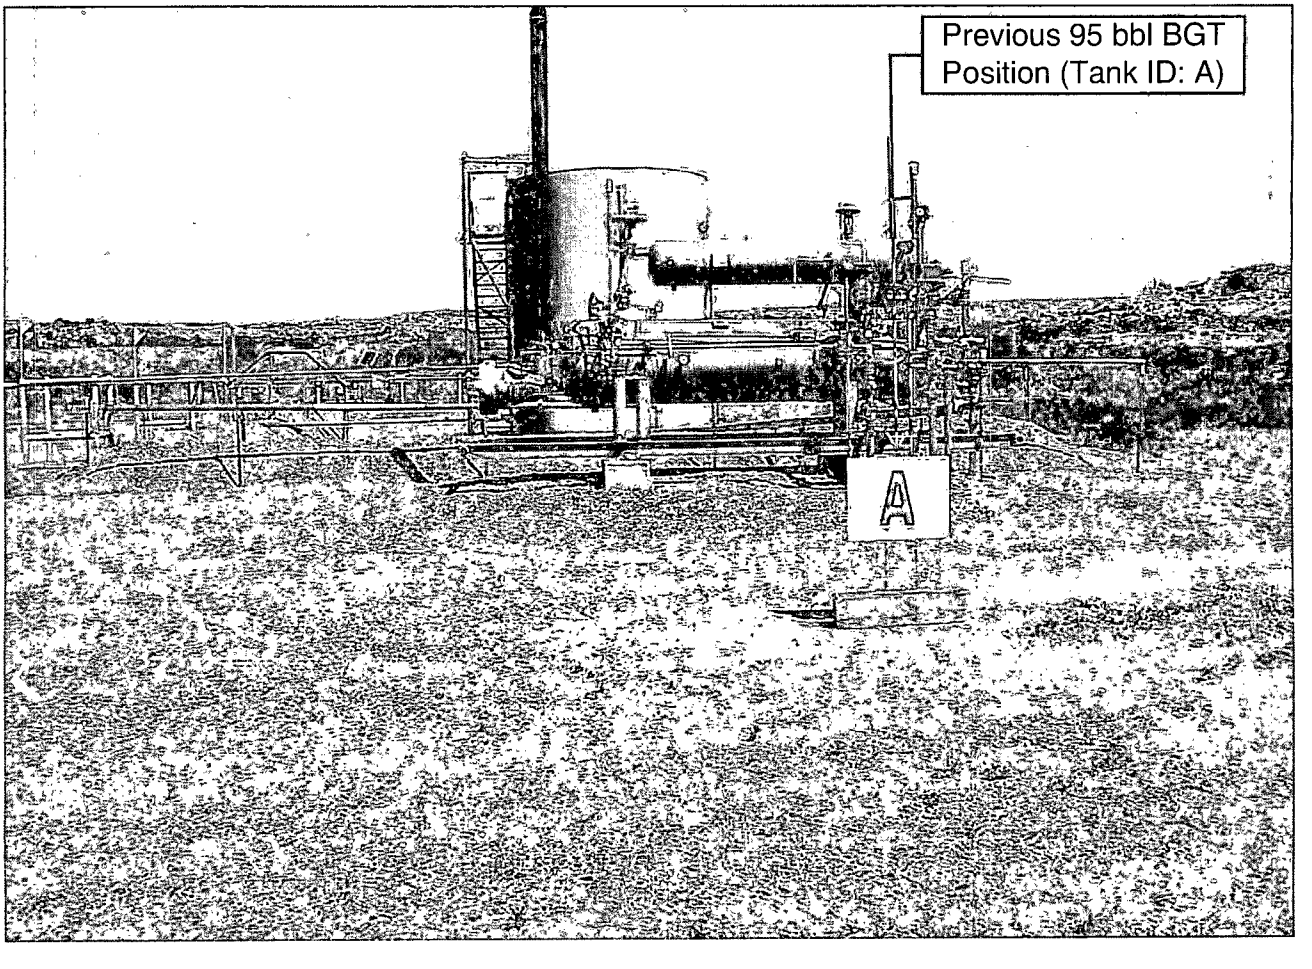
Previous 95 bbl BGT
Position (Tank ID: A)
A
