Pit, Below-Grade Tank, or
12351 Proposed Alternative Method Permit or Closure Plan Application

BELOW-GRADE TANK CLOSURE PLAN

Riddle F LS 10
API No. 3004521144
Unit Letter M, Section 17, T28N, R8W

Release Notification and Corrective Action

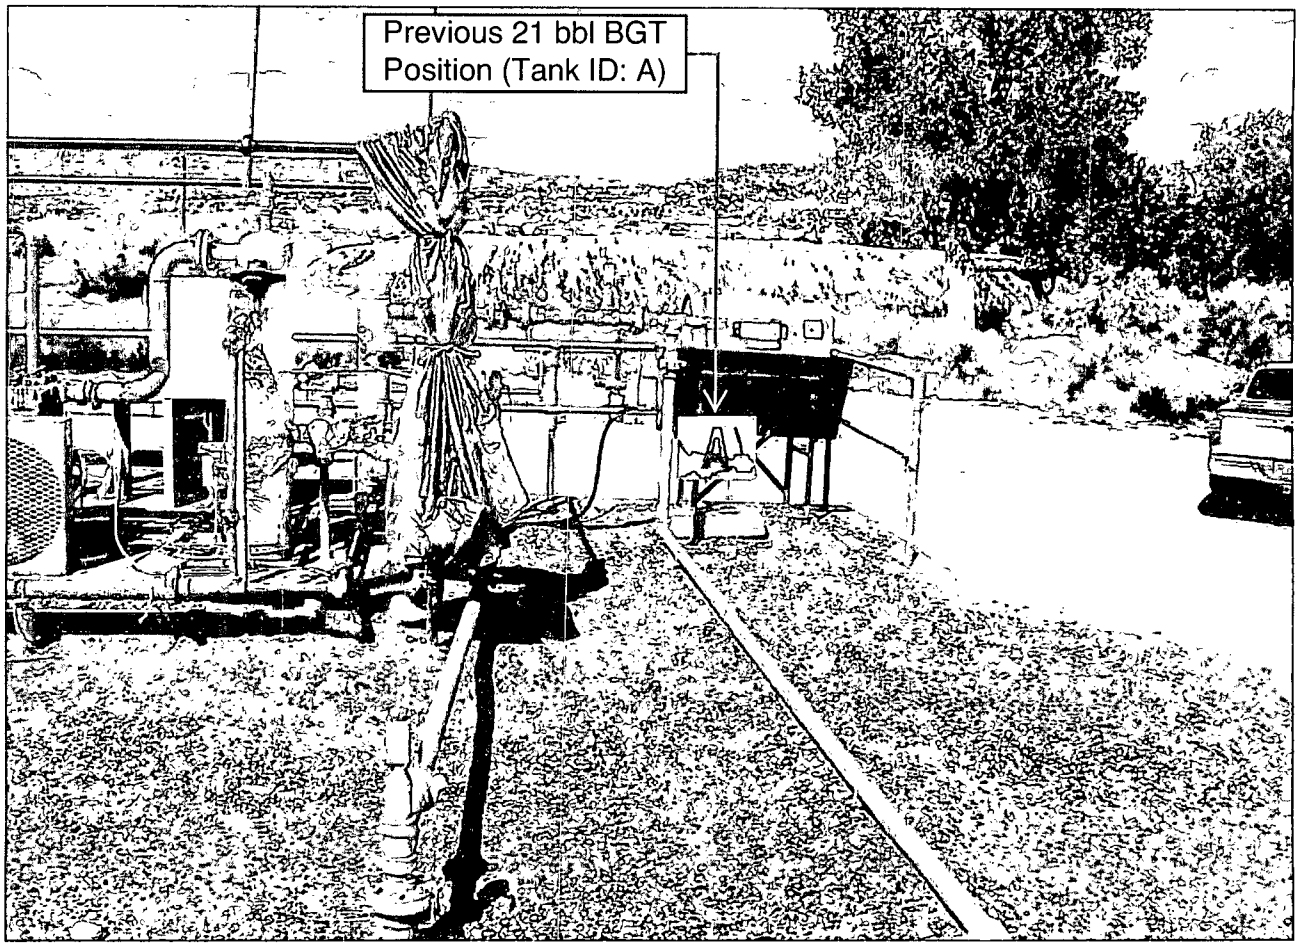
Previous 21 bbl BGT
Position (Tank ID: A)

9. If the sampling demonstrates that a release has not occurred or that any release does not exceed the concentrations specified above, then BP shall backfill the excavation, with compacted, non-waste containing, earthen material; construct a division-prescribed soil cover, re-contour and re-vegetate the location. The location will be reclaimed if it is not with in the active process area
The area under the BGT was backfilled with clean soil and is still within the active well area.

10. BP shall reclaim the BGT location and all areas associated with the BGT including associated access roads to a safe and stable condition that blends with the surrounding undisturbed area. BP shall substantially restore the impacted surface area to the condition that existed prior to oil and gas operations by placement of the soil cover as provided in Subsection H of 19.15.17.13 NMAC, re-contour the location and associated areas to a contour that approximates the original contour and blends with the surrounding topography and re-vegetate according to Subsection I of 19.15.17.13 NMAC.
The area over the BGT is covered by the raised compressor pad and is still within the active well area. This area will be reclaimed when the well is plugged and abandoned as part of final reclamation.
