**STAGE 1 ABATEMENT PLAN**

**SOUTH LANGLIE JAL UNIT**

**CONSISTING OF PORTIONS OF  
SECTIONS 7, 8, 17 & 18**

**TOWNSHIP 25 SOUTH – RANGE 37 EAST  
LEA COUNTY, NEW MEXICO**

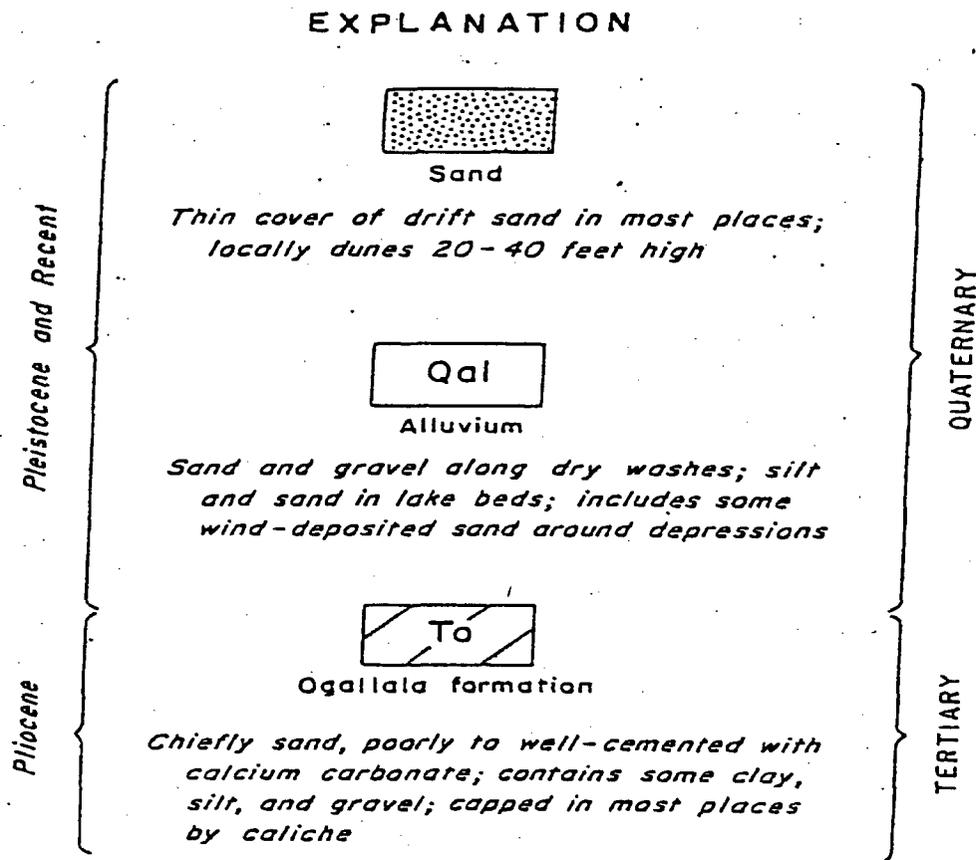
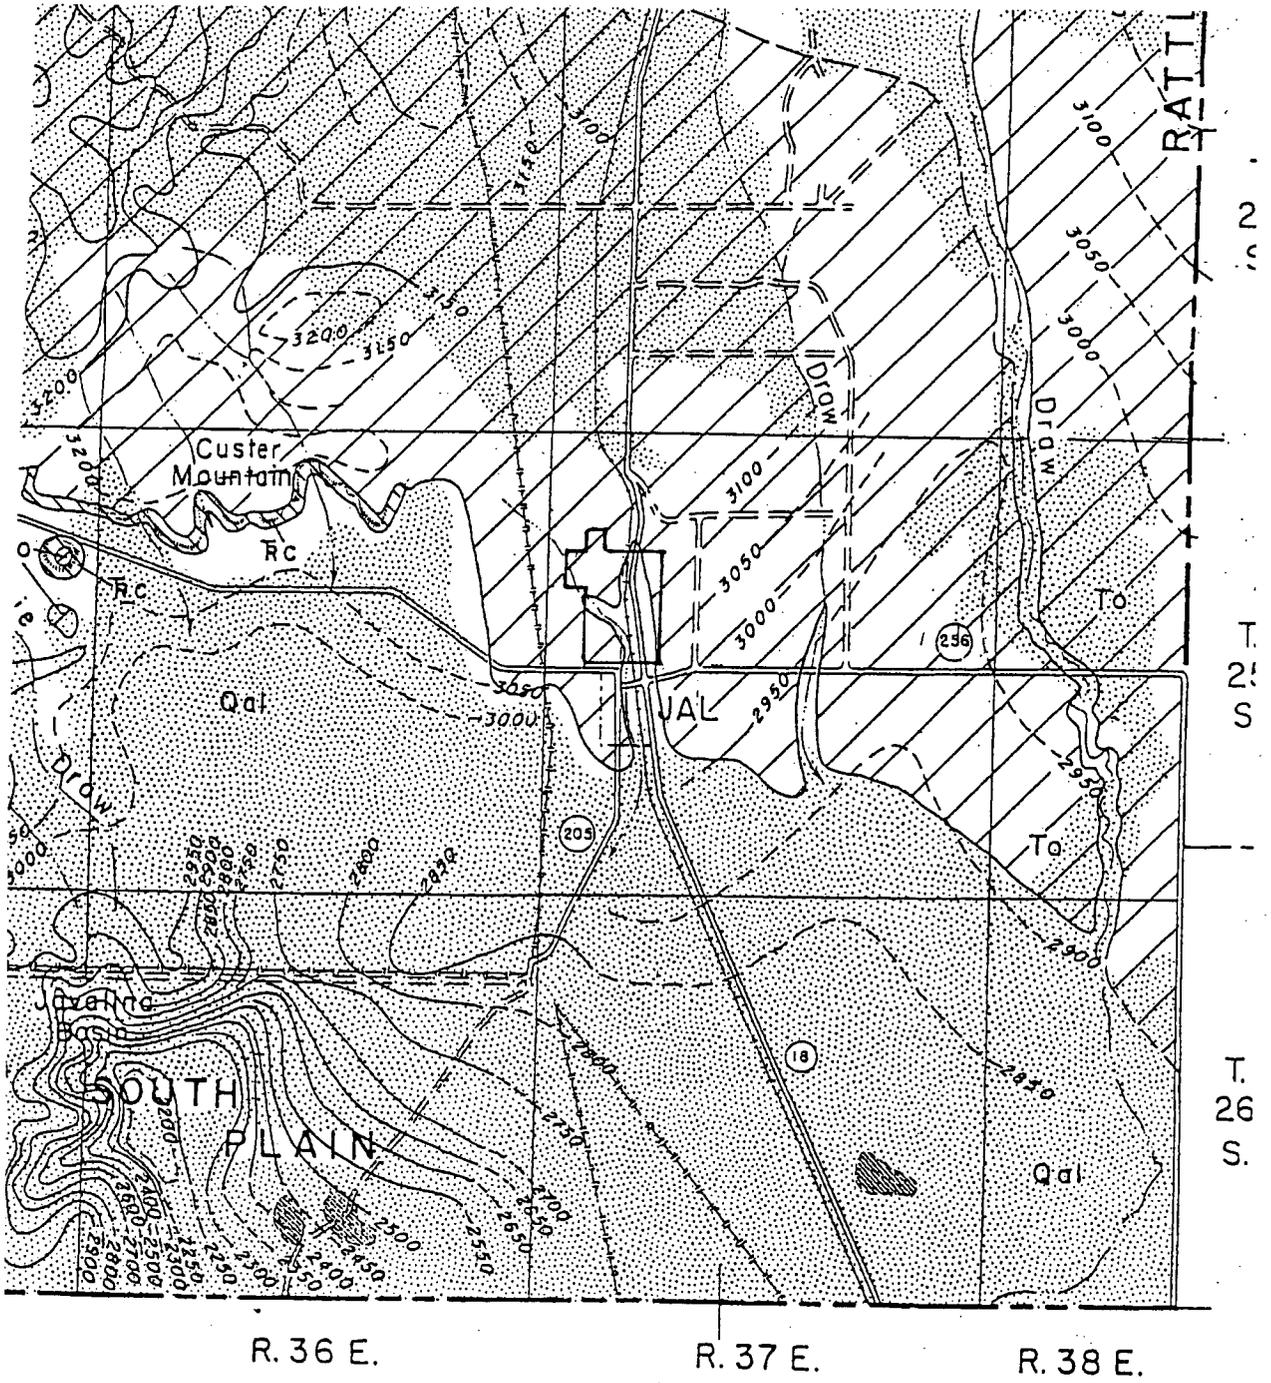
A.5 *Copy of a portion of the Geologic Map of Southern Lea County, New Mexico showing type of material on the surface as well as the age of that material.*

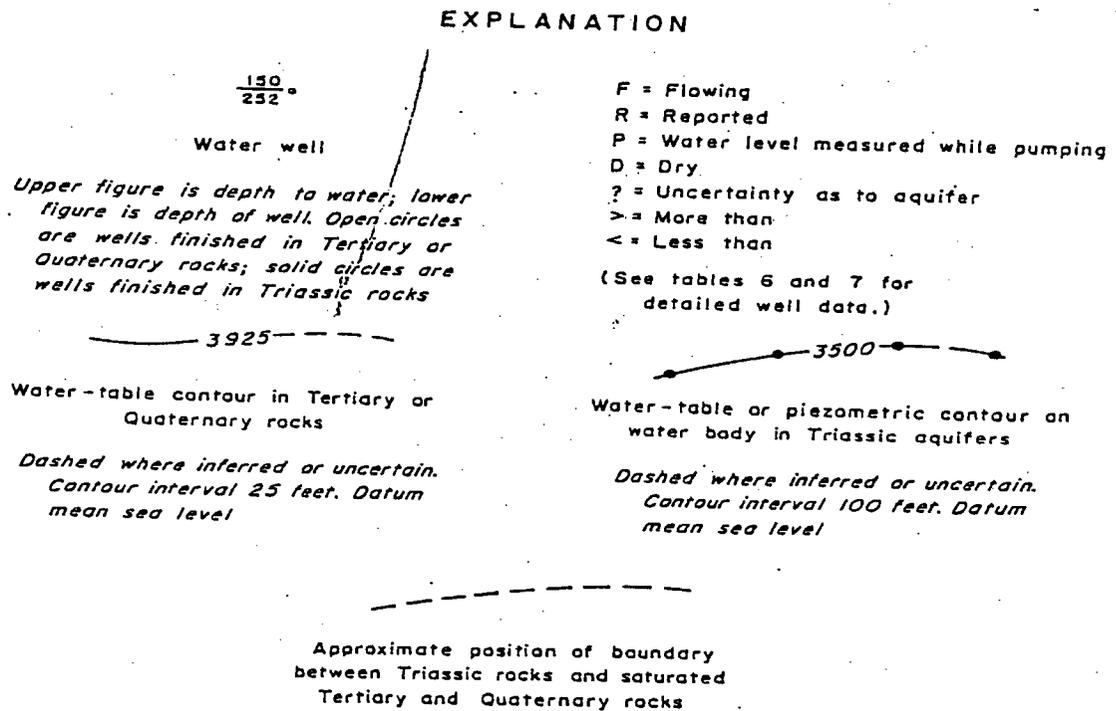
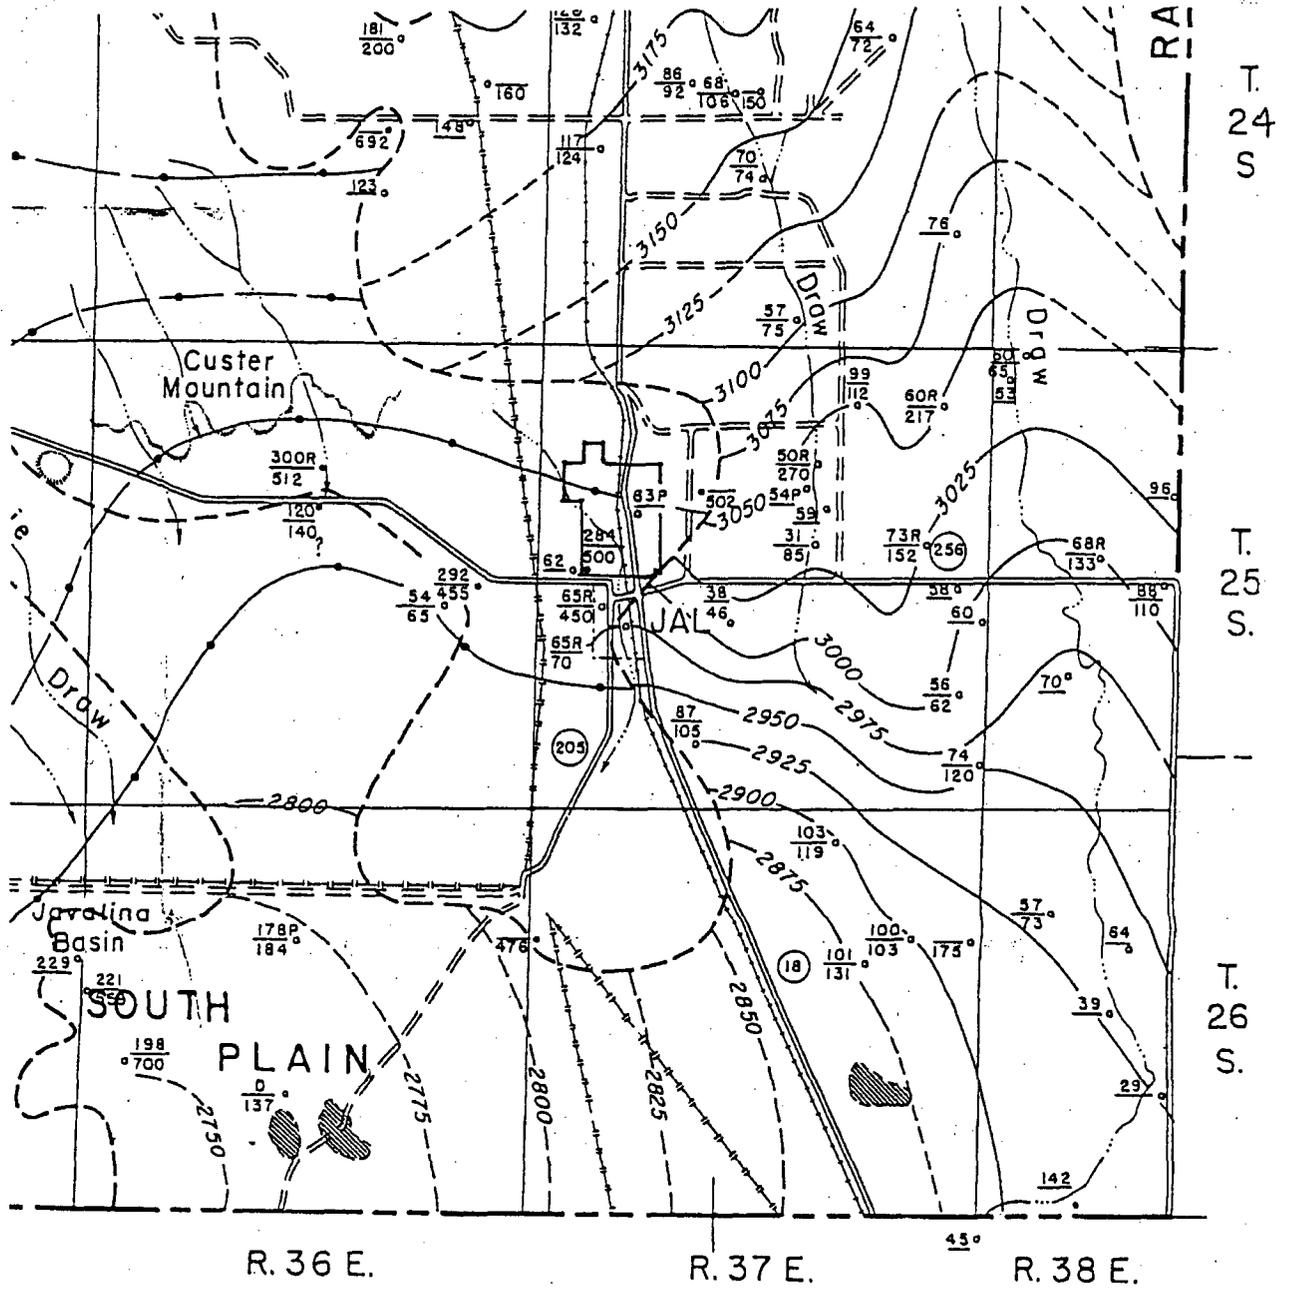
**A.6 Copy of a portion of the Ground-Water Map of Southern Lea County, New Mexico showing water-table contours, type of rock from which the water is found, depth to water, depth of well and whether the well is flowing or being pumped.**

Previous borings and measurements appear to indicate groundwater is moving to the southeast, possibly from the hills located north and west of Jal, New Mexico. This flow crosses the unit and would cause contamination from sources north and west of the unit to pass underneath the property of the surface owner and the City of Jal, New Mexico. There is a possibility regional groundwater flows will go in a different direction over a limited area due to near-surface impermeable strata, hills, etc. It appears this may be the case along the north edge of the golf course where there is indications surface and groundwater flow is to the north, towards the Osborn home. The proposed test and monitoring wells, as well as use of local water wells should help confirm the general direction of groundwater flow. In order to determine the direction of groundwater flow, all existing water wells used in this survey and all new wells put in by Chaparral shall be surveyed in, accurately spotted on a USGS Topographic Map and from this an accurate direction of groundwater flow and contaminate migration determined.

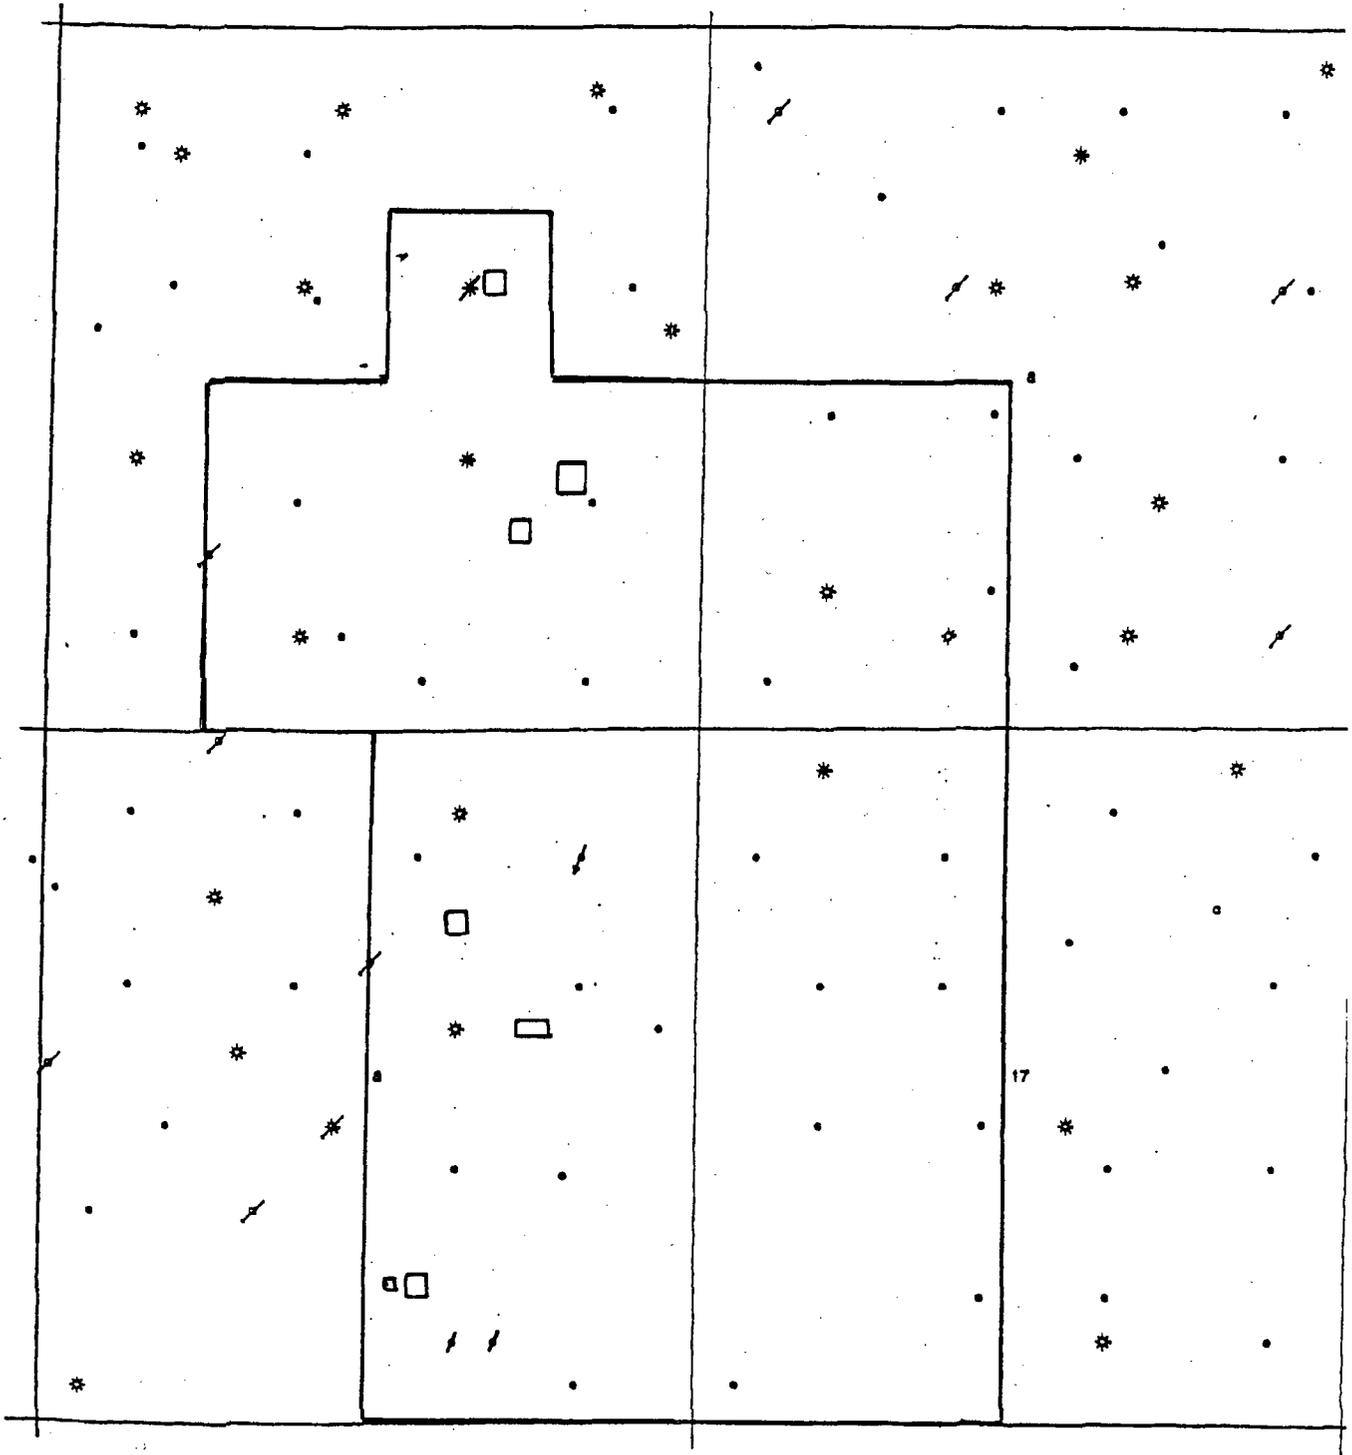
**A.7**      ***Well Spot Map showing the location of all  
known oil and gas wells, water injection wells,  
tank batteries and pits.***

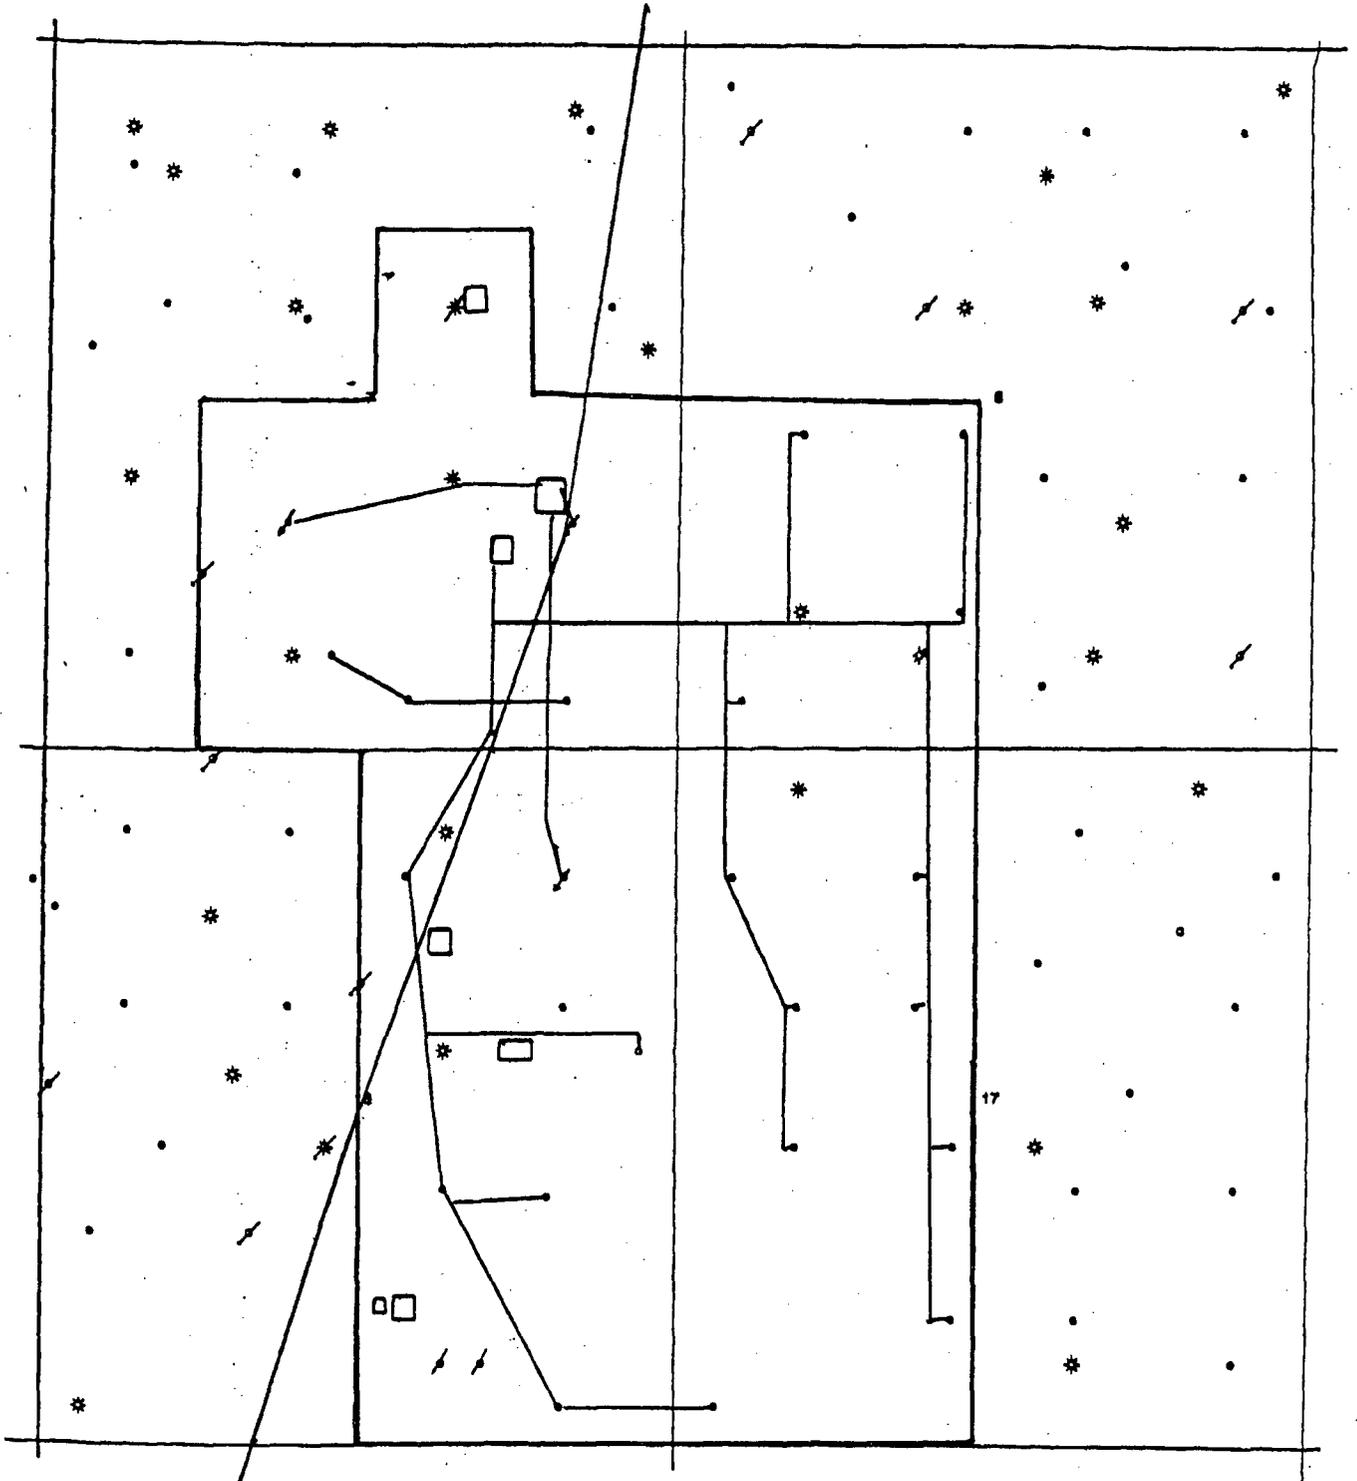
**A.8**      ***Pipeline Map showing all known pipelines,  
flowlines and injection lines.***

NOTE: Map is based on memory and aerial photos. May not be entirely accurate. On the ground investigation will determine actual ROW for all pipelines, flowlines and injection lines. A new map may be made as new lines or correct ROW's are found.

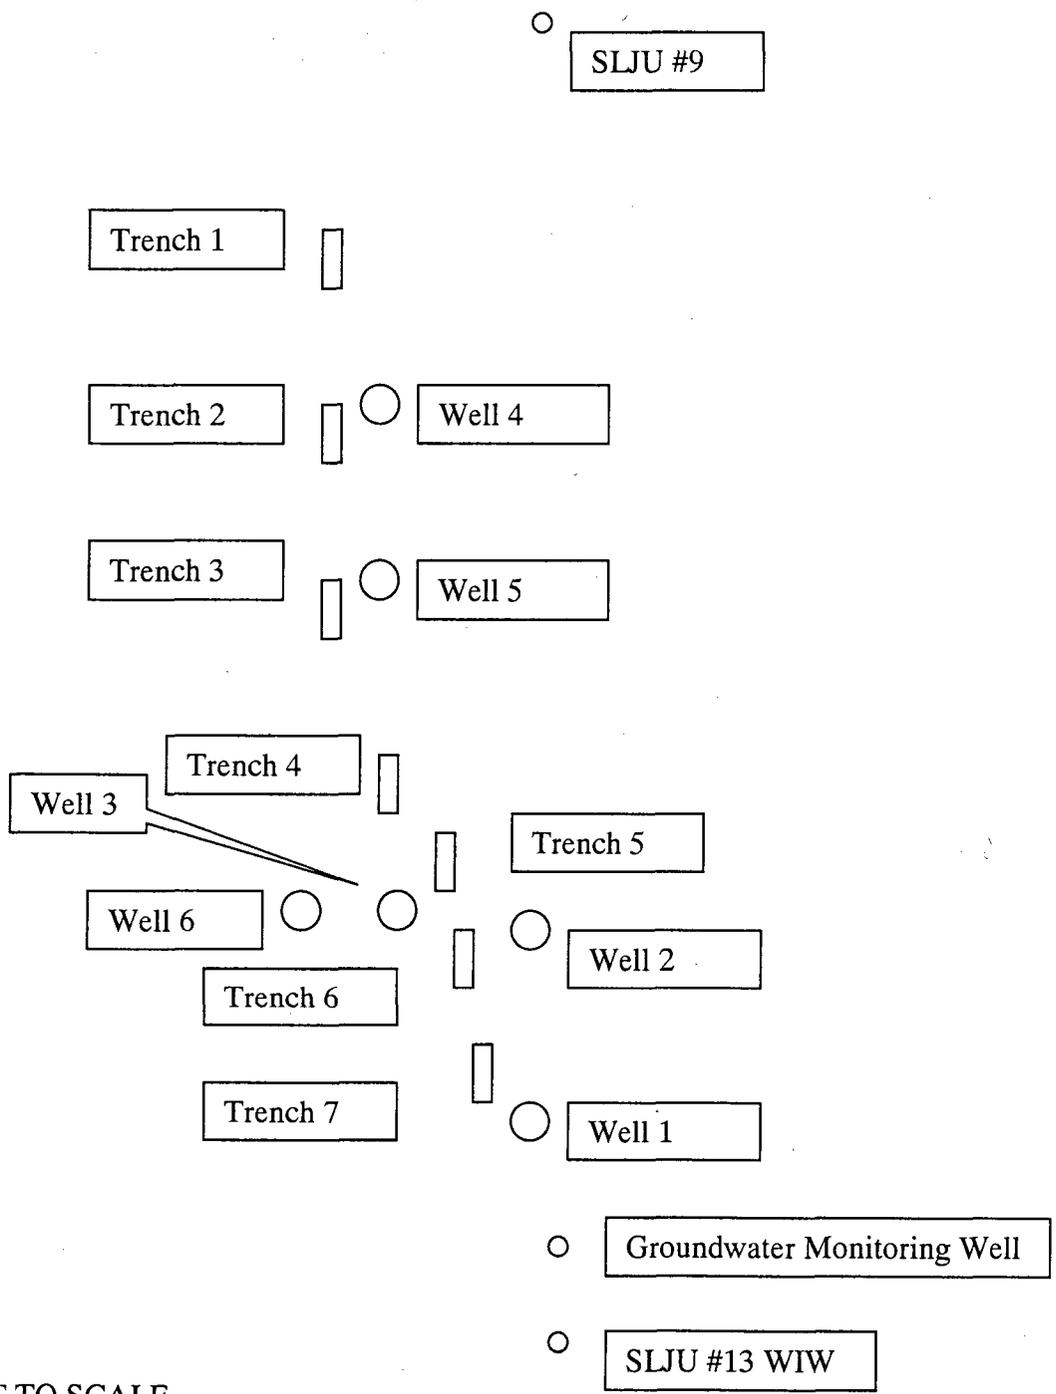
**Sampling Sites Along the Release of 10 January 1999**  
**Trenches and Bore Holes**

(Samples taken on 15, 16 & 18 January 1999 and 20 & 21 July 1999vby CERL.)

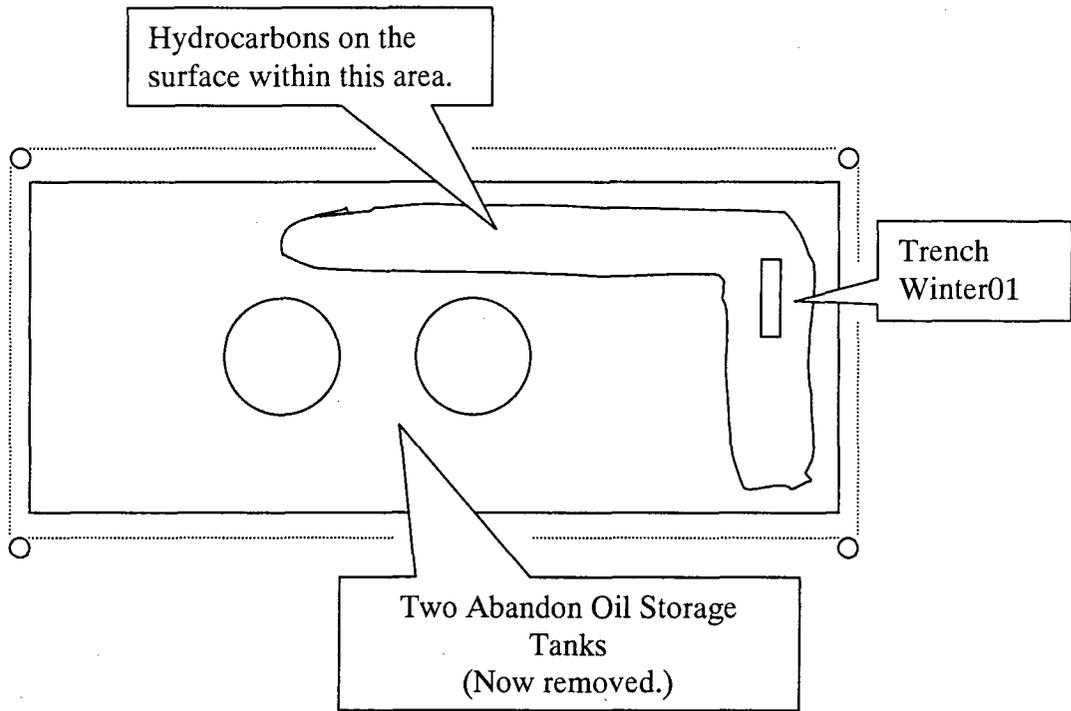
**Winters "E" Abandon Tank Battery**

(Sampled by CERL.)

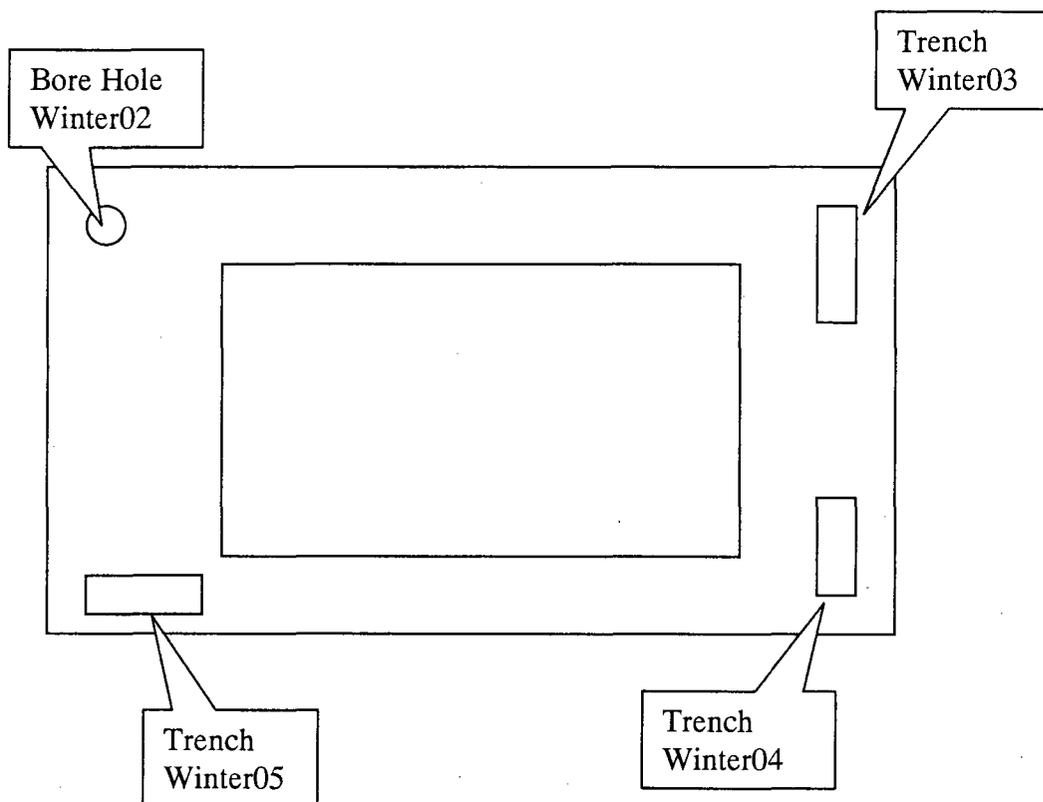
**Winters "C" Abandon Tank Battery**

(Sampled by CERL.)

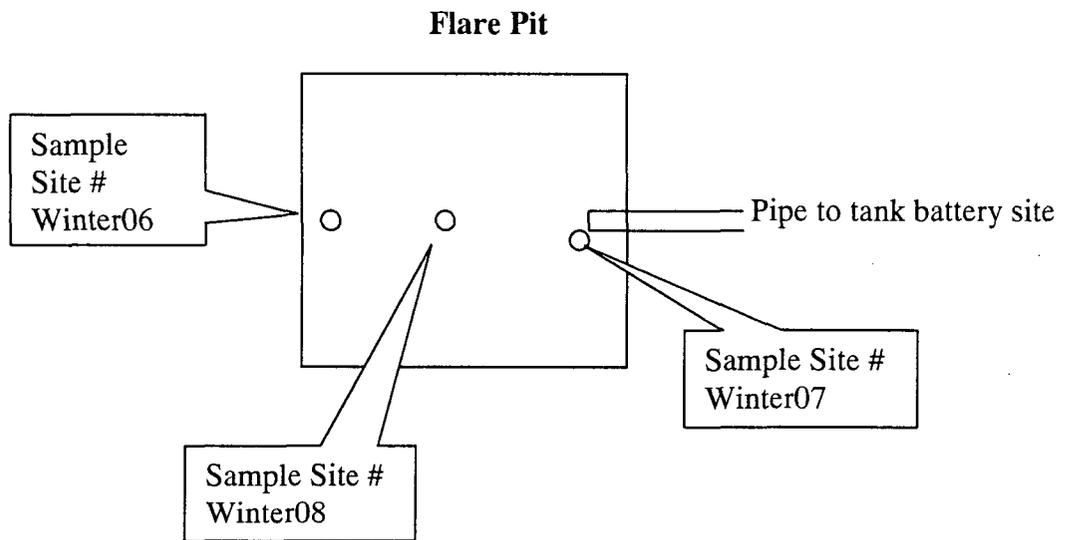
**Gutman Lease Abandon Tank Battery Flare Pit**

(Sampled by CERL.)

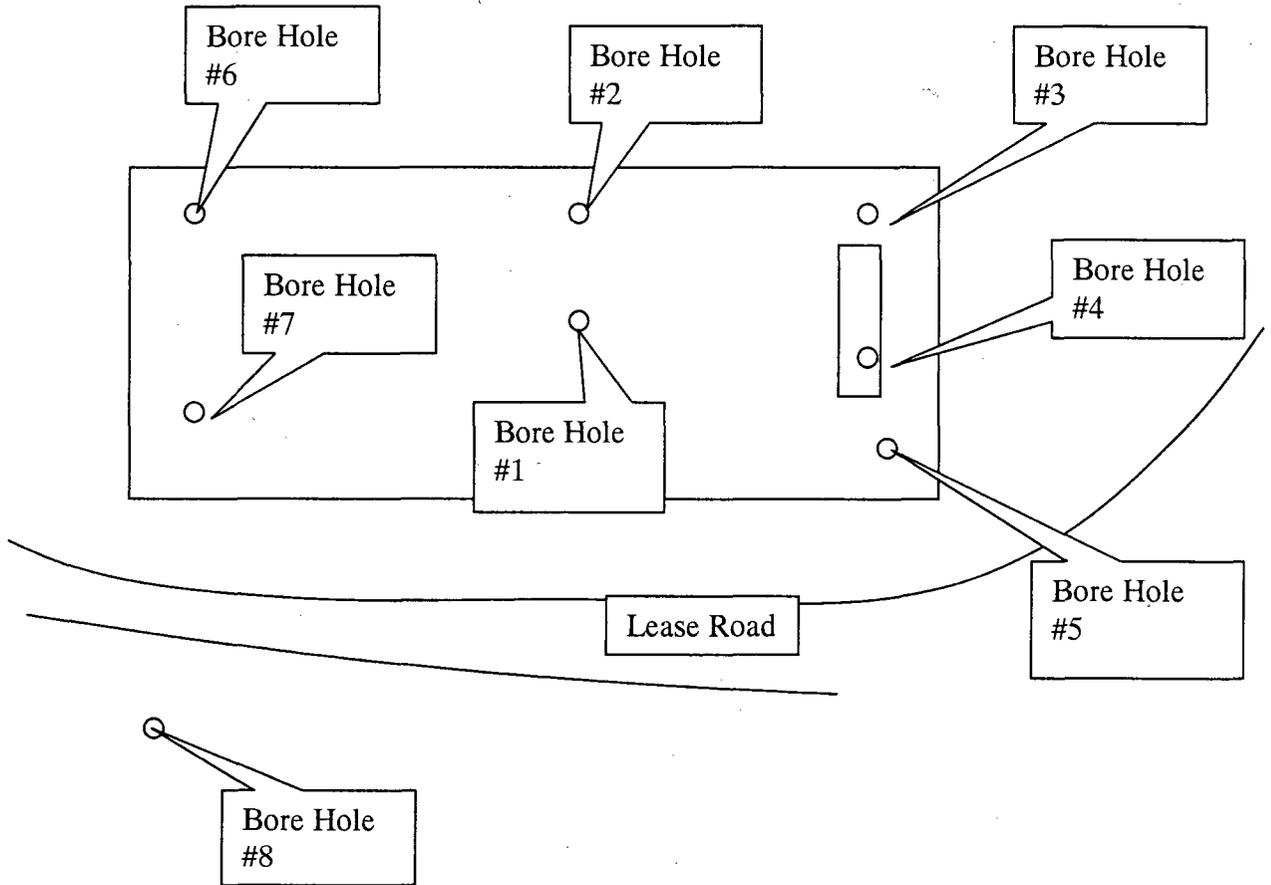
SESI Site #1

### Winters "E" Abandon Tank Battery

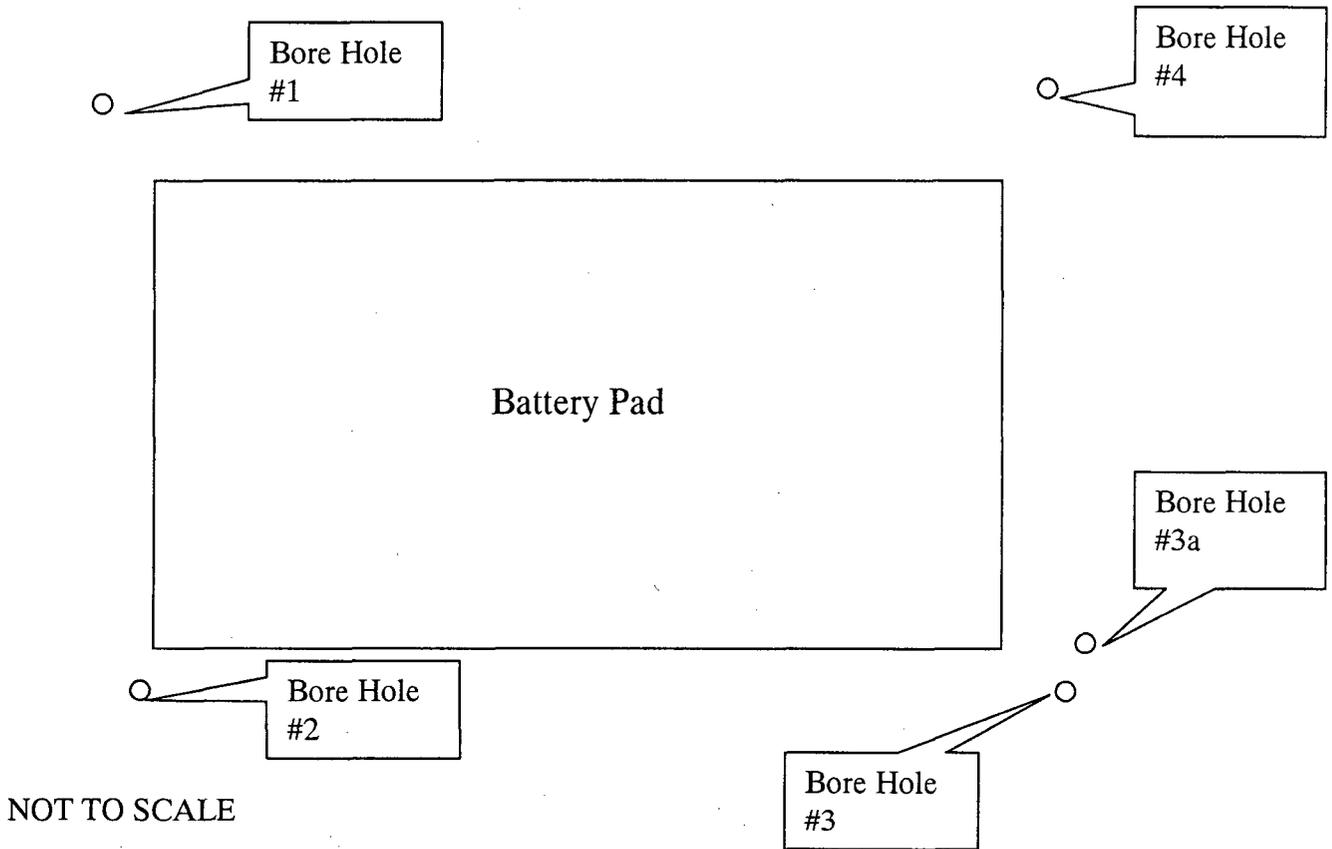
**SESI Site #2**

**Winters "C" Abandon Tank Battery**

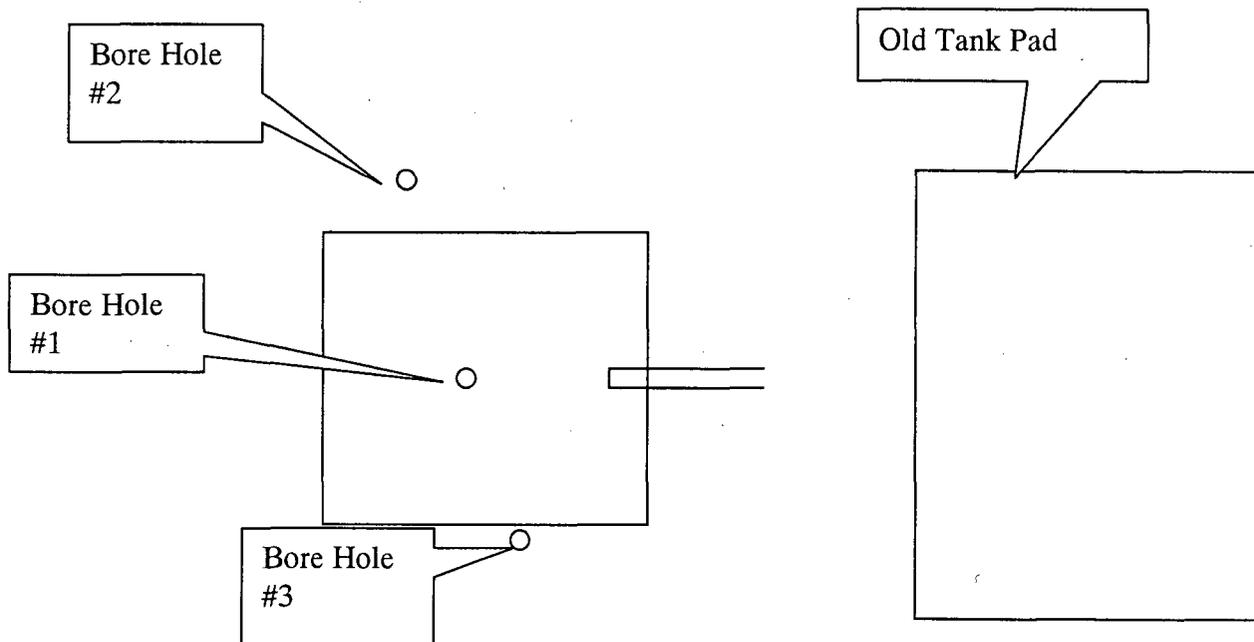
SESI Site #3

### Gutman Lease Abandon Tank Battery Flare Pit

Flare Pit
