1.
Operator: BP America Production Company OGRID #: 778
Address: 200 Energy Court, Farmington, NM 87401
Facility or well name: Gallegos Canyon Unit Com I 181
API Number: 3004507707 OCD Permit Number:
U/L or Qtr/Qtr F Section 34 Township 29N Range 12W County: San Juan
Center of Proposed Design: Latitude 36.68594 Longitude -108.09013 NAD: ☐ 1927 ☒ 1983
Surface Owner: ☐ Federal ☐ State ☒ Private ☐ Tribal Trust or Indian Allotment

BELOW-GRADE TANK CLOSURE PLAN

Gallegos Canyon Unit Com I 181
API No. 3004507707
Unit Letter F, Section 34, T29N, R12W

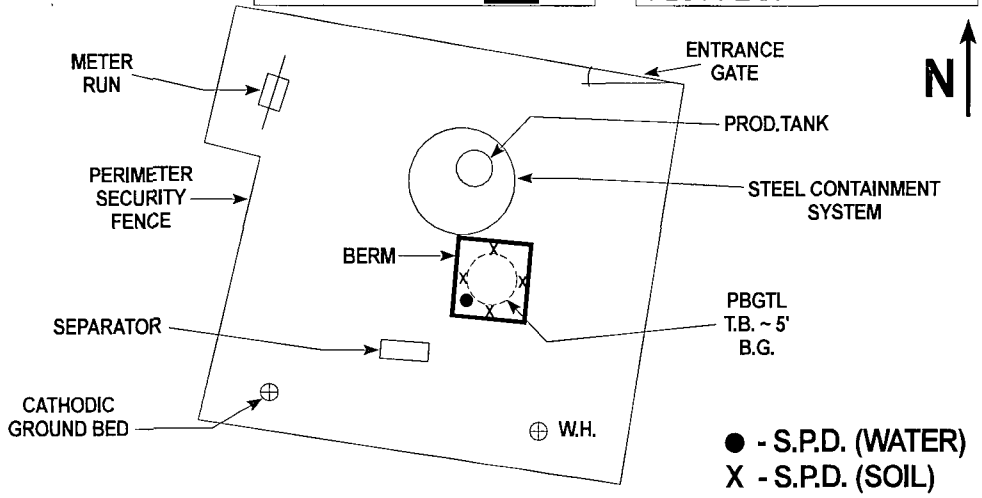
PLOT PLAN circle: attached

DISCOLORATION/STAINING OBSERVED: [YES] NO EXPLANATION - GRAY/BLACK @ 4' - 5' BELOW GRADE.

APPARENT EVIDENCE OF A RELEASE OBSERVED AND/OR OCCURRED : [YES] NO EXPLANATION: DISCOLORATION AND STRONG HYDROCARBON ODOR.

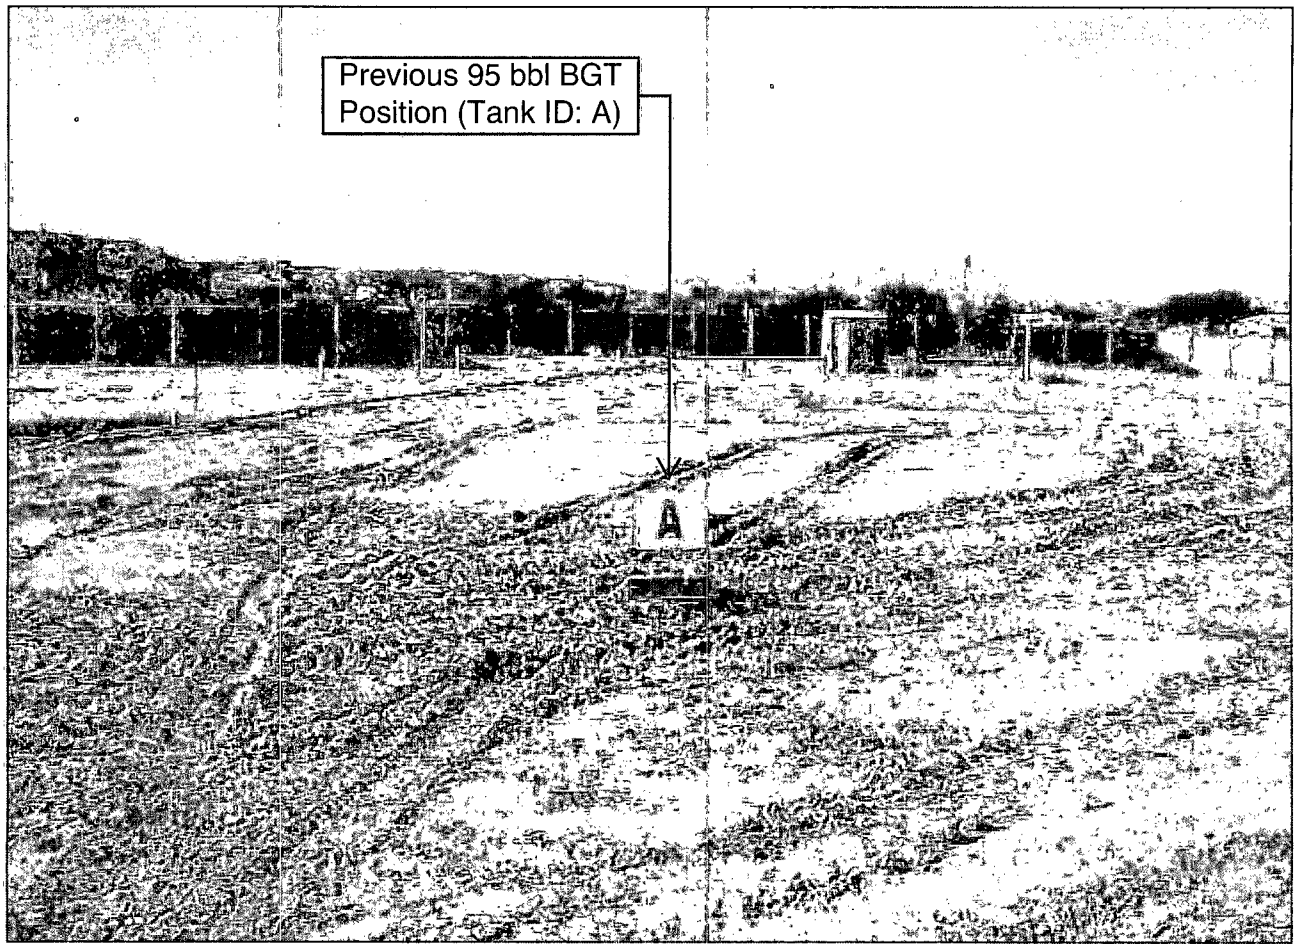
Previous 95 bbl BGT
Position (Tank ID: A)
A
