**GCU 40**  
 Fruitland Coal  
 API # 30-045-07182  
 T-28N, R-12-W, Sec. 29  
 San Juan County, New Mexico

**Well History**

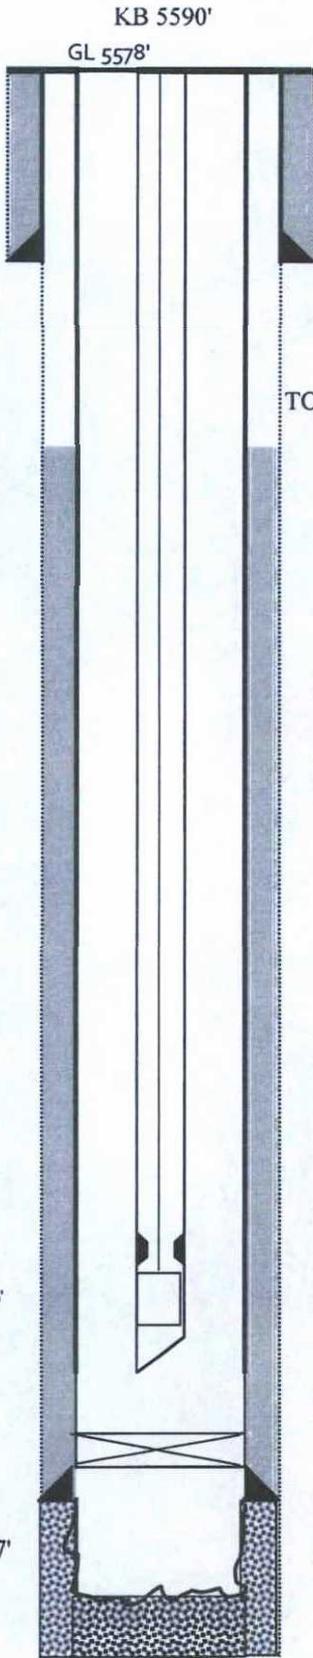
NIPPLE, PROFILE, "F", 2.375 OD, 1.780 ID @ 1266'

EOT @ 1281'

CIBP @ 1287'

TOC: Unknown

9 5/8" 32.3# H-40 @ 72'  
 cmt w/ 75 sx

TOC: unknown
