Pit, Below-Grade Tank, or
12687 Proposed Alternative Method Permit or Closure Plan Application

1.
Operator: BP America Production Company OGRID #: 778
Address: 200 Energy Court, Farmington, NM 87401
Facility or well name: Florance 93
API Number: 3004512061 OCD Permit Number: 6324
U/L or Qtr/Qtr C Section 30 Township 30N Range 9W County: San Juan
Center of Proposed Design: Latitude 36.78662 Longitude -107.82428 NAD: ☐ 1927 ☒ 1983
Surface Owner: ☒ Federal ☐ State ☐ Private ☐ Tribal Trust or Indian Allotment

BELOW-GRADE TANK CLOSURE PLAN

Florance 93
API No. 3004512061
Unit Letter C, Section 30, T30N, R9W

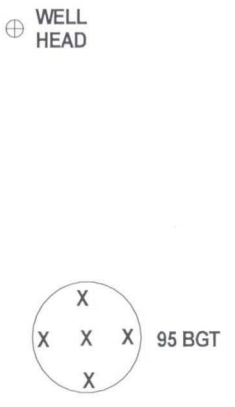
SITE SKETCH

EXCAVATION DIMENSIONS (if applicable): NA ft. X NA ft. X NA ft. cubic yards excavated (if applicable): NA

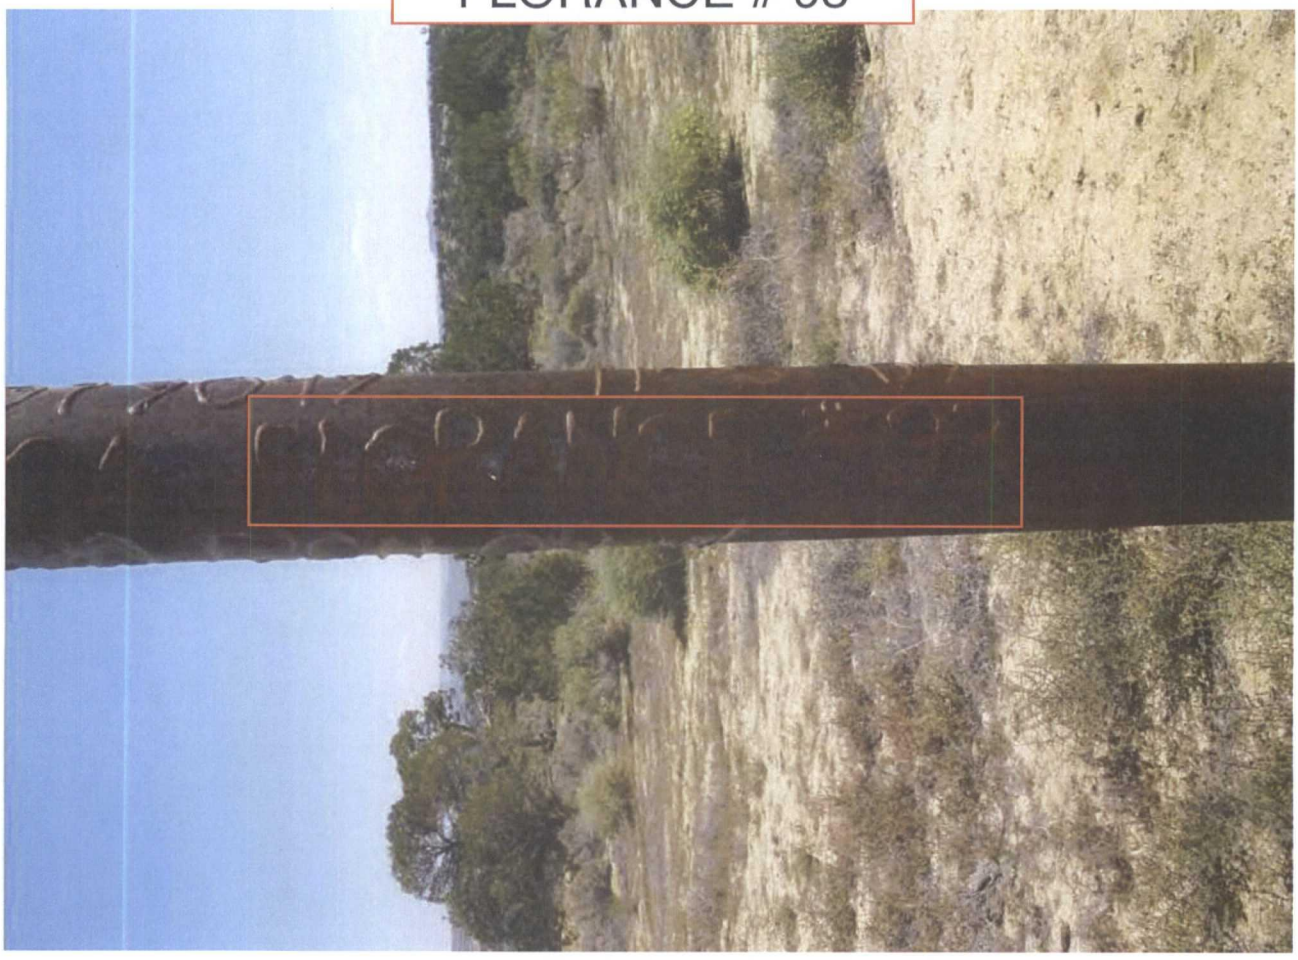
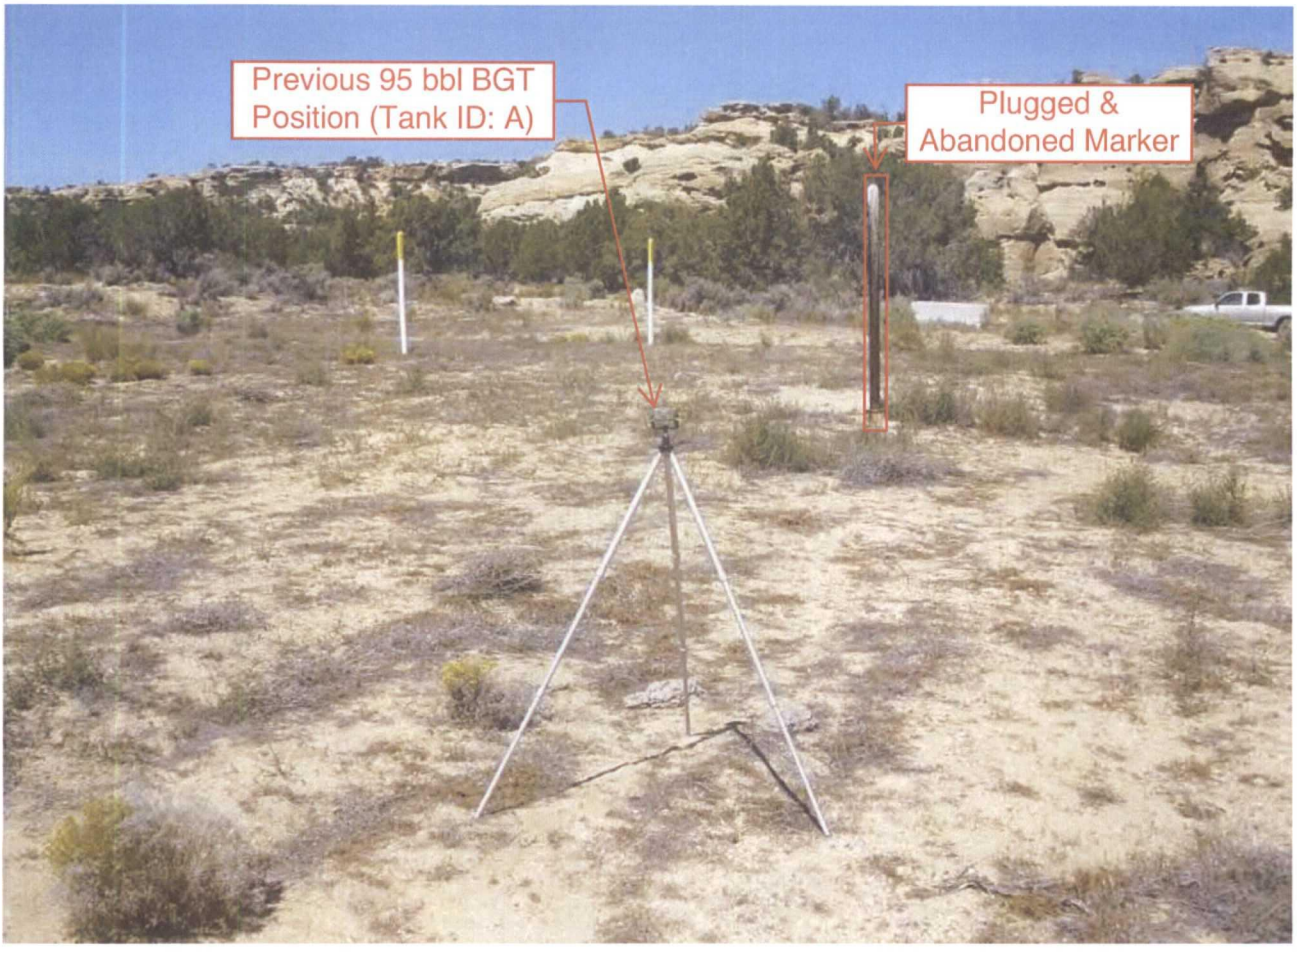
FLORANCE # 93

10. BP shall reclaim the BGT location and all areas associated with the BGT including associated access roads to a safe and stable condition that blends with the surrounding undisturbed area. BP shall substantially restore the impacted surface area to the condition that existed prior to oil and gas operations by placement of the soil cover as provided in Subsection H of 19.15.17.13 NMAC, re-contour the location and associated areas to a contour that approximates the original contour and blends with the surrounding topography and re-vegetate according to Subsection I of 19.15.17.13 NMAC.
The area over the BGT has been reclaimed since the well was plugged and abandoned.

Previous 95 bbl BGT
Position (Tank ID: A)
Plugged &
Abandoned Marker
