# **Gallegos Canyon Unit 145E**

Dakota

API # 30-045-24291

T-29N, R-12-W, Sec. 26

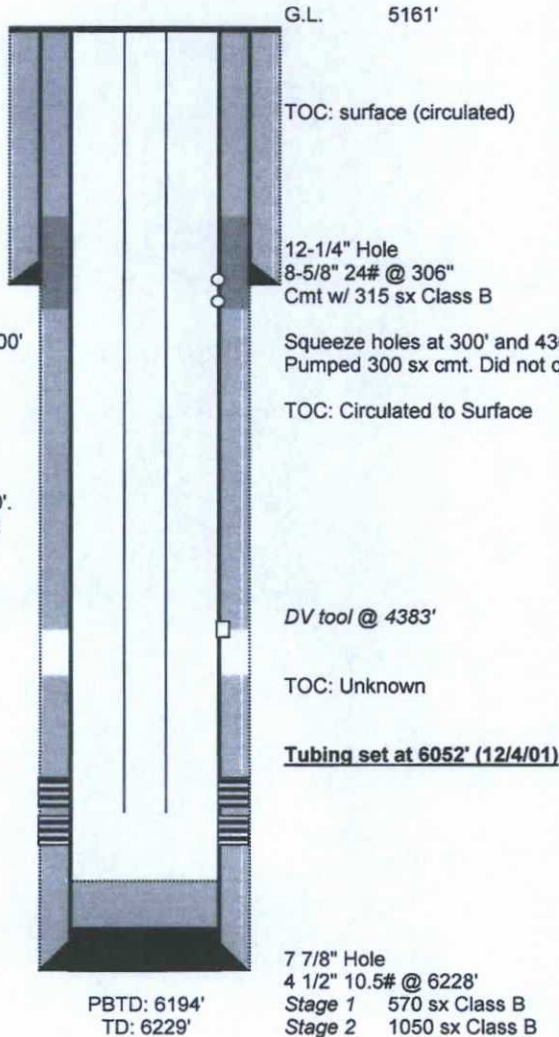
## **Dakota Perforations**

5992-6006'

6074-6114'

Fraced w/ 42,000 gals frac fluid & 131,000# 20/40 sand

1/16/01: Bradenhead repair. Perfed 430-431'.

Pumped 100 sx Class G cmt.

Perfed 300-301'. Pumped 200 sx Class G.
