# Pit, Below-Grade Tank, or
# Proposed Alternative Method Permit or Closure Plan Application

1.
Operator: BP America Production Company OGRID #: 778
Address: 200 Energy Court, Farmington, NM 87401
Facility or well name: Gallegos Canyon Unit 242E
API Number: 3004523901 OCD Permit Number:
U/L or Qtr/Qtr K Section 24 Township 28N Range 12W County: San Juan
Center of Proposed Design: Latitude 36.64497 Longitude -108.06758 NAD: ☐ 1927 ☒ 1983
Surface Owner: ☒ Federal ☐ State ☐ Private ☐ Tribal Trust or Indian Allotment

BELOW-GRADE TANK CLOSURE PLAN

**Gallegos Canyon Unit 242E – Tank A (95 bbl)**
**API No. 3004523901**
**Unit Letter K, Section 24, T28N, R12W**

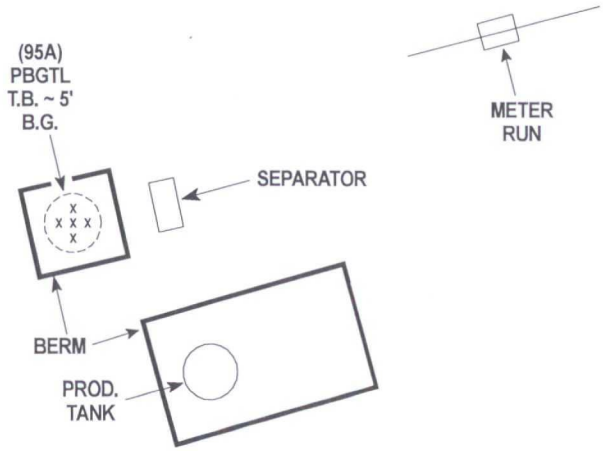
PLOT PLAN circle: attached

DISCOLORATION/STAINING OBSERVED: YES / [NO] EXPLANATION -

APPARENT EVIDENCE OF A RELEASE OBSERVED AND/OR OCCURRED : YES / [NO] EXPLANATION:

BGT Located : off / [on] site
