**Hutton GC 1E**  
Dakota  
API # 30-045-24152  
T-29N, R-12-W, Sec. 06  
San Juan County, New Mexico

History

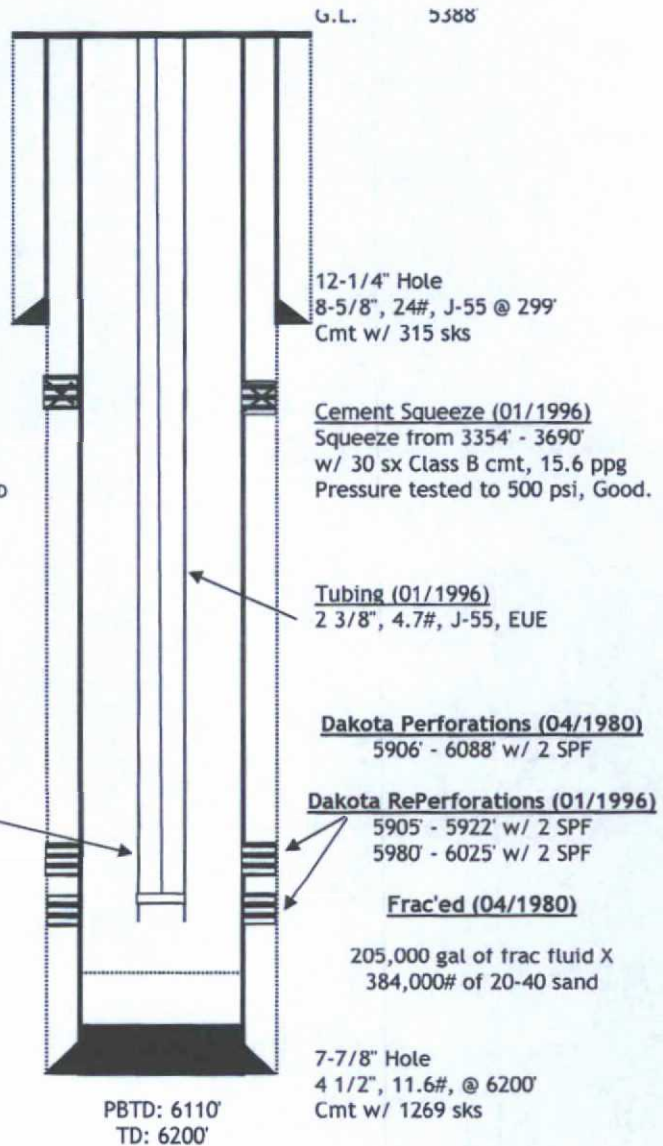
Tubing Detail (2013)

TUBING, 2.375, 4.7#, J-55, EUE

NIPPLE, PROFILE, "F", 2.375 OD, 1.780 ID

MULE SHOE, 2.375

Rod Detail (2012)

ROD, POLISHED: 1.25 X 16 FT

Rods: 4' pony

RODS, PONY: 8' x 0.75 GRD. D

RODS: 3/4" rods (203 jts)

RODS: 3/4" molded guide rods (32jts)

RODS: 1.25" sinker bars (5 jts)

PUMP, RHAC, 2.0 X 1.25 X 14

F nipple @ 6046

EOT @ 6064
