Pit, Below-Grade Tank, or
13045 Proposed Alternative Method Permit or Closure Plan Application

1.
Operator: BP America Production Company OGRID #: 778
Address: 200 Energy Court, Farmington, NM 87401
Facility or well name: Florance #27A
API Number: 3004522349 OCD Permit Number:
U/L or Qtr/Qtr E Section 26 Township 29N Range 9W County: San Juan
Center of Proposed Design: Latitude 36.69997 Longitude -107.75439 NAD: ☐1927 ☒1983
Surface Owner: ☒ Federal ☐ State ☐ Private ☐ Tribal Trust or Indian Allotment

BELOW-GRADE TANK CLOSURE PLAN

Florance #27A
API No. 3004522349
Unit Letter E, Section 26, T29N, R9W

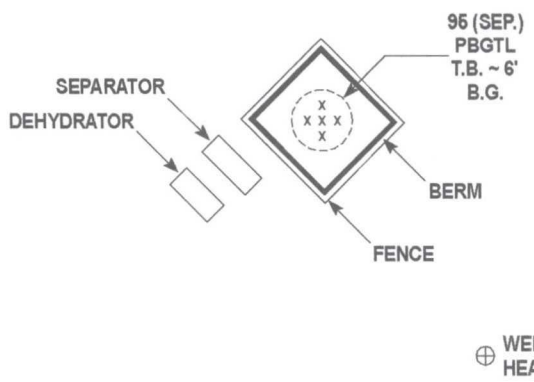
SITE SKETCH

DISCOLORATION/STAINING OBSERVED: ~~YES~~ / NO EXPLANATION - ~~MINOR STAINING OBSERVED AT BEDROCK SURFACE BENEATH 95 BGT (TANK) ONLY.~~

ADDITIONAL COMMENTS: BACKHOE USED TO COLLECT SAMPLES. ~~BEDROCK OBSERVED AT APPROX. 5 FT. BELOW GRADE AT 95 BGT (TANK) POSITION. WILL GET 95 BW/DB BGT AT 95 BGT (TANK) LOCATION.~~ NO APPARENT EVIDENCE OF ANY IMPACTS OBSERVED AT 95 BGT (SEP.).

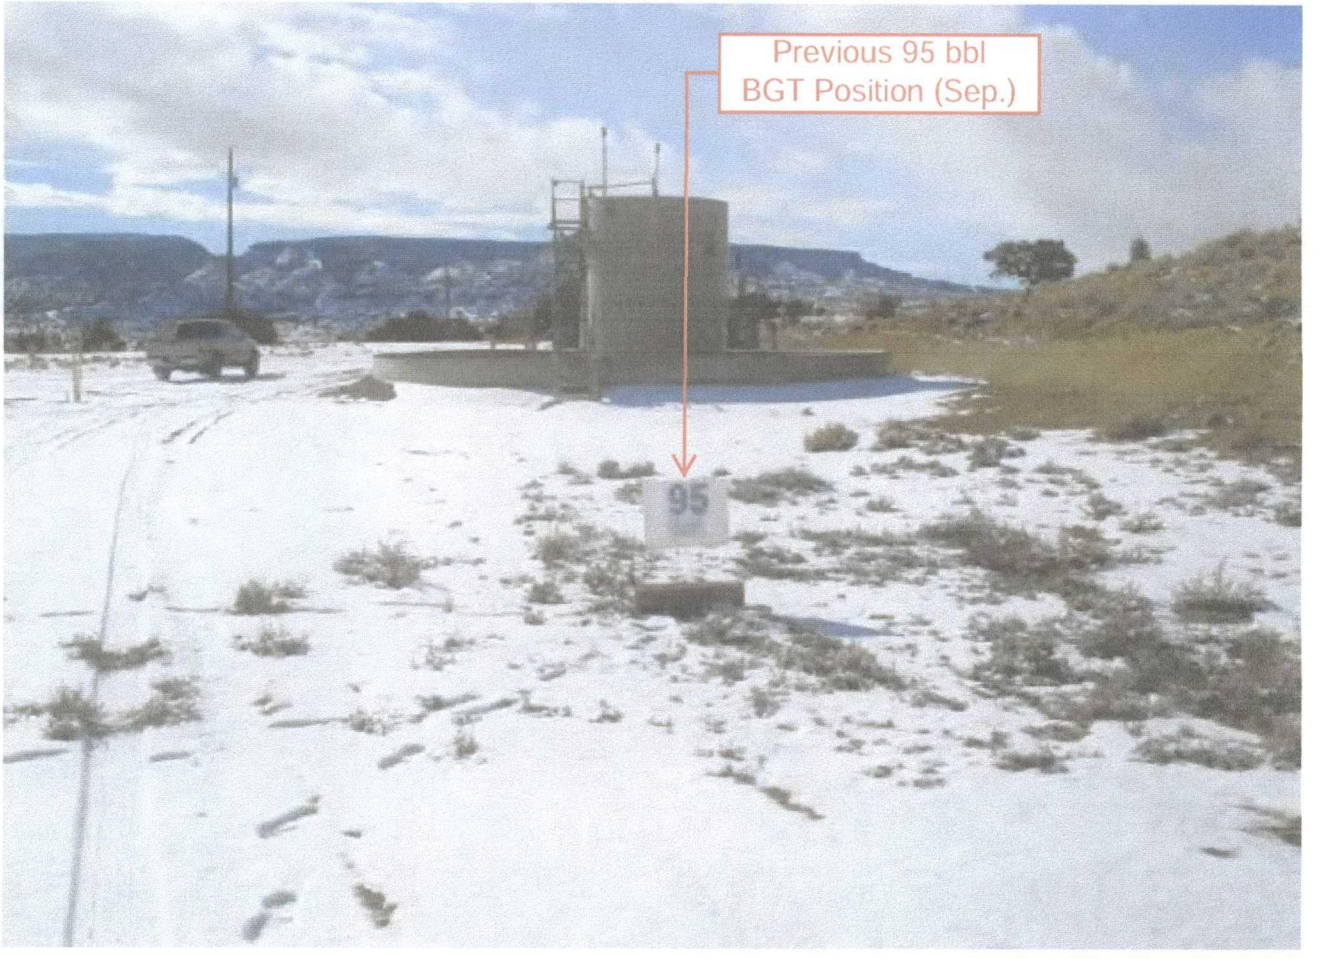
Previous 95 bbl
BGT Position (Sep.)
95

10. BP shall reclaim the BGT location and all areas associated with the BGT including associated access roads to a safe and stable condition that blends with the surrounding undisturbed area. BP shall substantially restore the impacted surface area to the condition that existed prior to oil and gas operations by placement of the soil cover as provided in Subsection H of 19.15.17.13 NMAC, re-contour the location and associated areas to a contour that approximates the original contour and blends with the surrounding topography and re-vegetate according to Subsection I of 19.15.17.13 NMAC.
The area over the BGT is still within the active well area. This area will be reclaimed when the well is plugged and abandoned as part of final reclamation.
