**Heaton Com LS 009A**

API # 30-045-24988

Unit I - Sec. 32 - T31N - R11W  
San Juan, NM**Fruitland Perforations**

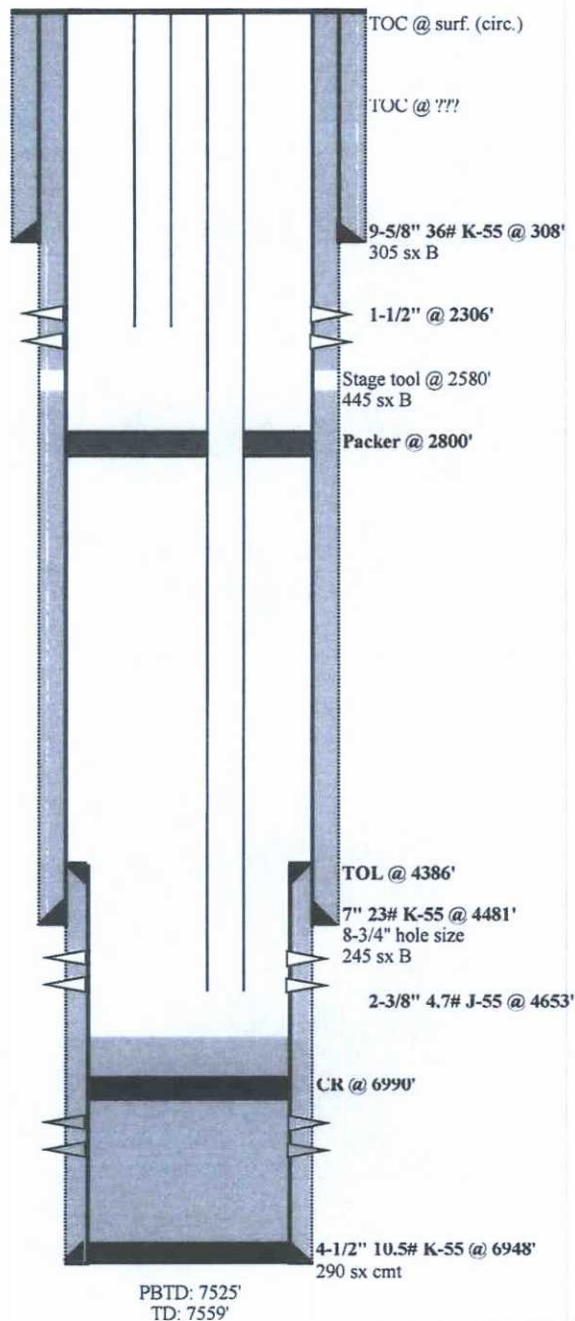
Frac'd w/ 70% Q foam &amp; 172k# 20/40 sd

**Mesa Verde Perforations**

Frac'd w/ 70% Q foam &amp; 75k# 12/20 sd

**Dakota Perforations**

Frac'd w/ 60k gal 70% Q foam &amp; 112k# 20/40 sd

GL: 6281'

PBTD: 7525'  
TD: 7559'**OIL CONS. DIV DIST. 3**
