Pit, Below-Grade Tank, or
14198 Proposed Alternative Method Permit or Closure Plan Application

GALLEGOS CANYON UNIT 520
API 30-045-28595
(J) Section 22 – T29N – R12W
San Juan County, New Mexico

BELOW-GRADE TANK CLOSURE PLAN

Gallegos Canyon Unit 520
API No. 3004528595
Unit Letter J, Section 22, T29N, R12W

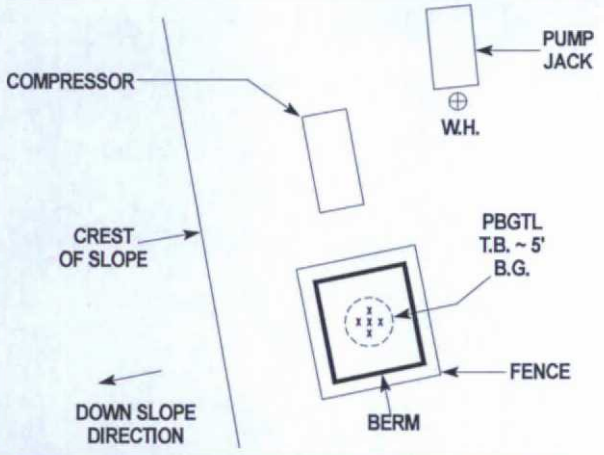
PLOT PLAN circle: attached

DISCOLORATION/STAINING OBSERVED: YES / [NO] EXPLANATION -

APPARENT EVIDENCE OF A RELEASE OBSERVED AND/OR OCCURRED : YES [NO] EXPLANATION:
