**SUNDRY NOTICES AND REPORTS ON WELLS**

Amoco Production Company requests permission to perform a bradenhead repair on this well per attached procedures.

PAN AMERICAN PETROLEUM CORPORATION  
 E. H. PIPKIN NO. 5  
 1155 ENL & 1460 FEL, SEC. 36, T28N, R11W  
 BASIN DAKOTA POOL  
 SAN JUAN CO., NEW MEXICO

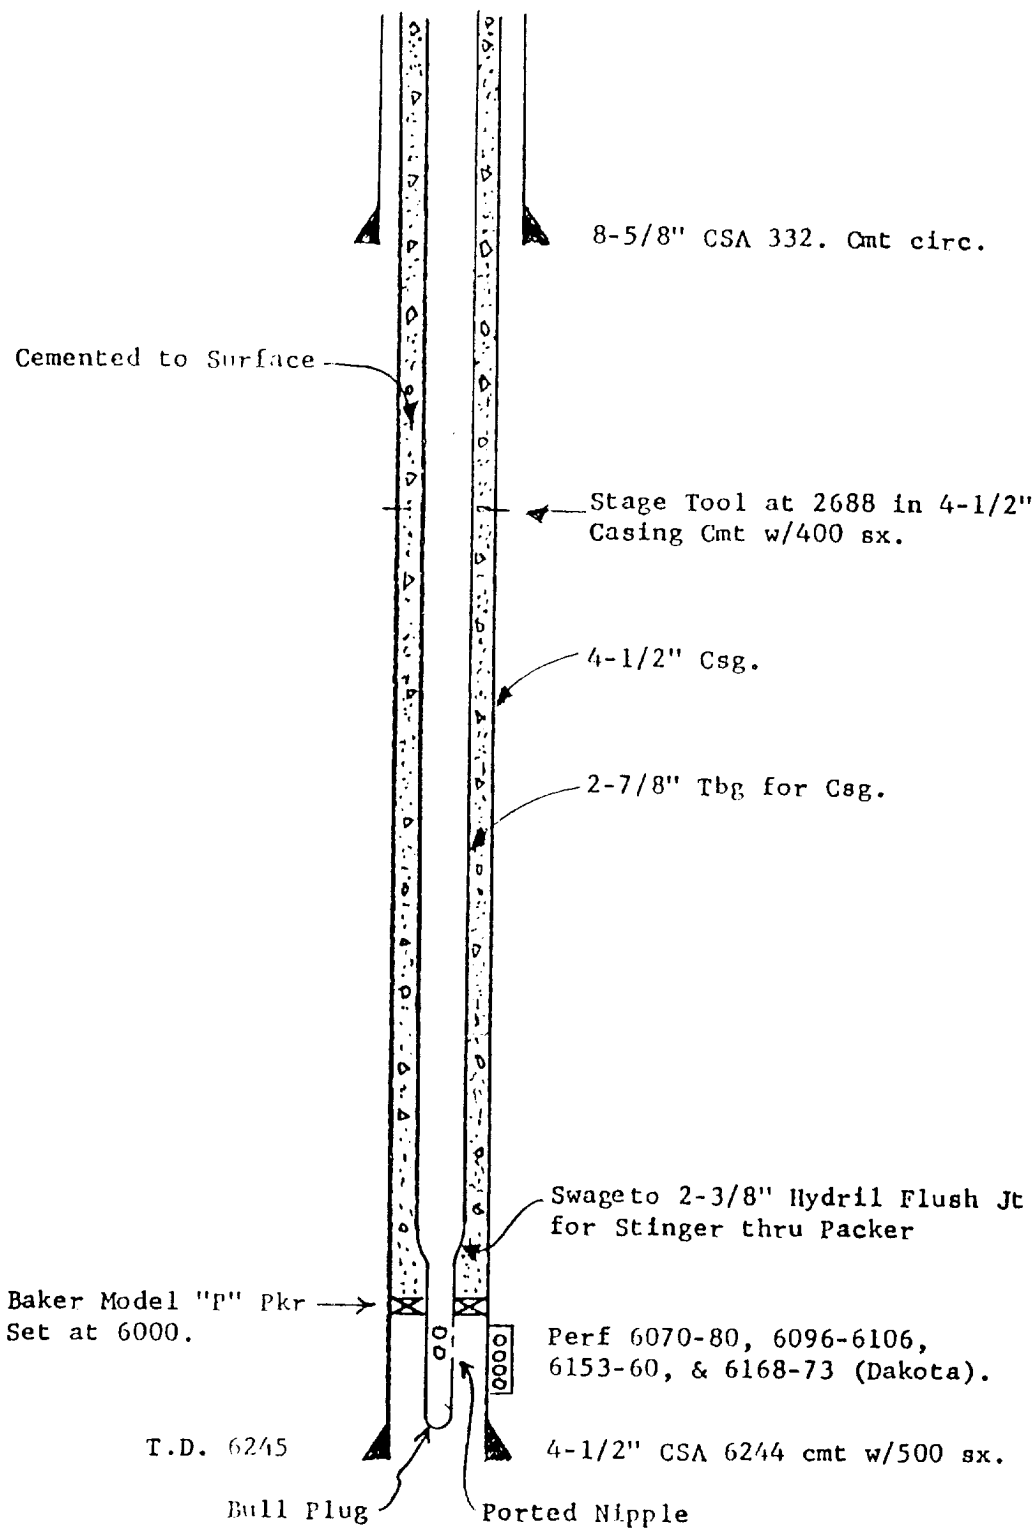
**Brief description of work:** The EH Pipkin #5 was initially completed 5/60. In 8/65 2 7/8" tubing was cemented in the hole above a permanent packer. This procedure followed an apparently successful cement squeeze of casing leaks in the Mesaverde interval. A bradenhead problem has been identified on this well making the bradenhead repair difficult and somewhat risky.

Due to the slimhole design of this well and two casing strings present across the majority of the wellbore we are unable to run a CBL to identify the cement top outside of the 4 1/2" casing. We also have 230 psig pressure between the 2 7/8" casing and the 5 1/2" casing indicating 2 7/8" a problem with the casing integrity. The integrity problem could be a leak in the 2 7/8" casing, a seal leak in the casing head, or more probably a channel in the 2 7/8" x 4 1/2" annulus. The 8 5/8" surface casing is set at 332' and the bottom of the Ojo is at 545'. The 4 1/2" was cemented near surface through a DV tool located at 2688'. The stage volume was 400 sx Class A with 6% gel. The theoretical cement height for this slurry is 3078'. We know that this is incorrect as there was no report of cement being circulated to surface (although good circulation was reported) and there is bradenhead pressure and water flow from this annular space. Given this data, we plan to run a CBL inside the 2 7/8" to see if we can locate a cement top even though cement was reported as circulated to surface. We then plan to perforate through the 2 7/8" and 4 1/2" casing strings at approximately 595'. If successful in establishing circulation to surface, will create a seal between the Ojo and surface sands eliminating our bradenhead problem. If unable to circulate, we will design our cement squeeze to cover the Ojo thereby isolating our problem. If necessary, we'll also perforate and cement squeeze or circulate to surface from a point just below the surface casing shoe.
