Pit, Below-Grade Tank, or
14451 Proposed Alternative Method Permit or Closure Plan Application

1.
Operator: BP America Production Company OGRID #: 778
Address: 200 Energy Court, Farmington, NM 87401
Facility or well name: Gallegos Canyon Unit 219E
API Number: 3004525449 OCD Permit Number:
U/L or Qtr/Qtr D Section 23 Township 28N Range 12W County: San Juan
Center of Proposed Design: Latitude 36.65305 Longitude -108.08733 NAD: ☐1927 ☒1983
Surface Owner: ☒ Federal ☐ State ☐ Private ☐ Tribal Trust or Indian Allotment

BELOW-GRADE TANK CLOSURE PLAN

Gallegos Canyon Unit #219E
API No. 3004525449
Unit Letter H, Section 21, T28N, R12W

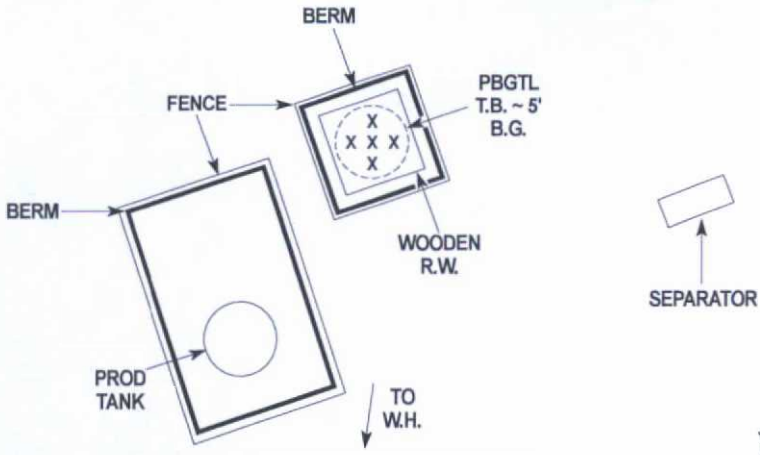
PLOT PLAN circle: attached

BGT Located : off / on site

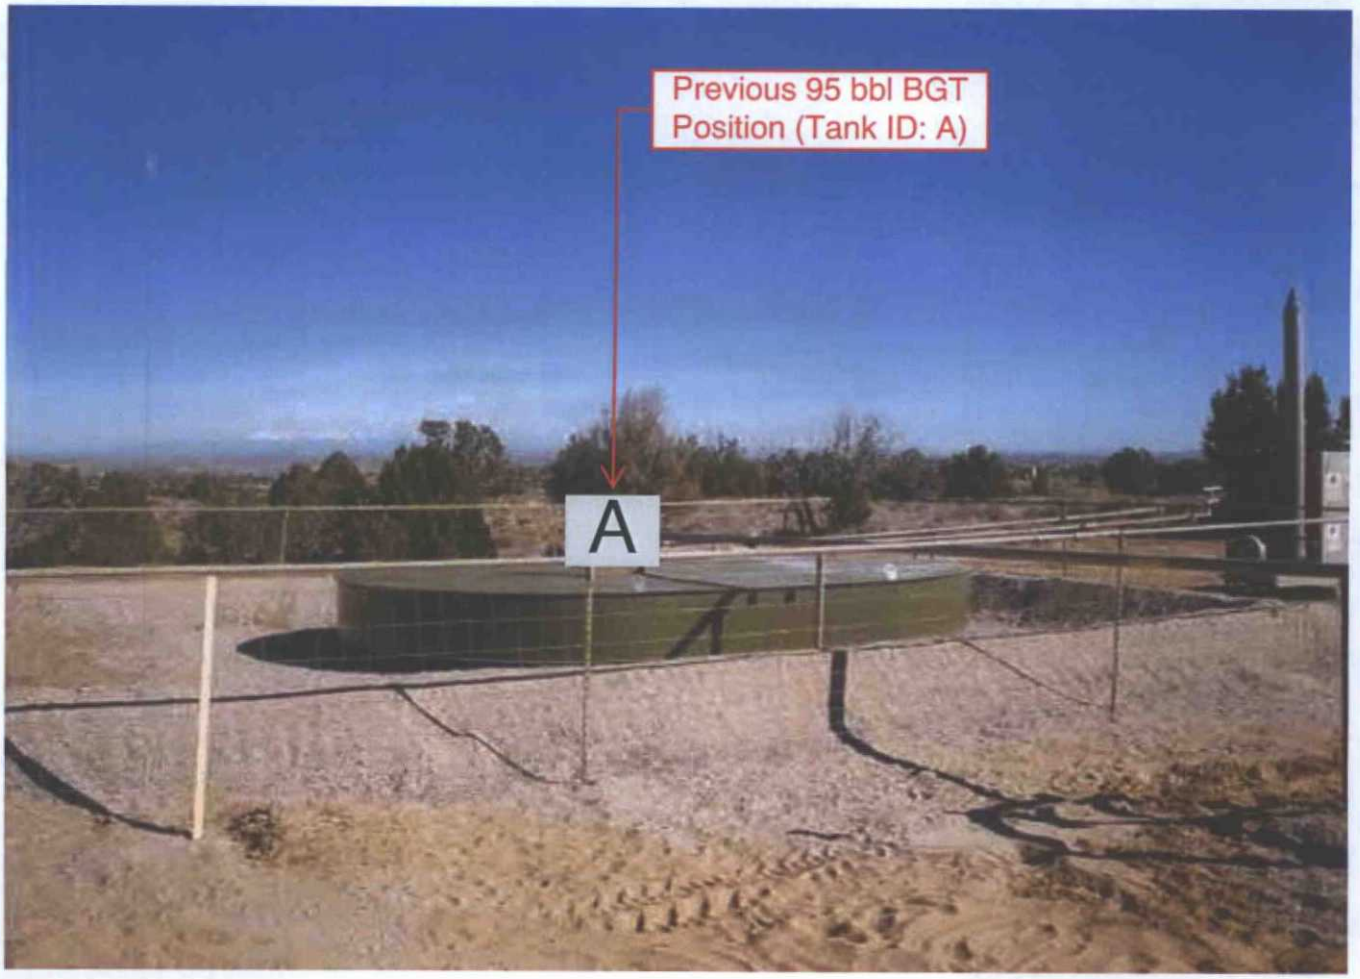
Previous 95 bbl BGT
Position (Tank ID: A)
A

9. If the sampling demonstrates that a release has not occurred or that any release does not exceed the concentrations specified above, then BP shall backfill the excavation, with compacted, non-waste containing, earthen material; construct a division-prescribed soil cover, re-contour and re-vegetate the location. The location will be reclaimed if it is not with in the active process area
Sampling results determine no significant release has occurred. Area was backfilled with clean, earthen material and is within the active well pad.

10. BP shall reclaim the BGT location and all areas associated with the BGT including associated access roads to a safe and stable condition that blends with the surrounding undisturbed area. BP shall substantially restore the impacted surface area to the condition that existed prior to oil and gas operations by placement of the soil cover as provided in Subsection H of 19.15.17.13 NMAC, re-contour the location and associated areas to a contour that approximates the original contour and blends with the surrounding topography and re-vegetate according to Subsection I of 19.15.17.13 NMAC.
The area has been backfilled and will be reclaimed once the well has been plugged and abandoned.
