Sundry Notices and	Reports on Well	s
		API	# (assigned by OCD) 30-045-20681
1. Type of Well GAS		5.	Lease Number Fee
		6.	State Oil&Gas Lease
2. Name of Operator		7.	Lease Name/Unit Name
MERIDIAN OIL		8.	Lackey Well No.

PERTINENT DATA SHEET

Lackey #3 Aztec Pictured Cliffs SE Section 19, T-29-N, R-9-W Recommended Casing Repair Procedure

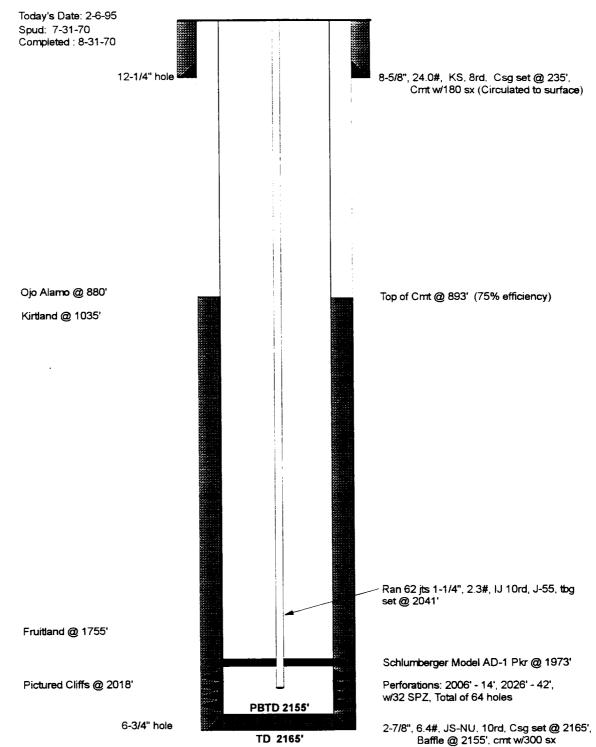
CURRENTAztec Pictured Cliffs

1000'FSL, 1550' FEL

SE Section 19, T-29-N, R-09-W, San Juan County, NM

WELLNAME:					i				
WELLIAMINE.	Lackey #3				DP NUMBER: PROP. NUMBER:		52373A 072251801		
WELL TYPE:	Aztec Pictured Cliff	s			ELEVATION:	GL: KB:	5634' 5645'		
LOCATION:	SE Sec. 19, T29N,				INITIAL POTENTIAL:	AOF	2,931	MCF/D	
	San Juan County, New Mexico			SICP:	June, 1985	265	PSIG		
OWNERSHIP:	GWI: NRI:	52.471482% 43.813687%			DRILLING:		SPUD DATE: COMPLETED: TOTAL DEPTH: PBTD: COTD:	: :	07-31-70 08-31-70 2165' 2155' 2155'
CASING RECORD:									
HOLE SIZE	SIZE	WEIGHT	GRADE	<u>DEPTH</u>	EQUIP.		CEMENT	_	TOC
12-1/4"	8-5/8"	24.0#	KS	235'	•	180 sx			surface
6-3/4"	2-7/8"	6. 4#	JS-NU	2165		215 sx			893' (75%
Tubing	1-1/4"	2.3#	J- 55	2041'					
	Ran 2 jts (ta	ilpipe), Schlumi	oerger Mode	el AD-1 Pack	ter, 60 jts 1-1/4", 2.3#, J-55	, 10rd, tbg set	@ 2165'.		
FORMATION TOPS:	Ran 2 jts (ta Ojo Alamo Kirtland Fruitland Pictured Cliffs	ilpipe), Schlumt	880' 1035' 1755' 2018'	el AD-1 Pack	ter, 60 jts 1-1/4", 2.3#, J-55	, 10rd. tbg set o	@ 2165'.
