2. Name of Operator MERIDIAN OIL		8	. Well Name & Number Scott #2A
3. Address & Phone No. of Operato PO Box 4289, Farmington, NM	97499 (505) 326-9700		. API Well No. 30-045-21994

WORKOVER PROCEDURE - TUBING REPLACEMENT

Scott 2A
DPNO 53561A / 53561B
Blanco Pictured Cliffs / Mesaverde
Section 31, T32N, R10W
San Juan County, New Mexico

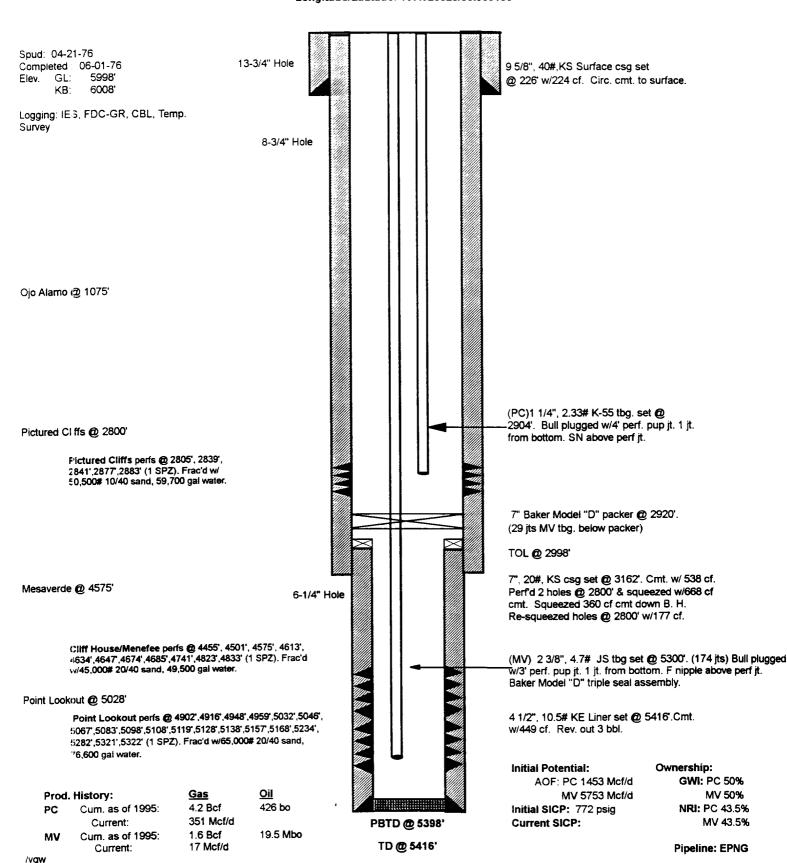
Blanco Pictured Cliffs/Blanco Mesaverde DPNO: 53561A / 53561B

1650' FSL, 980' FEL Sec. 31, T32N, R10W, San Juan Co., NM Longitude/Latitude: 107.928820/36.939150
