Pit, Below-Grade Tank, or Proposed Alternative Method Permit or Closure Plan Application

BP AMERICA PRODUCTION COMPANY
SAN JUAN BASIN, NORTHWEST NEW MEXICO

BELOW-GRADE TANK CLOSURE PLAN

Barrett A 010
API No. 3004526826
Unit Letter O, Section 20, T31N, R09W

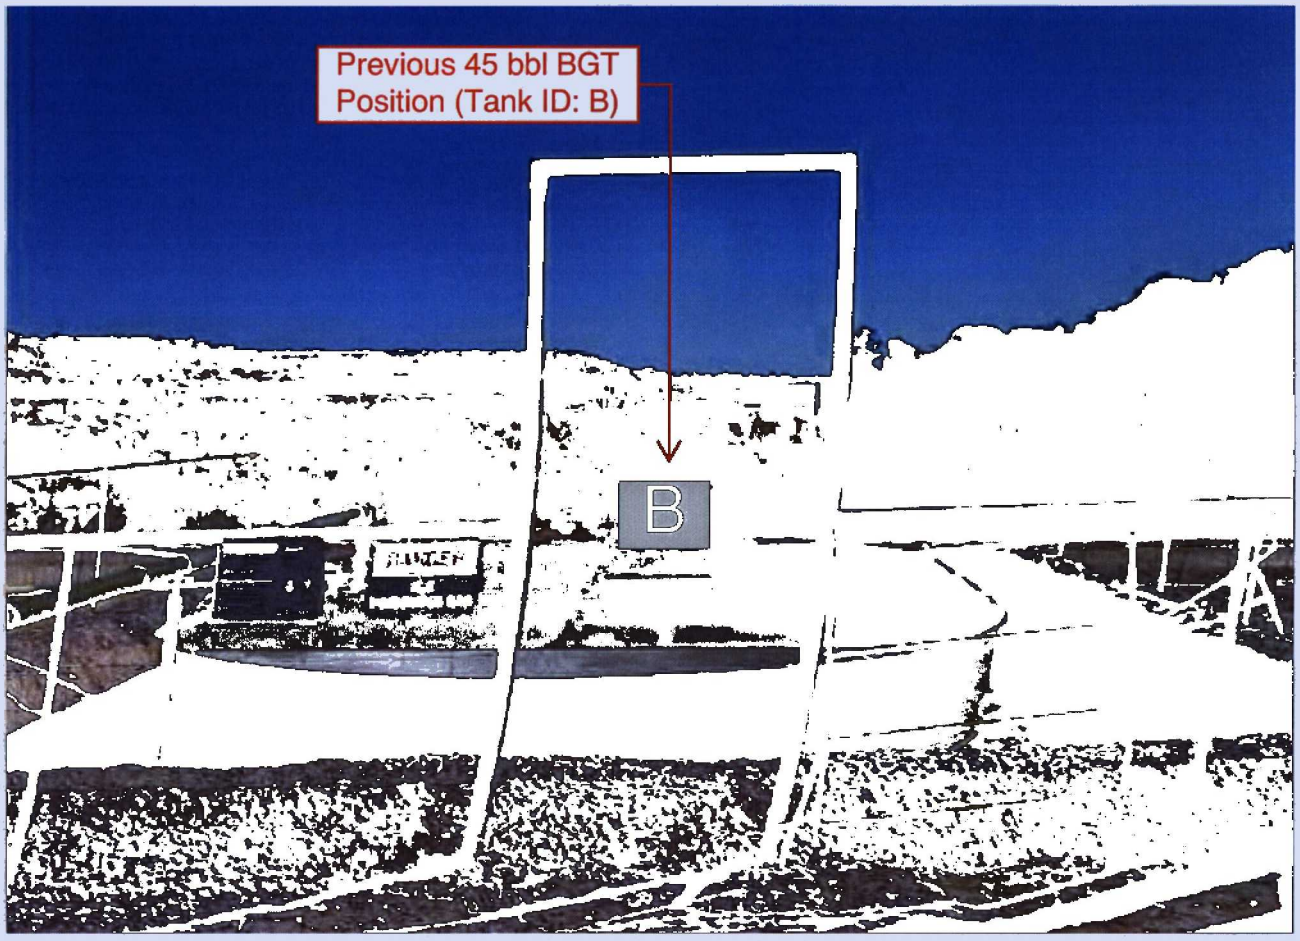
Previous 45 bbl BGT
Position (Tank ID: B)
B

10. BP shall reclaim the BGT location and all areas associated with the BGT including associated access roads to a safe and stable condition that blends with the surrounding undisturbed area. BP shall substantially restore the impacted surface area to the condition that existed prior to oil and gas operations by placement of the soil cover as provided in Subsection H of 19.15.17.13 NMAC, re-contour the location and associated areas to a contour that approximates the original contour and blends with the surrounding topography and re-vegetate according to Subsection I of 19.15.17.13 NMAC.
    The area has been backfilled and will be reclaimed once the well has been plugged and abandoned.
